Artikel: Crack growth tests to assess the remaining fatigue life of old steel

bridges

Autor: Brandes, Klaus

Crack Growth Tests to Assess the Remaining Fatigue Life of Old Steel Bridges

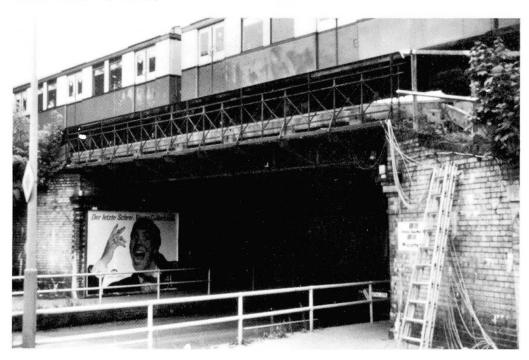
Figure 1.
Steel bridge
of the
Berlin
Metropolitan, built
in 1898,
replaced
1988

Up to now, crack growth tests have been included in the investigation of three bridges in our institute [5] [8]. The first one, a road bridge, was built in 1952 with unidentified material from the thirties. The other ones, two parallel bridges of the Berlin Metropolitan, fig. 1, were erected in 1898. The latter ones are now replaced because of widening of the streets they crossed. In all cases, we measured strains under traffic. The two bridges of the Berlin Metropolitan will be used as models of natural size to evaluate their fatigue life after hundred years of loading, maintance and corrosion.

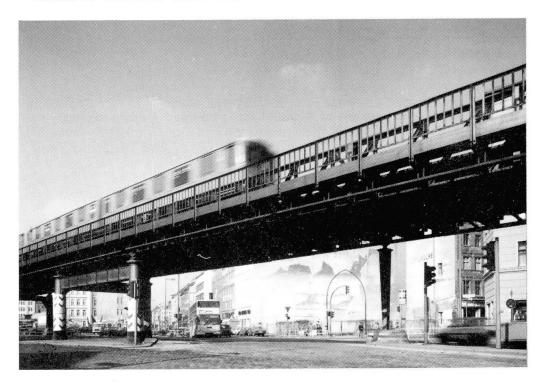
Figure 2.
Truss girder bridge of the Berlin Underground, built in 1902, replaced in 1989

Today, we perform cyclic loading tests on parts of the Berlin Underground Bridge shown in fig. 2, which was built in 1902.

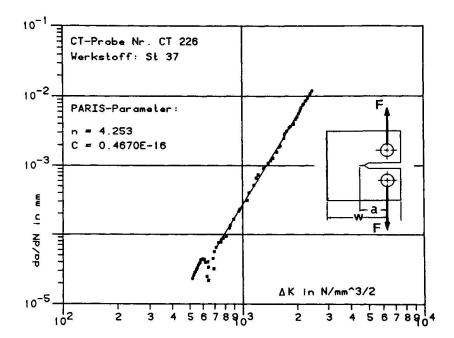
Figure 3.
Result of
one of the
crack
growth
tests (ASTM
E 647-83)
with regression
line regarding the
Paris equation (1)

The crack growth tests which supplemented the set of standard technological tests (strength, chemical analysis) were performed according to ASTM E 647-83 [10]. The specimens were 12.5 mm thick. The initial value of the cyclic stress intensity factor Δ K reached 300 N/mm^{3/2} to 500 N/mm^{3/2}.

The results of the tests, given in terms of the Paris-equation, fig. 3, $da/dN = C \Delta K^{R}$ (1)

have proven that there is no significant difference between mild steel produced at the turn of the centuries and today.

The value of n tends to a little bit higher values than presented in textbooks for present-day steel

$$n = 2.83 \dots 4.75$$
.

However, relatively large values of n correspond to very small values of C, $C \approx 10^{17}$ for n > 4.3.

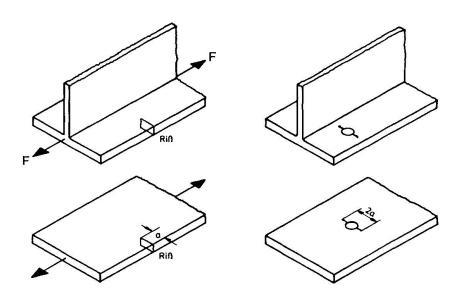
Figure 4.
Crack patterns in
riveted members for
evaluating
stress intensity factors
and crack
growth

The application of fracture mechanics in the evaluation of remaining fatigue life implies the modelling of cracks in structural members, which can presumably appear, fig 4. The propagation of cracks then is only governed by the stress intensity at the crack's tip as expressed by the Paris equation. On this basis, it is possible to predict how far a certain crack can grow within the period of time between two inspections.

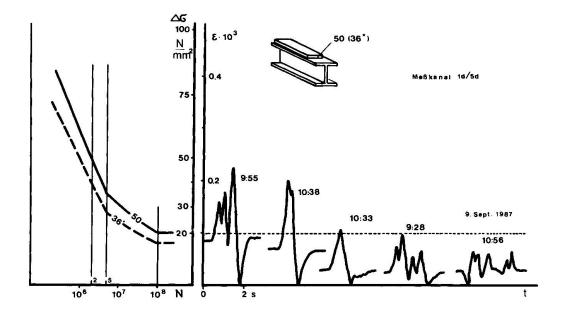
Figure 5. Measured strains/stresses during about 3 hours of observation at one measuring point.

The curves on the right hand side represent the largest measured cycles (indicated: time of vehicle passing) [5] which are compared with the cut-off limits of the ECCS-fatigue strength curve 50 (36*) [11]

The long-life fatigue behaviour of welded structures has been subject of discussion and research quite recently [9]. However, the same problems occur for old riveted structures, too. Looking at the results of measurements at some bridges, we found that only very few of the stress cycles exceed the cut-off limits as given e. g. in the ECCS Recommendations [11], fig. 5. Because of the fact that the allowable stresses about 100 years ago reached about 90 N/mm² or even 120 N/mm², the stresses in structural members of bridges of the Metropolitan or Underground in Berlin reach under traffic only 30 N/mm² or even 50 N/mm². Maybe, that in the past, in the course of an eventful history, overloadings could have taken place. This uncertainty of the loading in the past makes it complicated to judge the fatigue damage that bridges could have experienced during service life.
