Zeitschrift: IABSE reports = Rapports AIPC = IVBH Berichte
Band: 60 (1990)

Artikel: Seismic behaviour of reinforced brick masonry cavity walls
Autor: Shen, Jumin / Zhou, Xinggang / Feng, Shiping
DOI: <https://doi.org/10.5169/seals-46535>

Seismic Behavior of Reinforced Brick Masonry Cavity Walls

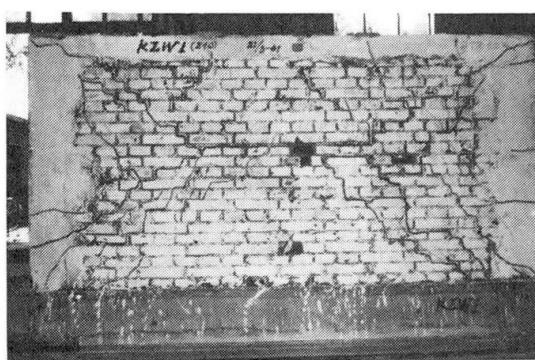
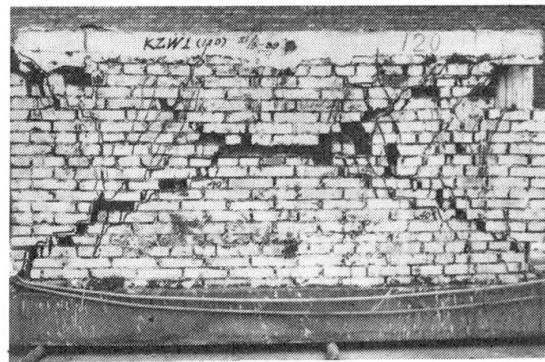
Fig.1 Crack Pattern of Specimen KZW1

The observed crack pattern of specimen KZW 1 following test is shown in Figure 1. The visible cracks are observed in the central portion of specimens when the applied lateral load is about 70-75% ultimate load. However, the visible cracks of specimen with the opening appear in the corner of the opening. As increasing of loading and displacement the cracks develop toward the corner of the wall and connect to form major X shape diagonal crack. At the about 90% ultimate load the diagonal cracks are extended through the wall. At the ultimate state the wall is divided into four blocks by the extending diagonal cracks. With increasing cycles of the loading the blocks slide along the surface of cracks. Finally, some broken parts of the wall are splitted and the specimen is failed. Comparing with normal specimen, the cracking pattern of the cavity wall specimen is almost identical. The failure pattern of the specimen is similar to that of post earthquake damage surveys of the walls.

The first cracks of reinforced concrete column are observed at the section at distance $h/3$ from the bottom of the column under about 70% lateral ultimate loading level. The second cracks appear at the column middle. The measured maximum width of crack of the column at the ultimate state is 3 mm. Due to confined effect of reinforced concrete column the accumulated deformation of the wall is decreased and the fall off of the wall is prevented. In the process of cyclic loading the top displacement at the thicker wall leaf with reinforced concrete column is gradually different from that of the thinner leaf without the column. At ultimate state the top displacement difference in the plane of the cavity wall is about 30-40 mm. The thinner leaf of the cavity wall cracks seriously as shown in Figure 1.

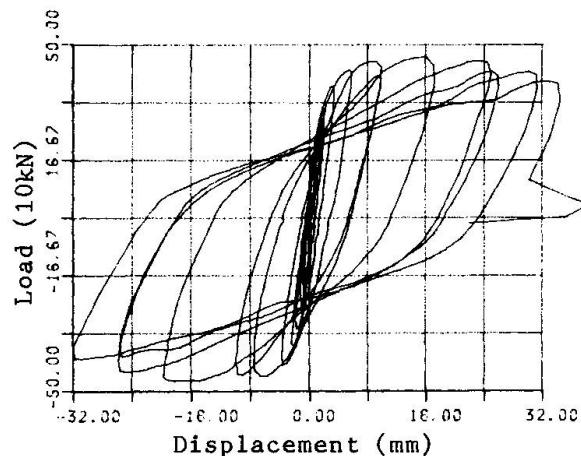
Fig.2 Speciemn BGW2

Hysteresis curves of lateral load P versus to displacement Δ of specimens BGW, KZW and DZW are shown in Figure 2-4 respectively. Obviously, the hysteresis loop of brick masonry wall with reinforced concrete columns is much different from perfect elasto-plastic behavior and shows rounding and pinching behavior due to the closing of cracks with increasing the numbers of cycle. In the stage of reloading the considerable degradation of the specimen stiffness can be observed. In the stage of unloading the degradation of stiffness is existed but not so significant. It is shown that the hysteresis loop behavior of brick masonry cavity wall is almost the same as the normal brick masonry wall. The hysteresis loop behavior of specimens with opening is poorer than that of specimen without opening. From the tests, the different type of connection has little influence on the hysteresis characteristics of the specimens.

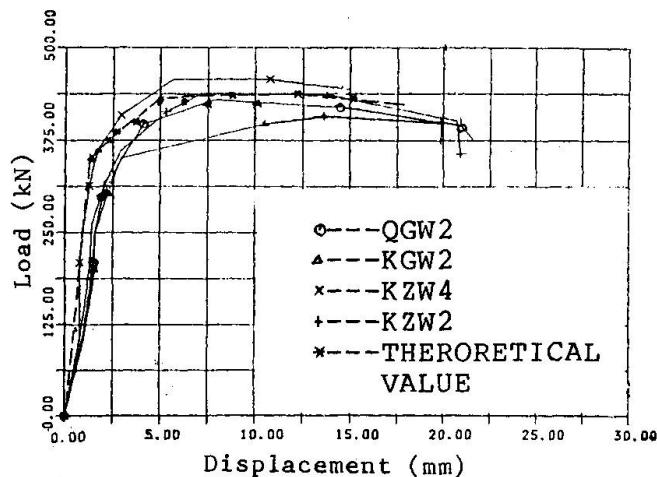
Fig.5 Load-Displacement Curves

Envelopes of the hysteresis loops of the measured top displacement of specimens are shown in Figure 5. It is indicated that in the initial stage the load-displacement relationship is linear and after cracking the displacement increases significantly with appeared and developed cracks. The measured post-cracking stiffness K is illustrated in Figure 6. It can be seen that as increasing displacement the stiffness of specimen decreases obviously. The stiffness K may be calculated from the following empirical formula:

where Mu -- the ultimate moment of concrete column; f -- friction coefficient. The calculated results of the cracking and ultimate load are given in Table 2. It is shown that the calculated results are in a good agreement with the measured values. In Figure 5 the corresponding calculated load -- displacement curve is also shown. From the comparison the calculated complete curves are in good agreement with that from the test.

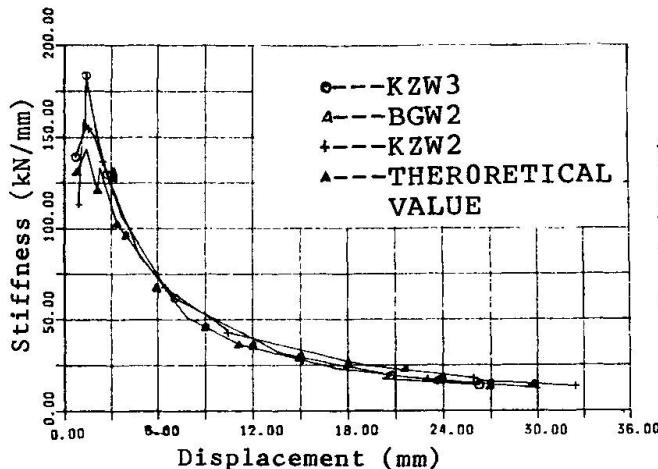
Fig.6 Stiffness Degradation

$$K=0.0017(\Delta/H)^{-0.91} K_0 \quad (\Delta/H > 1/1000) \quad (1)$$

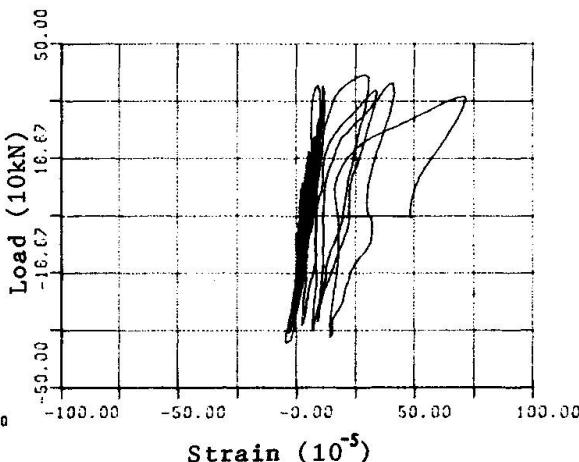
Fig.7 Load-Strain loops for Tie

The load-strain curve of connecting tie in the cavity wall is shown in Figure 7. It is shown that the connecting ties in the cavity wall have little influence on the behavior of the wall under lateral loading, especially as the ties are used at the upper and lower part of the wall. As viewed from the stiffness, the effect of the vertical or lateral brick connection on the

behavior of the cavity wall is much greater than that of the connecting ties. On the other hand, however, the existence of brick connection may easily destroy the continuity of the cavity wall, it is not suitable to subjected earthquake loading.
