**Artikel:** Seismic behaviour of reinforced brick masonry cavity walls  
**Autor:** Shen, Jumin / Zhou, Xinggang / Feng, Shiping  
**DOI:** <https://doi.org/10.5169/seals-46535>

## Seismic Behavior of Reinforced Brick Masonry Cavity Walls

Fourteen brick cavity wall specimens and two normal brick wall specimens with reinforced concrete columns under lateral cyclic loading have been tested. The effects of reinforced concrete columns, ties and other factors on the seismic behavior of cavity walls are studied.

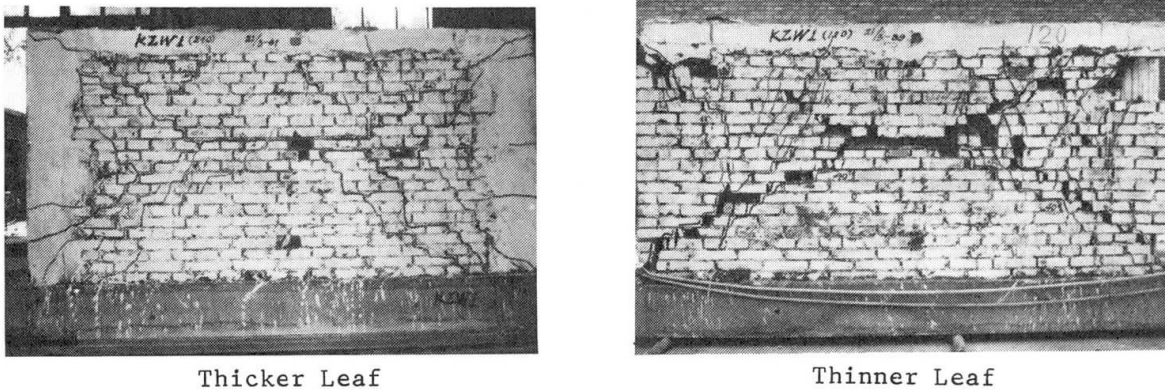
Fig.1 Crack Pattern of Specimen KZW1

The observed crack pattern of specimen KZW 1 following test is shown in Figure 1. The visible cracks are observed in the central portion of specimens when the applied lateral load is about 70-75% ultimate load. However, the visible cracks of specimen with the opening appear in the corner of the opening. As increasing of loading and displacement the cracks develop toward the corner of the wall and connect to form major X shape diagonal crack. At the about 90% ultimate load the diagonal cracks are extended through the wall. At the ultimate state the wall is divided into four blocks by the extending diagonal cracks. With increasing cycles of the loading the blocks slide along the surface of cracks. Finally, some broken parts of the wall are splitted and the specimen is failed. Comparing with normal specimen, the cracking pattern of the cavity wall specimen is almost identical. The failure pattern of the specimen is similar to that of post earthquake damage surveys of the walls.

The first cracks of reinforced concrete column are observed at the section at distance  $h/3$  from the bottom of the column under about 70% lateral ultimate loading level. The second cracks appear at the column middle. The measured maximum width of crack of the column at the ultimate state is 3 mm. Due to confined effect of reinforced concrete column the accumulated deformation of the wall is decreased and the fall off of the wall is prevented. In the process of cyclic loading the top displacement at the thicker wall leaf with reinforced concrete column is gradually different from that of the thinner leaf without the column. At ultimate state the top displacement difference in the plane of the cavity wall is about 30-40 mm. The thinner leaf of the cavity wall cracks seriously as shown in Figure 1.

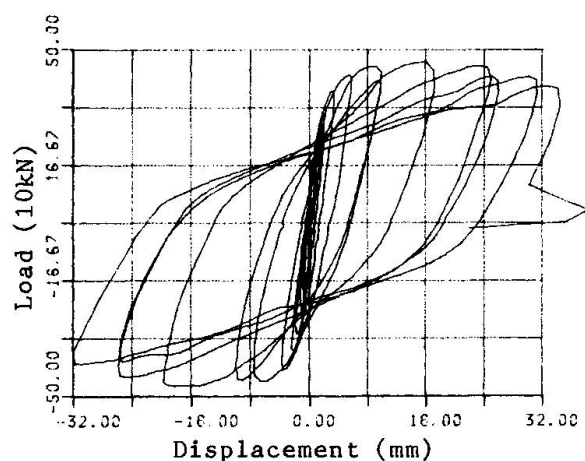
Fig.2 Specimen BGW2

Hysteresis curves of lateral load  $P$  versus to displacement  $\Delta$  of specimens BGW, KZW and DZW are shown in Figure 2-4 respectively. Obviously, the hysteresis loop of brick masonry wall with reinforced concrete columns is much different from perfect elasto-plastic behavior and shows rounding and pinching behavior due to the closing of cracks with increasing the numbers of cycle. In the stage of reloading the considerable degradation of the specimen stiffness can be observed. In the stage of unloading the degradatin of stiffness is existed but not so significant. It is shown that the hysteresis loop behavior of brick masonry cavity wall is almost the same as the normal brick masonry wall. The hysteresis loop behavior of specimens with opening is poorer than that of specimen without opening. From the tests, the different type of connection has little influence on the hystersis characteristics of the specimens.

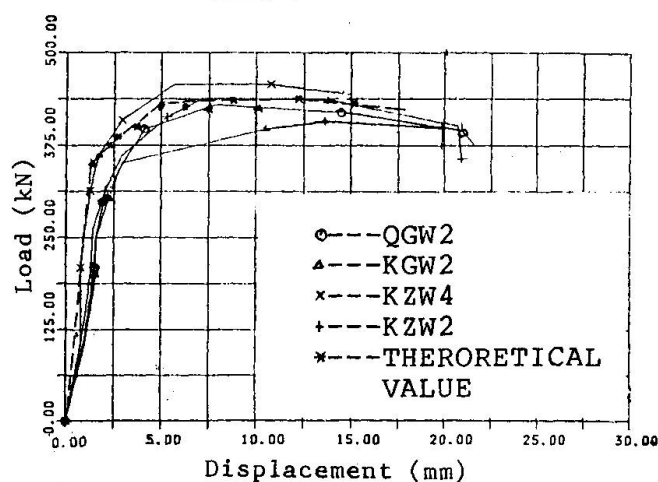
Fig.5 Load-Displacement Curves

Envelopes of the hysteresis loops of the measured top displacement of specimens are shown in Figure 5. It is indicated that in the initial stage the load-displacement relationship is linear and after cracking the displacement increases significantly with appeared and developed cracks. The measured post-cracking stiffness  $K$  is illustrated in Figure 6. It can be seen that as increasing displacement the stiffness of specimen decreases obviously. The stiffness  $K$  may be calculated from the following empirical formula:

where  $M_u$  -- the ultimate moment of concrete column;  $f$  -- friction coefficient. The calculated results of the cracking and ultimate load are given in Table 2. It is shown that the calculated results are in a good agreement with the measured values. In Figure 5 the corresponding calculated load -- displacement curve is also shown. From the comparison the calculated complete curves are in good agreement with that from the test.

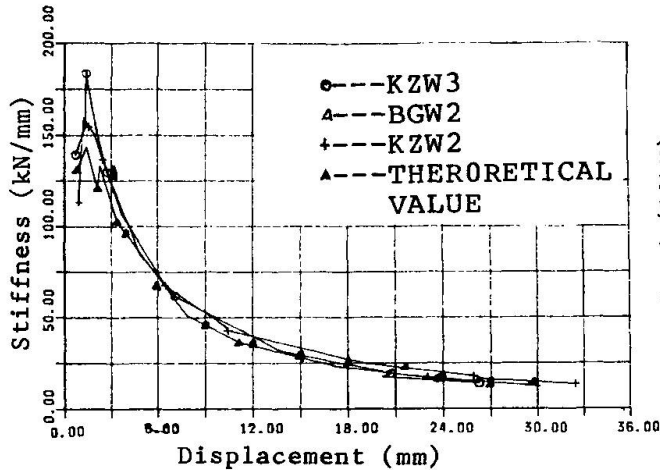
Fig.6 Stiffness Degradation

$$K = 0.0017(\Delta/H)^{-0.91} K_0 \quad (\Delta/H > 1/1000) \quad (1)$$

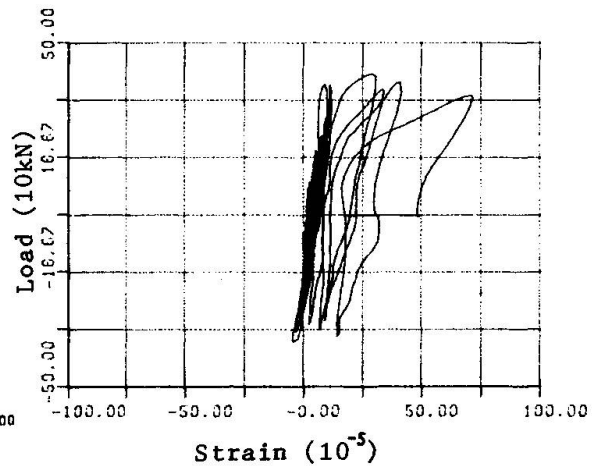
Fig.7 Load-Strain loops for Tie

The load-strain curve of connecting tie in the cavity wall is shown in Figure 7. It is shown that the connecting ties in the cavity wall have little influence on the behavior of the wall under lateral loading, especially as the ties are used at the upper and lower part of the wall. As viewed from the stiffness, the effect of the vertical or lateral brick connection on the

behavior of the cavity wall is much greater than that of the connecting ties. On the other hand, however, the existence of brick connection may easily destroy the continuity of the cavity wall, it is not suitable to subjected earthquake loading.
