Zeitschrift: IABSE reports = Rapports AIPC = IVBH Berichte
Band: 62 (1991)

Artikel: Lateral load behaviour of large panel precast buildings
Autor: Garcia, Luis E. / Sozen, Mete A.
DOI: <https://doi.org/10.5169/seals-47653>

Lateral Load Behaviour of Large Panel Precast Buildings

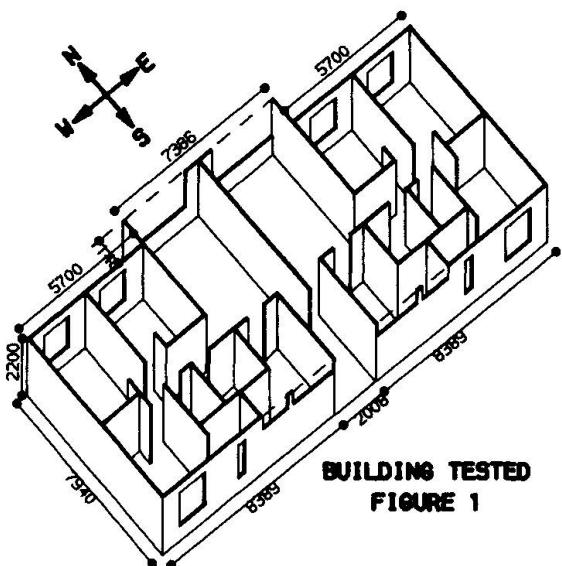
BUILDING TESTED
FIGURE 1

The full scale precast building tested was a five-story low-rise apartment building with an area per floor of 157,64 m² as shown in Figure 1. The clear height of the precast panels was 2,20 m and the floor slabs had a thickness of 250 mm. The total height of the building was 12,25 m (Figure 2). The total mass of the building was 460 metric tons. All continuity reinforcement was located and welded in the gaps between precast elements. These gaps were filled later with grout. All the precast panels were 80 mm thick. The internal reinforcement of the panel did not extend from the borders of the panel. Each panel had horizontal bars that extended into the vertical connection. One 9,5-mm diameter vertical reinforcing bar was located in all vertical joints between panels. All 63 vertical joints between precast panels had vertical reinforcement; but only in 24 of them it was continuous from floor to floor. No vertical reinforcement was anchored to the foundation. The building was, therefore, very lightly reinforced having only 24 bars with a 9,5 mm diameter from top to bottom without any connection to the foundation. All floors, including the roof, were made up of plant precast steam cured elements. The edges the floor elements had connecting reinforcing bars that were welded to similar bars in the neighboring elements, achieving the continuity needed to obtain a floor diaphragm effect.

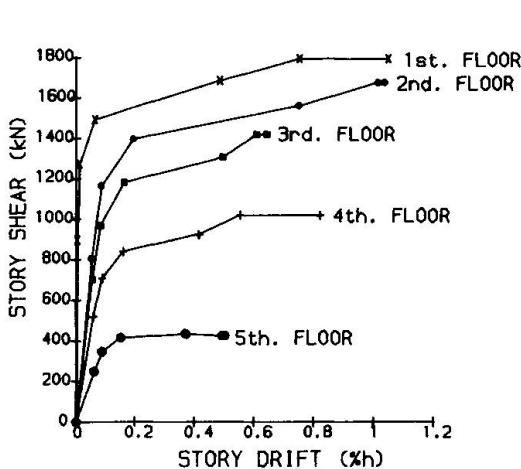
MEASURED STORY DRIFT
TEST E
FIGURE 3

A large decrease of stiffness was observed for the two tests that reached the strength level in the E-W direction (Test B) and then in the W-E direction (Test E) as the roof deflection reached in Test B was 16,5 mm for a base shear of 37,9% of the mass of the building, compared with 90,6 mm for a base shear of 41% of the mass of the building. It is note worthy that only for Test E the story drift in two of the floors was greater than 1% of the story clear height. For Test E the graph of story shear vs. story drift is presented in Figure 3. From these graphs it is evident that the structure went well into the inelastic range.

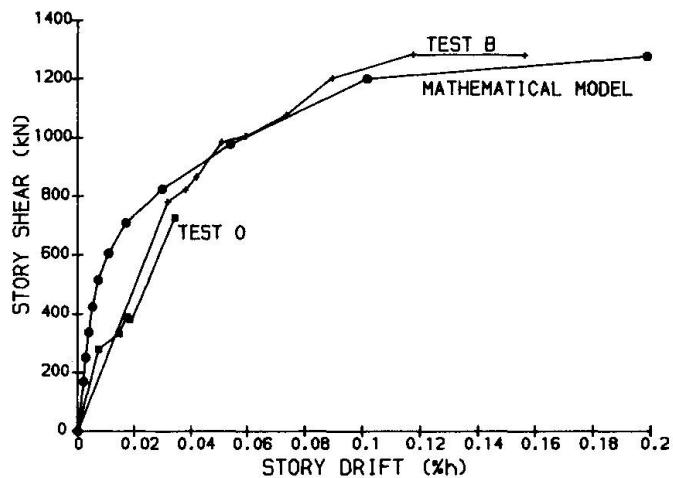
MATHEMATICAL MODEL RESULTS
THIRD FLOOR
FIGURE 4

An analytical model appropriate for describing the behavior observed during the experimental tests of the building was developed before the tests were carried out and was subsequently calibrated using the experimental results. The model takes into account the non-linear response of the structure by modifying the stiffness of the different elements as they are stressed by the lateral load. A procedure of successive linear stages was adopted to describe the general non linear behavior. The analysis is initiated with a monolithic structure. With the results of this analysis the possible modes of failure of the elements and their connections are evaluated and the one that occurs at a lower lateral load level is taken as critical. The properties of the critical element or connection involved are then modified. The level of lateral load and deflection obtained are recorded and a new linear elastic analysis is performed where a new evaluation is performed, giving a new critical element or connection. This procedure is repeated until loss of equilibrium is detected. The modes of failure that are verified correspond to: (a) sliding of the horizontal connection, (b) overturning of the panel, (c) cracking and sliding of the vertical connection between panels, (d) internal shear failure of the panel, and (e) yielding of the vertical continuity reinforcement. The results obtained with this mathematical model correspond to the first lateral loading of the building. Figure 4 shows, for the E-W direction, the results obtained for the third floor as compared with the measured experimental results of the same floor for Tests 0 and B. The agreement of the results is significant and the same is true for all the other floors.

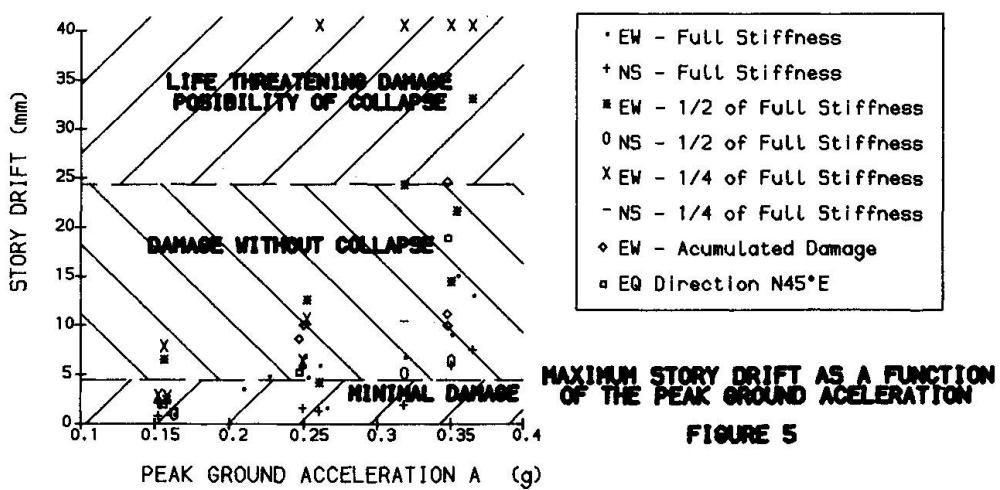
MAXIMUM STORY DRIFT AS A FUNCTION
OF THE PEAK GROUND ACCELERATION
FIGURE 5

The effect of the peak ground acceleration is shown in Figure 5, where the maximum story drifts are plotted against peak ground acceleration of the earthquake records. Only those cases where the stiffness of the structure was reduced to one half and one quarter of the initial stiffness have story drift beyond the 24 mm limit. With the soft soil records (Mexico and Miyagi) the maximum story drift obtained was 1,2 mm, well into the minimal damage zone. For damage accumulation, three successive application of the full El Centro record, showed for the third application a maximum story drift of 24,3 mm.

From the observed damage during the static tests of the precast building, bounds for the response were established. These bounds were a story drift of 4 mm for minimal damage and a story drift of 24 mm for the threshold of life threatening damage.
