**Zeitschrift:** IABSE reports = Rapports AIPC = IVBH Berichte  
**Band:** 66 (1992)

**Artikel:** Fretting fatigue of galvanised steel roping wire  
**Autor:** Waterhouse, Robert B. / Smallwood, Rusell  
**DOI:** <https://doi.org/10.5169/seals-50704>

## Fretting Fatigue of Galvanised Steel Roping Wire

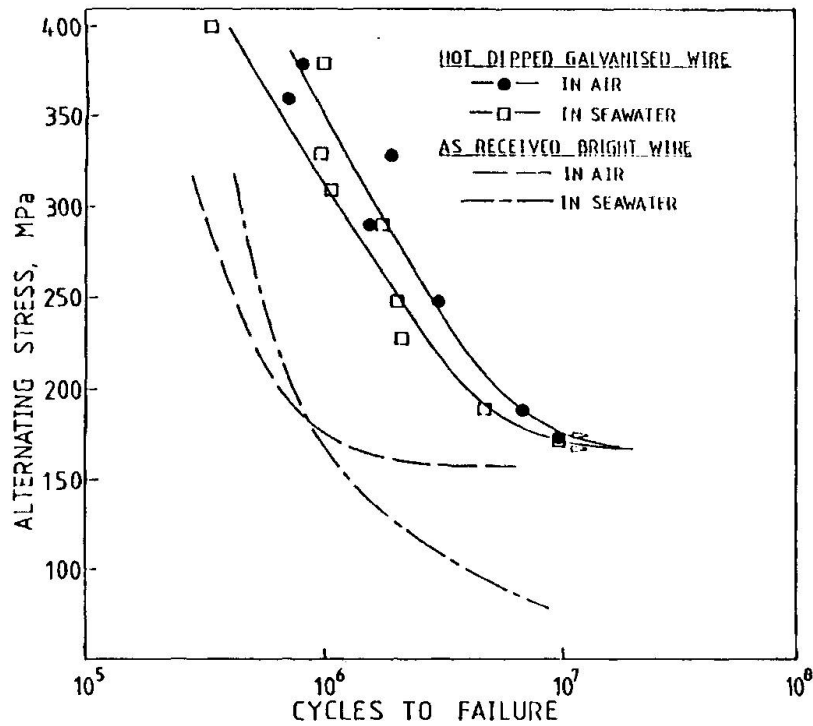
Fig. 4 Fatigue curves for hot-dip galvanised wire in air and seawater under fretting conditions.

The effect of the two types of galvanising on the fatigue curves in air and seawater are shown in Figs. 4 and 5. It is apparent that both treatments produce approximately the same result both in air and seawater. Included in the figures are the curves for the untreated wire in the two environments. It should be noted that the untreated wire in seawater has no fatigue limit.

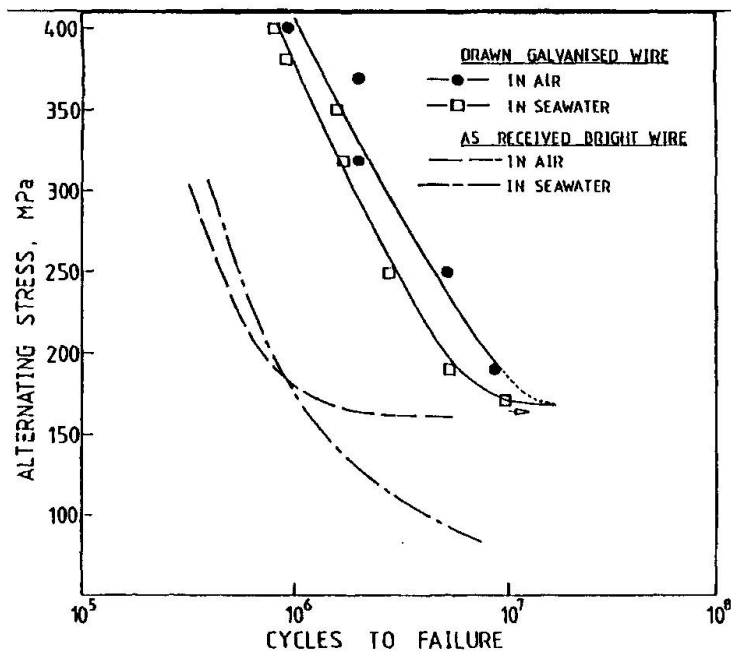
Fig. 5 Fatigue curves for drawn galvanised wire in air and seawater under fretting conditions.

At alternating stresses above the fatigue limit the drawn galvanised wires have a somewhat longer fatigue life in both media. This is attributed to the drawing process, while not influencing the alloy and columnar layers, consolidates and closes up defects in the outer equiaxed layer and reducing its thickness.
