Expert System for Integrated Cable Inspection Système expert pour le contrôle intégral des câbles

Hans-W. HÖHLE Dr.-Eng. DMT-Seilprüfstelle Bochum, Germany

## SUMMARY

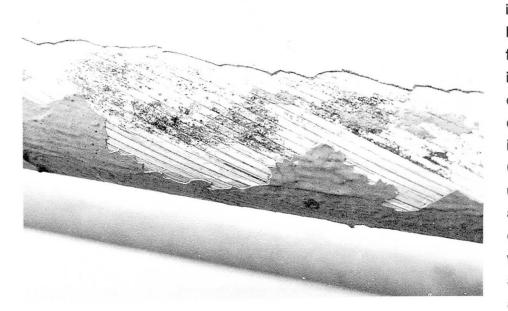
Fig. 11: Corrosion under an undestroyed corrosion protection, detected by EM-inspection

previous basic problem remains: The load carrying elements cannot be visually inspected, which makes an assessment of their condition possible only by electromagnetic inspection. Even under normal conditions, varying external temperatures can cause water to penetrate a plastic coating through hair fissures and other crevices. Then, under an apparently undamaged surface, corrosion can develop undetected. Initial contamination of the cable by chemicals, sand, etc. can accelerate the corrosion process.
