Artikel: Vibration and serviceability in post terminal buildings
Autor: Dahlsjö, Harald / Ohlsson, Sven
DOI: <https://doi.org/10.5169/seals-52584>

Vibration and Serviceability in Post Terminal Buildings

Civil Engineer
Swedish Post Real Estate Mgt
Stockholm, Sweden

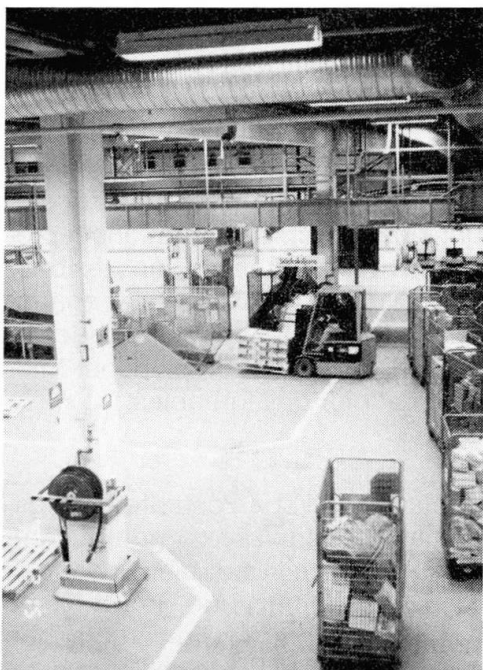
Fig. 1 Ground floor view

The ground floor includes a loading dock for lorries and two machine sorting lines for arriving mail. They are used for a first preliminary sorting with respect to letter size and item type. Furthermore the ground floor includes three machine sorting lines for mail leaving the terminal. The sorted mail is put into mailbags or post containers. One of these lines includes a robot station where sorted post parcels (boxes) are automatically put into containers. The first floor accommodates five machine sorting lines and one which is manually operated.

Post containers are continuously (day and night) transported across the ground floor to different stations by 8 forklift trucks. Each forklift will typically carry out 150 - 200 transportation tasks daily. A forklift weighs 27 kN and a post container adds a weight of 3 to 8 kN. The post is transported between the ground floor and the first floor by use of overhead conveyors. Except for forklift drivers, 15 persons are working on each floor at a time.

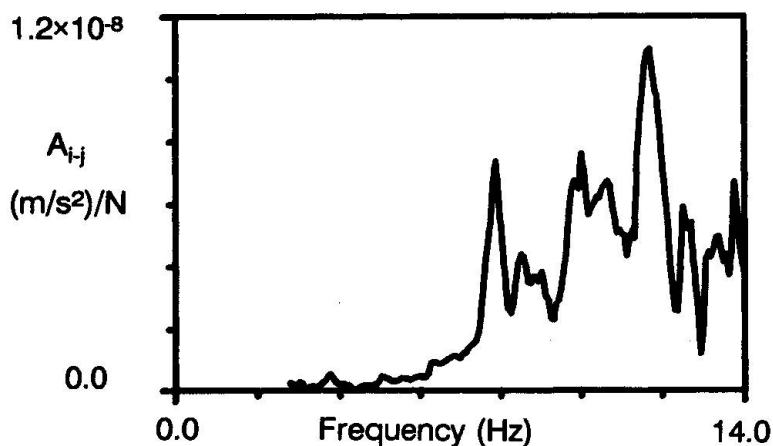
Fig. 2 Magnitude of accelerance function $A_{i,j}$ for two locations i,j at ground floor of the Årsta post terminal

A value for the fundamental frequency $f_1=7.8$ Hz was found for the floor area with 12 m span intended for forklift activity [4, 1989]. The second test series showed the same value for the fundamental frequency [4, 1991]. By 'the same' is meant identical within the two-digit accuracy. Higher modes were closely spaced, $f_2=8.5$ and $f_3=9.0$ Hz. The values for the experimentally measured natural frequencies are in fairly good agreement with theoretically calculated values based on the assumption about fully effective floor element cross sections (no cracks). Damping ratios c/c_{cr} for corresponding modes were evaluated to 1.3%, 1.2% and 1.7% respectively [4, 1991]. These values are rather typical (including the scatter) for this type of construction.

Two conclusions may be that the floor area in question is basically uncracked even after it had experienced some static and dynamic service loads and that no substantial effective increase in concrete stiffness has occurred due to ageing. The risk of future cracking and corresponding reduction in resonance frequencies may of course not be neglected. The experimental values found for damping ratios support the previous suggestion of $c/c_{cr}=1\%$ for design purposes.

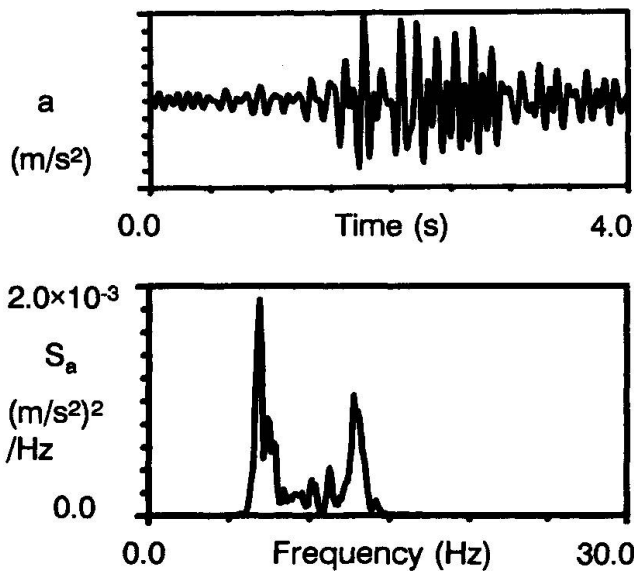
Fig. 3 Acceleration time record ($\pm 0.5 \text{ m/s}^2$) and corresponding acceleration spectral density S_a for ground floor due to regular driving of a forklift of type AT.

vicinity of the driving area for the forklift are presented in Figs. 3 and 4 (after [4] 1991). It is worth noting that the softer wheels of the forklift of type AT result in a low-frequency dominated acceleration spectrum, basically limited to the frequency band 5 - 15 Hz, while the corresponding frequency range for the forklift type Rocla is approximately 8 - 30 Hz. From Fig 3, it is clear that the spectral function shows a pronounced peak around 6.5 Hz. Closer studies have shown that this is not an effect of a floor resonance, but rather originates from the dynamic characteristics of the vehicle. This peak appears in vibration spectra for different floor areas and it changes only when the load carried by the forklift is altered.

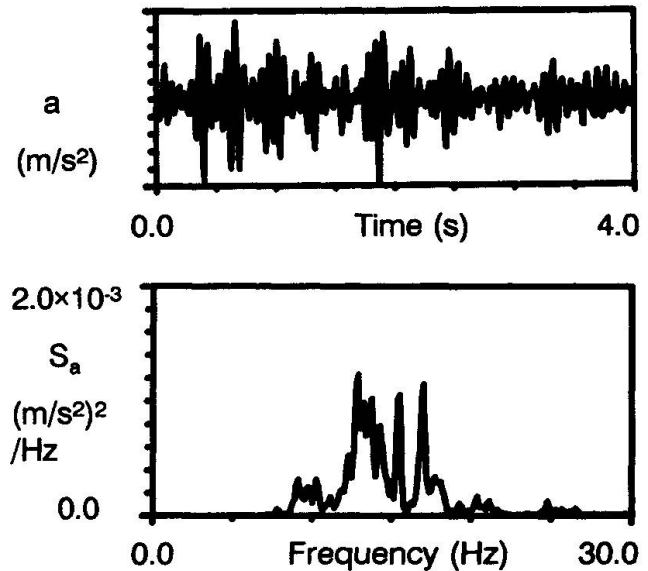
Fig. 4 Acceleration time record ($\pm 0.5 \text{ m/s}^2$) and corresponding acceleration spectral density S_a for ground floor due to regular driving of a forklift of type Rocla.
