**Zeitschrift:** IABSE reports = Rapports AIPC = IVBH Berichte  
**Band:** 70 (1993)

**Artikel:** Structural assessment of Lisbon's historical buildings  
**Autor:** Pompeu Santos, S. / Mun, Mary  
**DOI:** <https://doi.org/10.5169/seals-53292>

## Structural Assessment of Lisbon's Historical Buildings

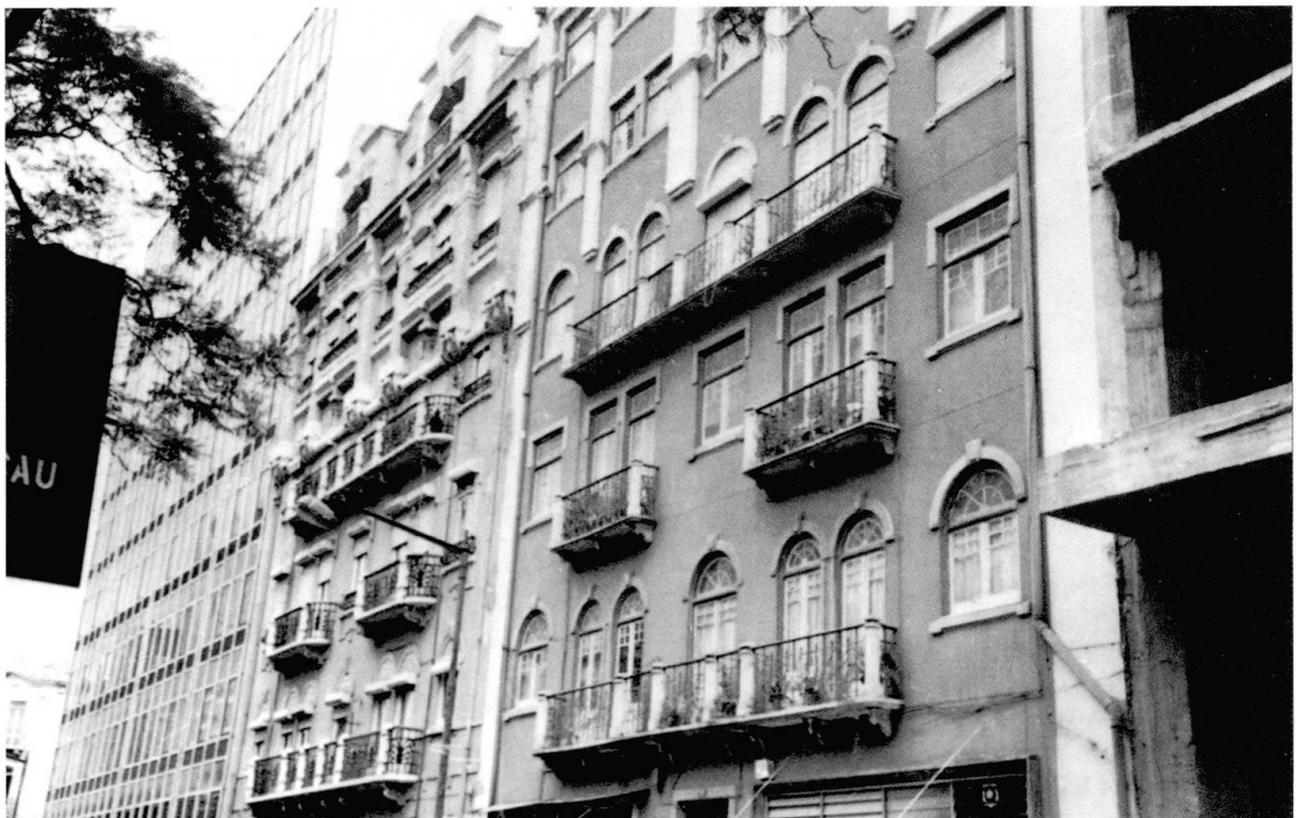
Fig. 1: Two surviving buildings in the Study Area

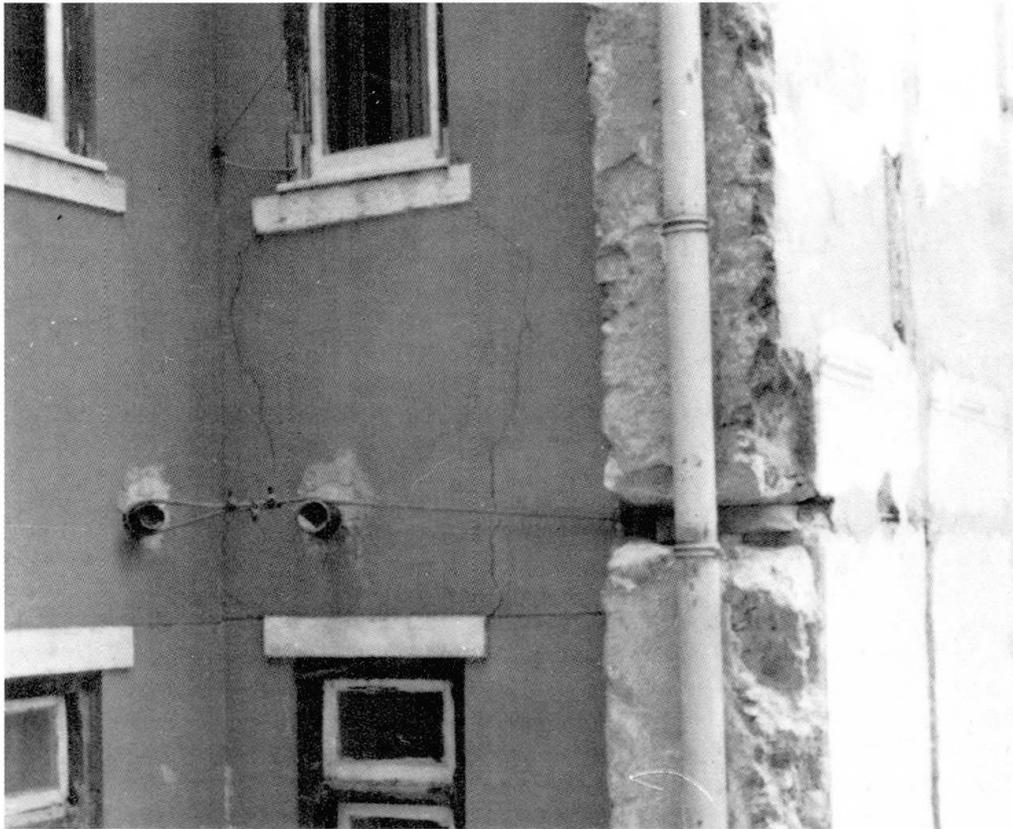
Fig. 2: Damaged masonry wall due to demolition of an adjoining building

- excavation works, both at the surface and underground, in the proximity of, or under existing buildings, resulting in localized differential settlements of the wall foundations;
- demolition of one of two buildings having a common separation wall, resulting in the destruction of the original connection between intersecting walls, both at the façade and at the back (Fig. 2);
- alterations to the existing structural system involving the total or partial demolition of load bearing walls (negative shoring-structure interaction);
- overloading through a change in building usage (eg. office archives in previous dwellings).

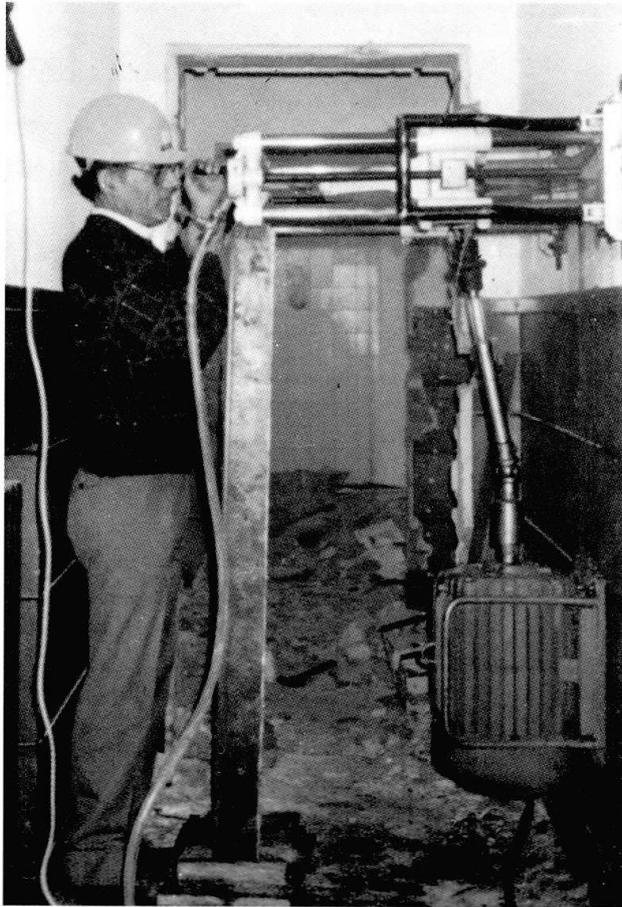
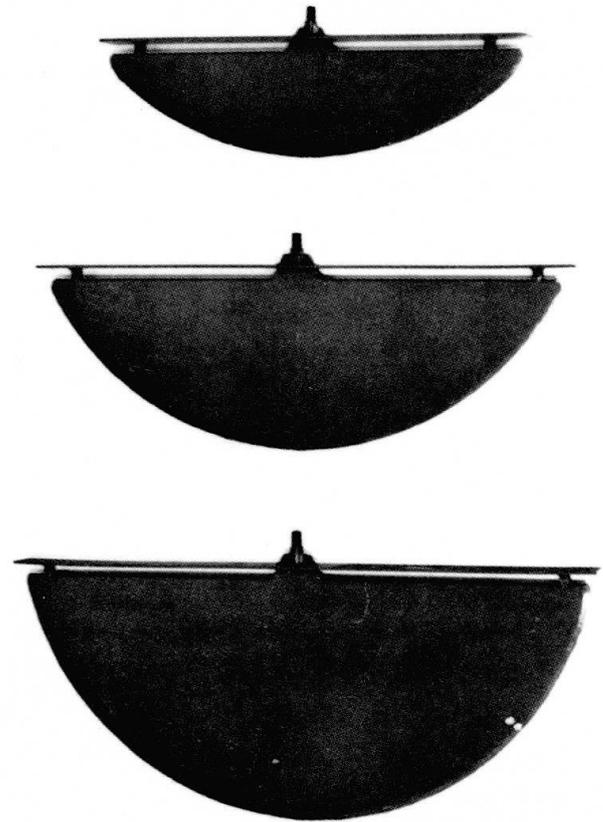
Fig. 3: Cutting operation in a flat jack test

A relatively recent development of the flat-jack technique permits also the determination of the strength and deformability characteristics of in-situ masonry. The technique consists basically in the insertion of flat-jacks in two parallel cuts made in the surface of the masonry wall. By applying pressure through the jacks, the masonry block between the two cuts can be tested for deformability (axial and transverse) and compressive strength [5].

The LNEC testing equipment consists of a set of hydraulic jacks, a cutting machine (fitted with a 600 mm diameter diamond disk), a device for extracting the jacks, pressure gauges and deformeters. The available equipment permits cuts from depths of 100mm up to 240mm (Fig. 3).
