Artikel: Structural assessment of Lisbon's historical buildings

Structural Assessment of Lisbon's Historical Buildings

S. POMPEU SANTOS Civil Engineer LNEC Lisbon, Portugal

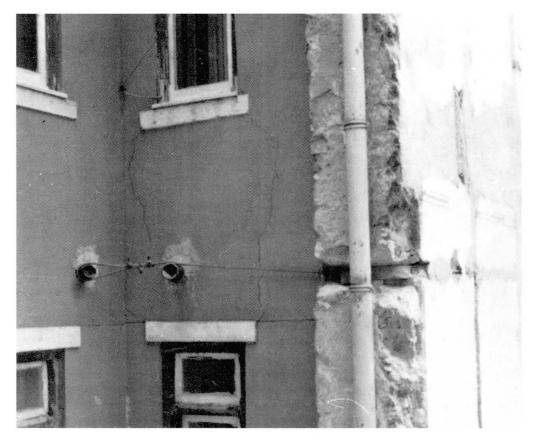
Fig. 2: Damaged masonry wall due to demolition of an adjoining building

- excavation works, both at the surface and underground, in the proximity of, or under existing buildings, resulting in localized differential settlements of the wall foundations;
- demolition of one of two buildings having a common separation wall, resulting in the destruction of the original connection between intersecting walls, both at the façade and at the back (Fig. 2);
- alterations to the existing structural system involving the total or partial demolition of load bearing walls (negative shoring-structure interaction);
- overloading through a change in building usage (eg. office archives in previous dwellings).
