Zeitschrift: IABSE reports = Rapports AIPC = IVBH Berichte
Band: 70 (1993)

Artikel: Investigation of historic masonry by means of radar
Autor: Kahle, Martin
DOI: <https://doi.org/10.5169/seals-53296>

Investigation of Historic Masonry by Means of Radar

Martin KAHLE

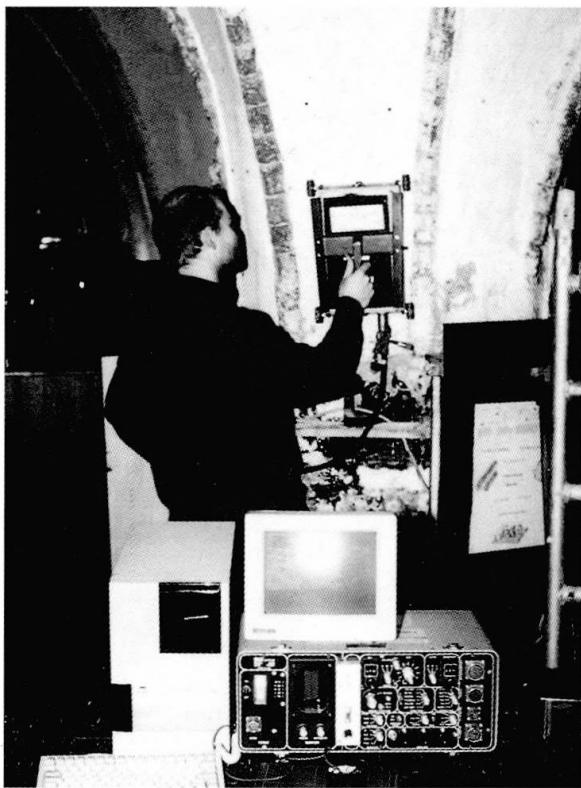
Fig. 1: The radar equipment

The main components of the equipment used are the control unit, a microcomputer containing specific software, a transmitter and a receiver. In the reflection arrangement both antennas are connected in one box which is moved along vertical or horizontal lines with scans every 2 cm approximately, fig. 1, 2, 3.

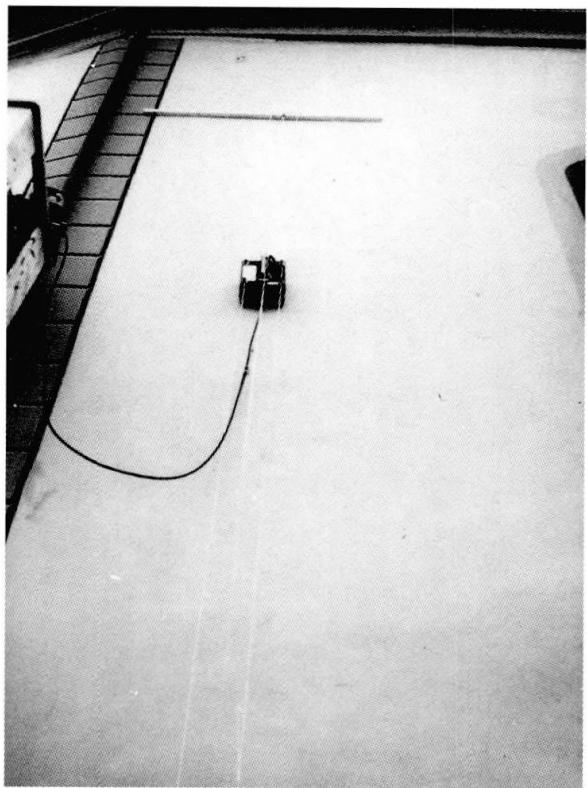
Fig. 2: The 500 MHz-antennas in the reflection arrangement

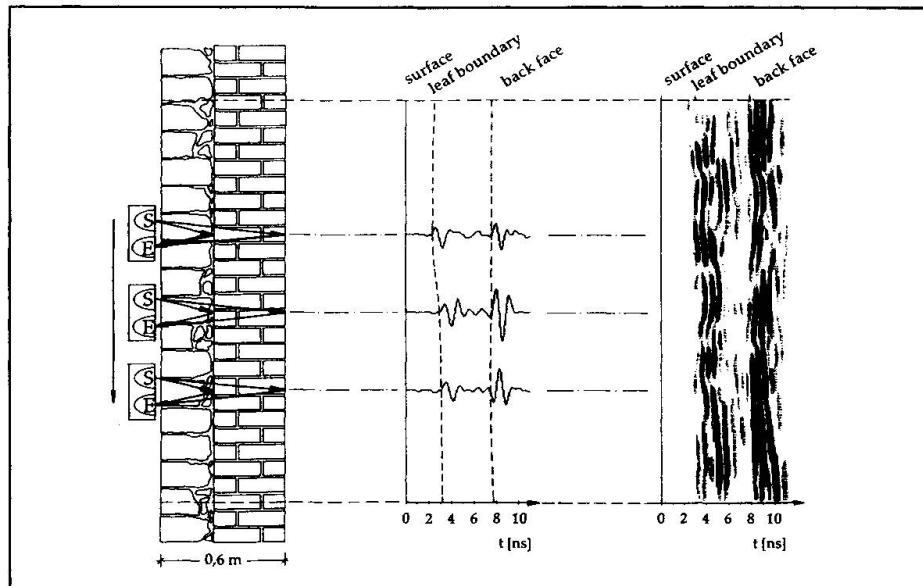
Fig. 3: The reflection arrangement on a multiple leaf wall; schematic cross section, received signals and radargram (S..transmitter, E..receiver, ↓..direction of profiling)

The received signals are amplified depending on the delay time, transmitted to the microcomputer and finally plotted in radargrams, fig. 3.

The radargram provides a graphic profile presenting the amplitudes of the electromagnetic waves as a function of the delay time between the moment of entering and leaving the structural part. In order to condense the data display it is convenient to use dots, whereby the colour code or the colour density (in the case of grey as in the figures shown) is associated with the magnitude of the amplitude, fig. 3.

The radar method is capable of detecting boundaries of multiple leaf masonry in the way depicted in fig. 3. The result of the investigation and the data quality is dependant on the nature of the boundary surface and the difference in the electrical material properties. Smooth boundaries yield clear and uniform reflection bands in the radargram. In this respect the example in fig. 3 is an ideal case.

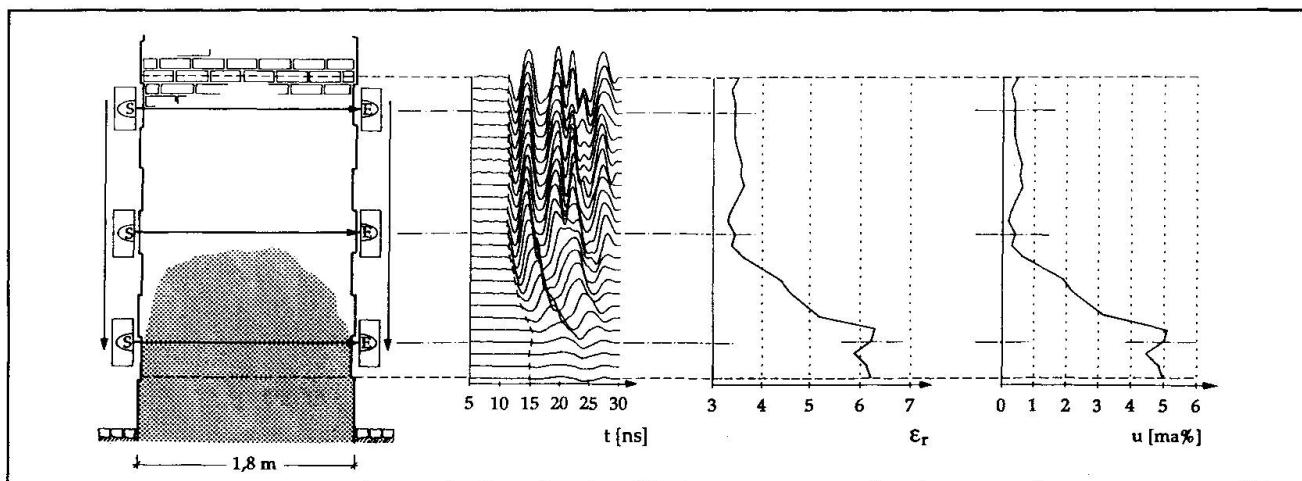
Fig. 4: The transmission arrangement on a column with rising moisture; schematic cross section, received signals, relative permittivity and moisture profile (S..transmitter, E..receiver, ↓..direction of profiling)

In the transmission arrangement, which is primarily employed for the assessment of moisture, transmitter and receiver are placed on opposing faces, fig. 4. Because of the difficult handling of the antennas, discrete scanning points at 5 or 10 cm spacing are chosen. The propagation time of the electromagnetic wave through the structural part is given by the location of the first deviation of the receiver signal, from which the velocity is calculated. Using equation 1 the relative permittivity is determined and from this value, the moisture content is derived (see §3 and §4.3).

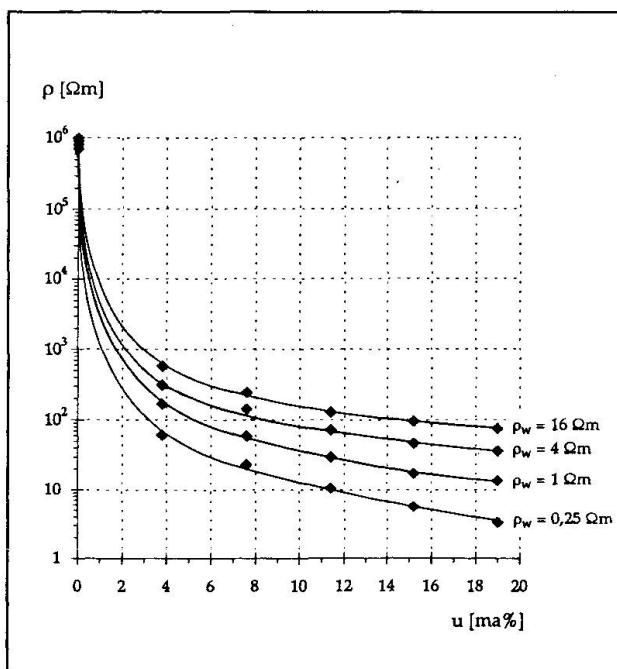
Fig. 5: Dependence of the electric resistivity ρ of brick on the gravimetric moisture content u ; parameter ρ_w is the resistivity of the porous aqueous solution

The resistivity was determined on samples of different materials with the geo-electric direct current method. The resistivities for brick, given as a function of the moisture and salt content, are shown in fig. 5.

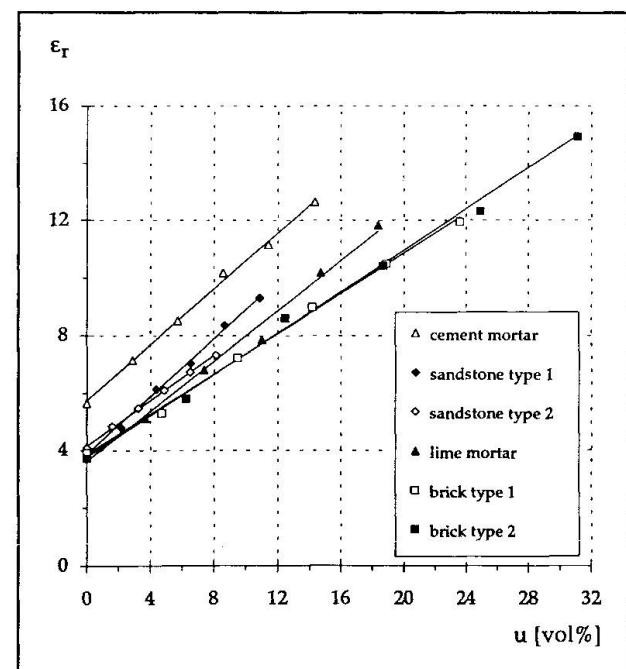
Fig. 6: Dependence of the relative permittivity ϵ_r of different materials on the volumetric moisture content u

The relative permittivities were measured using the radar technique in the transmission mode. The dependence of the permittivity on the moisture content, as depicted in fig. 6, may be approximated by a linear relation. Dissolved salts cause a slight increase up to 10 % of the relative permittivity. The influence of temperature and pressure was found to be insignificant for the application of radar on historic masonry.

The possibility of measuring the moisture content of masonry with radar is derived from the dependence of the relative permittivity on the amount of water in the material matrix, fig. 6. The transmission arrangement usually yields the best data, but the reflection arrangement can be used on the condition that the reflection from the back surface is caught precisely and the width of the structural part is known.

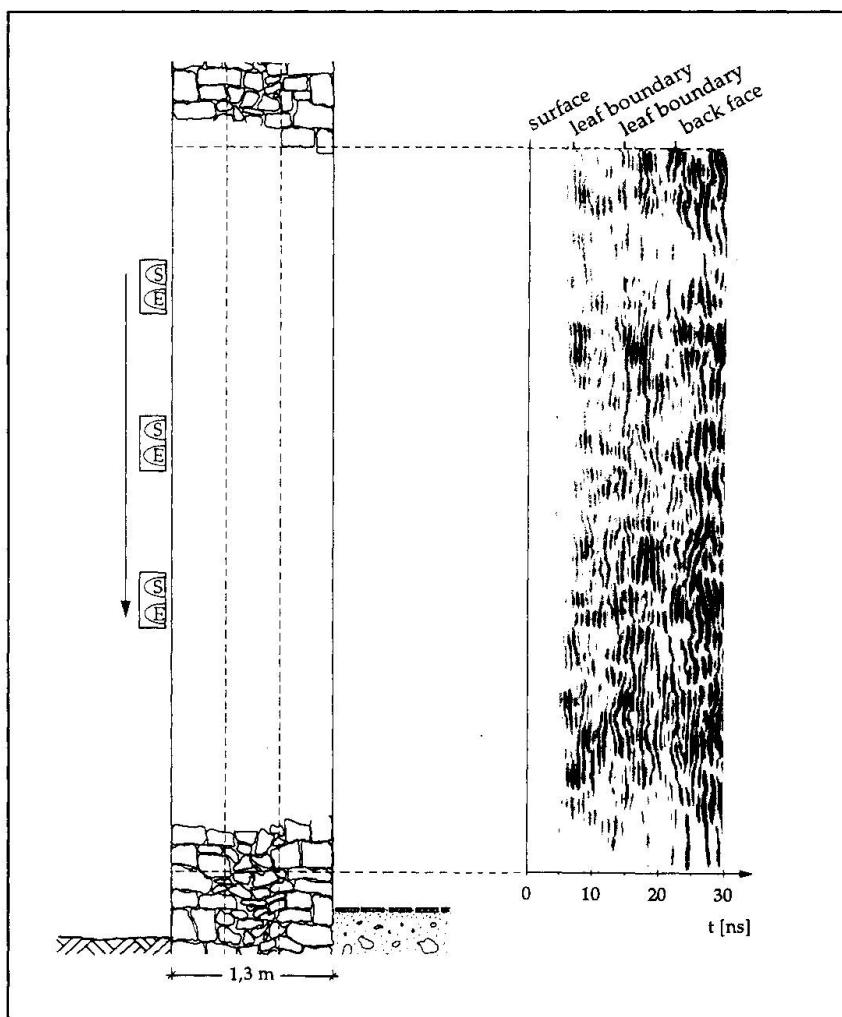
Fig. 7: Detection of leaf boundaries; wall cross section and radargram

Since the leafs are usually bonded and often consist of similar materials, the radargrams picked up from several multiple leaf stone walls looked like the one on fig. 7. The data is less distinct, but the leaf boundaries are imaged in short reflection bands and moreover, the leafs show different reflection patterns.

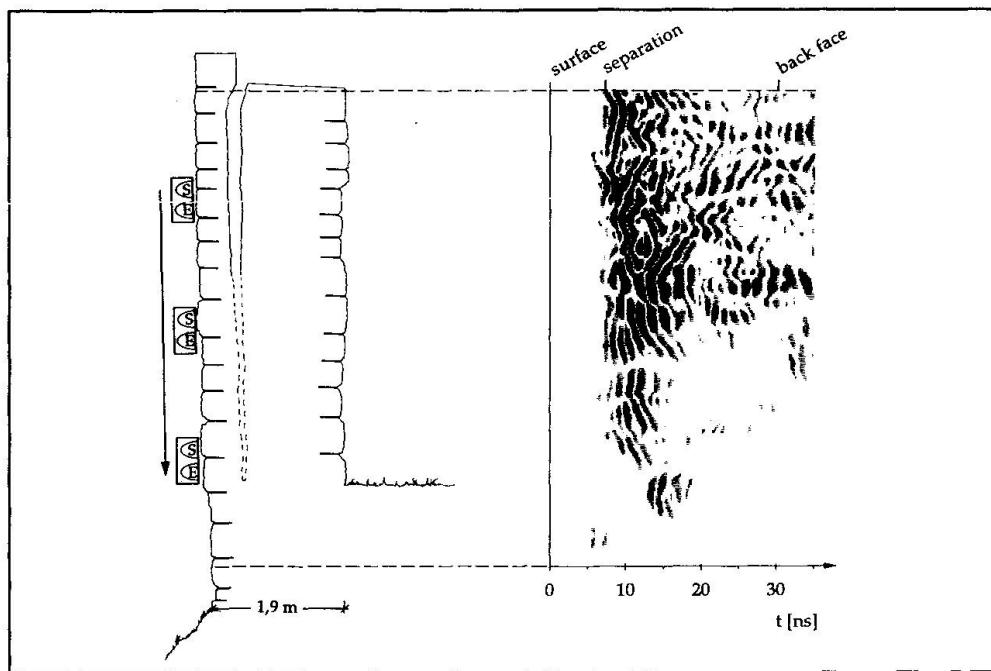
Fig. 8: Detection of leaf separations; wall cross section and radargram

Some investigations were carried out on walls with leafs which have separated, fig. 8. In these cases, because of the high reflection coefficient, the reflection from the interface stone/air was very strong with amplitudes in the order of 10 times as much as from comparable intact wall elements. If the gap was filled with debris the intensity was lower but still significant.

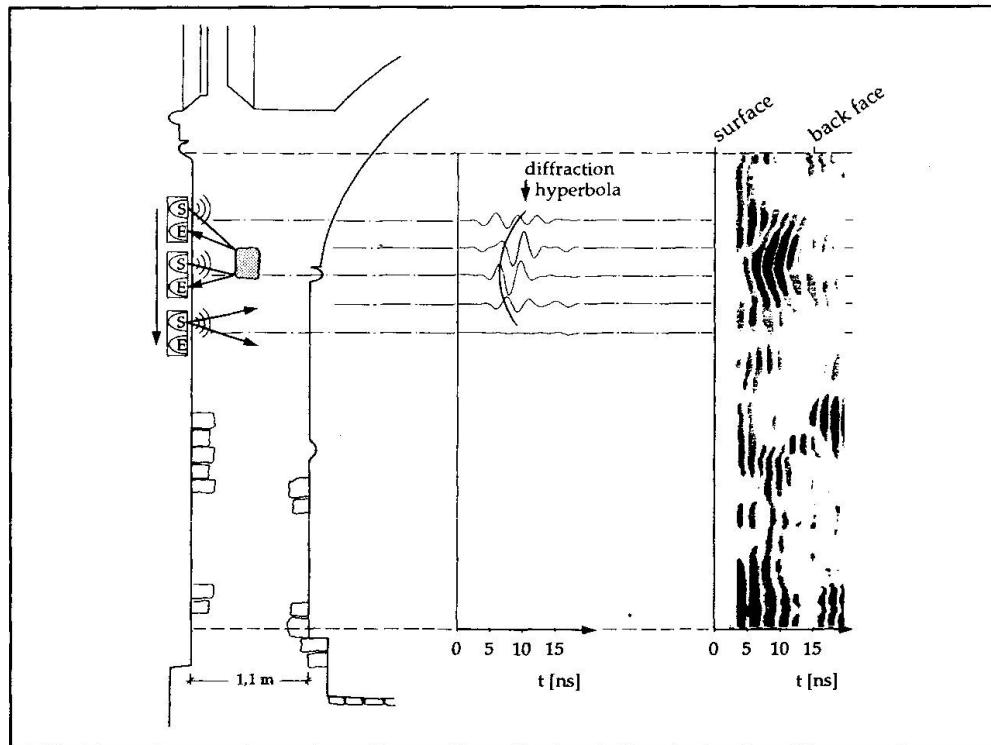
Fig. 9: The detection of anomalies with the reflection arrangement; wall cross section of the Matthiaskapelle in Kobern/Mosel, receiver signal and radargram

Because of its high resolution the radar method is capable of detecting discontinuities due to voids or enclosed materials. The reflections from the boundary of the anomaly are imaged as diffractions in the radargrams, fig. 9. A charac-

teristical hyperbolic shape is created because the anomaly is captured over a certain profile length while the distance between the anomaly and the antennas changes. At the Matthiaskapelle, shown in fig. 9, a long hole for a wooden tie beam was found by this means.

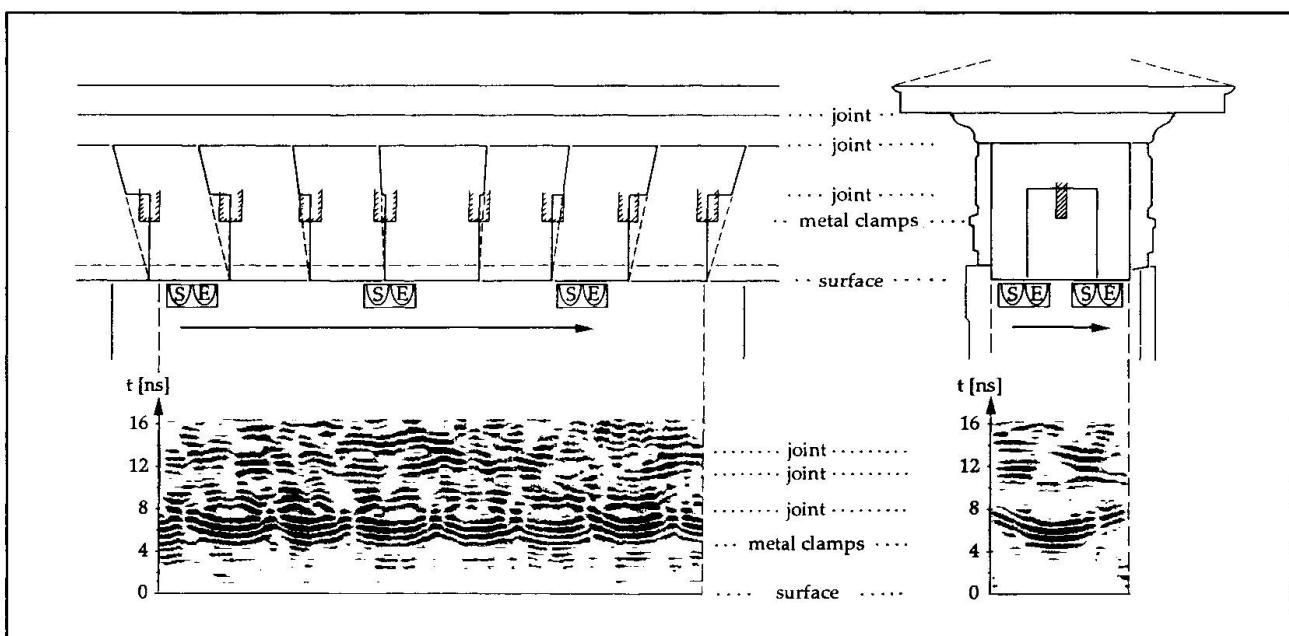
Fig. 10: Longitudinal and transversal cross section of the beam of the Jägertor in Potsdam and corresponding radargrams

Radar measurements on the Jägertor in Potsdam were carried out in order to define its bearing structure which was not known and especially to reveal possible hidden metal ties or clamps. The radargrams, picked up from underneath the beam, showed distinct diffractions from singular metal bodies plus reflection bands from several joints. Thus the data was interpreted in the way presented in fig. 10.

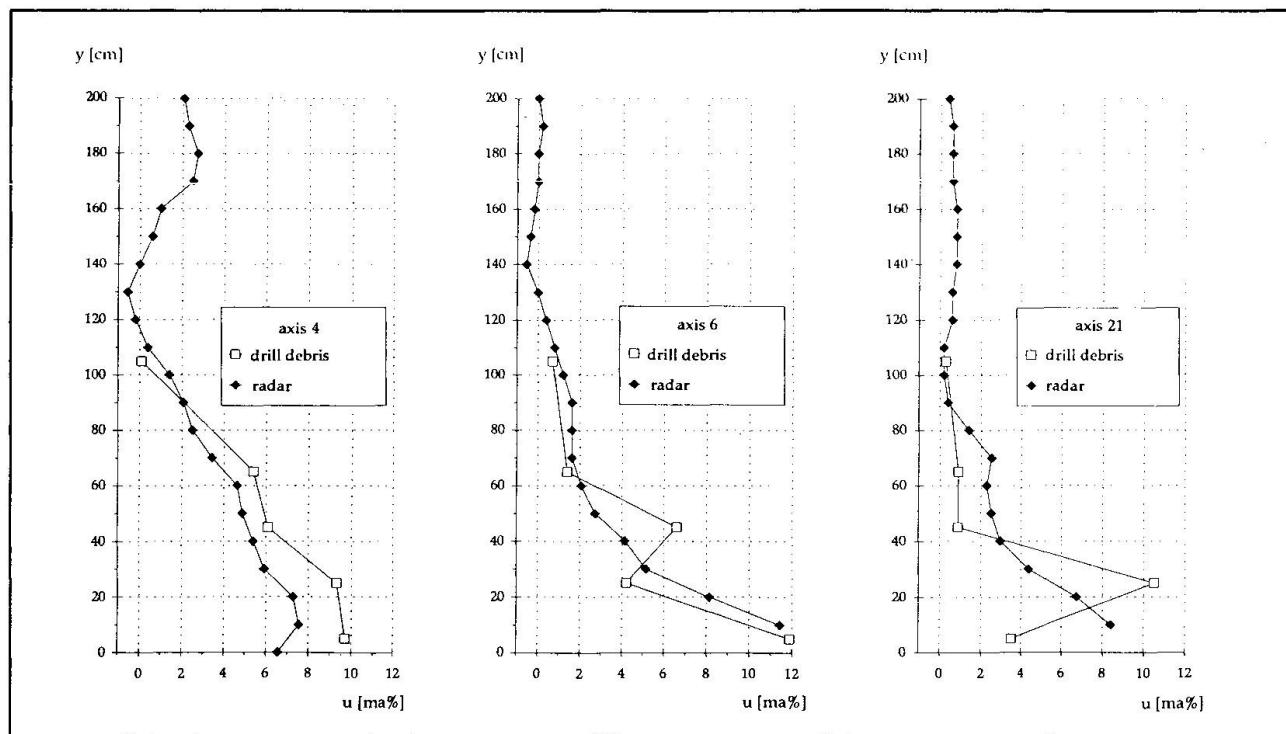
Fig. 11: Moisture content u of a brick wall at 3 cross sections, determined with radar or the gravimetric method on drill debris

A comparison of the results from radar and the gravimetric moisture determination on drill debris from about 120 samples was made on a brick wall of a church. Fig. 11 shows 3 cross sections with the values from both methods, the profiles from radar being much smoother because of the larger measuring volume.
