Zeitschrift: IABSE reports = Rapports AIPC = IVBH Berichte

Band: 70 (1993)

Artikel: Ultrasonic methods for damage evaluation in limestone columns

Autor: Benedetti, Andrea / Barboni, Marco

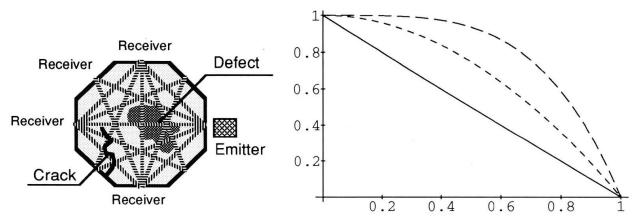
More precisely, in presence of rough localised cracks, ultrasonic scanning can be used in a way similar to tomography, by means of several intersecting travelling paths, which enable to draw information on the geometry of cracks [9] (fig.1).

Fig. 1 : Multi path scanning for defect positioning

Fig. 2: Damage index as a function of the proposed velocity relations

In fig. 2 the results of the presented damage laws are compared; As is clearly apparent, the different order of the exponent gives rise to a divergence of the indices; on the other hand, each definition is tailored on a different parameter and this should be taken into account when a damage measure has to be kept.

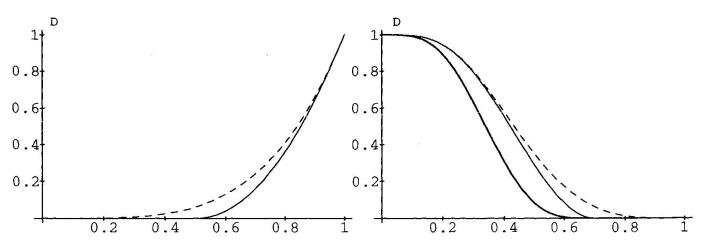
Fig. 3.a : Damage evolution as a function of stress level σ/f_k, as predicted by dilatancy

Fig. 3.b : Damage evolution as a function of the ultrasonic velocity ratio v_{us}/v_o

A drawback of rel. (5) is the need of the value of $\sigma_{\rm VC}$ which is of difficult definition indeed. However, contrary to the linear damage law, this type of representation involves a filtering (due to the exponent m), which runs finally to a step damage function; in fig.3 the results for m=2 and m=4 (solid lines) are compared with the case $\sigma_{\rm VC}$ =0, showing a relative insensitivity to the choice of the various constants.

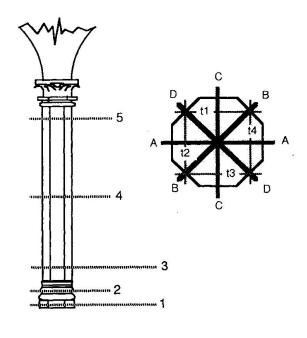
Fig. 4: Representation of the measure paths

microcracks are present resulting in the ultrasonic velocities reported in fig.4.

In the table of fig. 4 the values of the ultrasonic velocities measured after the filling operation are shown; as is apparent, the major change involves the sections what initially were not transparent.

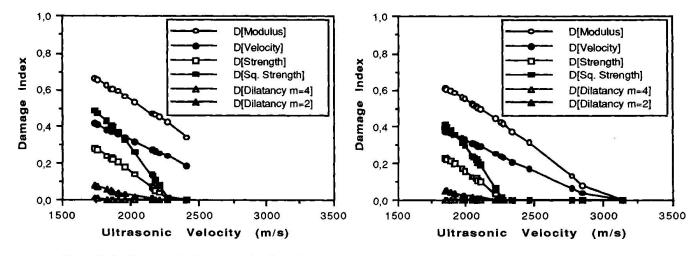
Fig. 5 & 6: Damage indices resulting from the various formulations for the damaged and restored column

In fig.s 5 and 6 the computed damage indices are compared for both conditions, before and after repair. As we said before, the various statements differ dramatically and is difficult to extract the correct one.

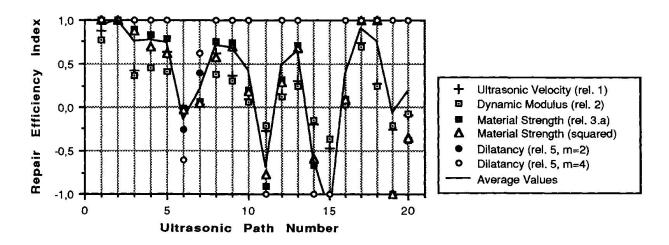
Fig. 7: Repair Efficiency as computed from the ratio of damage indices, before and after the strengthening

On the contrary, expressing the efficiency of the strengthening by means of the ratio of the relevant damage indices we can observe a significant agreement of the introduced indices. In fig. 7 the efficiency ratios for the various measurement paths are compared.
