**Zeitschrift:** IABSE reports = Rapports AIPC = IVBH Berichte  
**Band:** 71 (1994)

**Artikel:** Design and construction of Kupolen exhibition hall and sports arena  
**Autor:** Sundquist, Hakan / Granaht, Torbjörn  
**DOI:** <https://doi.org/10.5169/seals-54129>

## Design and Construction of Kupolen Exhibition Hall and Sports Arena

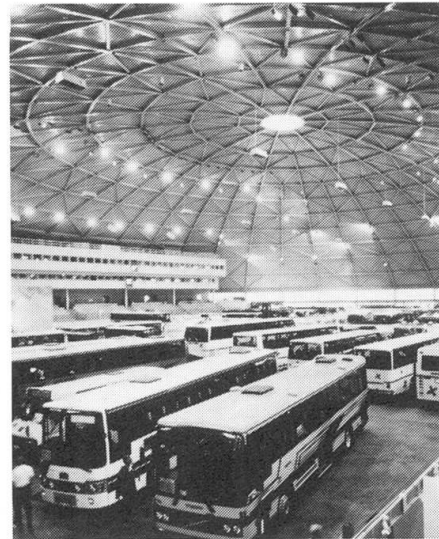
**Figure 3** Inside view of the dome.

The 7000 m<sup>2</sup> floor area of the main floor can also be used for large exhibitions, **Figure 3**, with a back up area 5000 m<sup>2</sup> for lounge, conference centre etc. To complete the project and to help financing the project, it also contains a 15000m<sup>2</sup> shopping mall under the main floor, a hotel and an office block with 4 stories. These 2 buildings are both situated under the cupola and along the long sides of the sports area but with no structural connection to the dome. The Kupolen sports and exhibition hall was constructed in 1989.
