Artikel: Design and construction of Kupolen exhibition hall and sports arena
Autor: Sundquist, Hakan / Granaht, Torbjörn
DOI: <https://doi.org/10.5169/seals-54129>

Design and Construction of Kupolen Exhibition Hall and Sports Arena

Hakan SUNDQUIST

Torbjörn GRANAHT

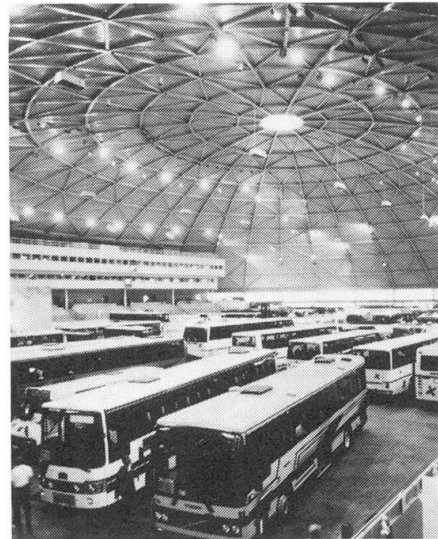
Figure 3 Inside view of the dome.

The 7000 m² floor area of the main floor can also be used for large exhibitions, **Figure 3**, with a back up area 5000 m² for lounge, conference centre etc. To complete the project and to help financing the project, it also contains a 15000m² shopping mall under the main floor, a hotel and an office block with 4 stories. These 2 buildings are both situated under the cupola and along the long sides of the sports area but with no structural connection to the dome. The Kupolen sports and exhibition hall was constructed in 1989.
