Rubrik: Session 4: Inspection, maintenance and operation

The Computer as an Aid to Better Design
L'ordinateur - auxiliaire en vue d'un meilleur projet
Der Computer als Entwurfshilfe

Engineering Maintenance at Birmingham International Airport

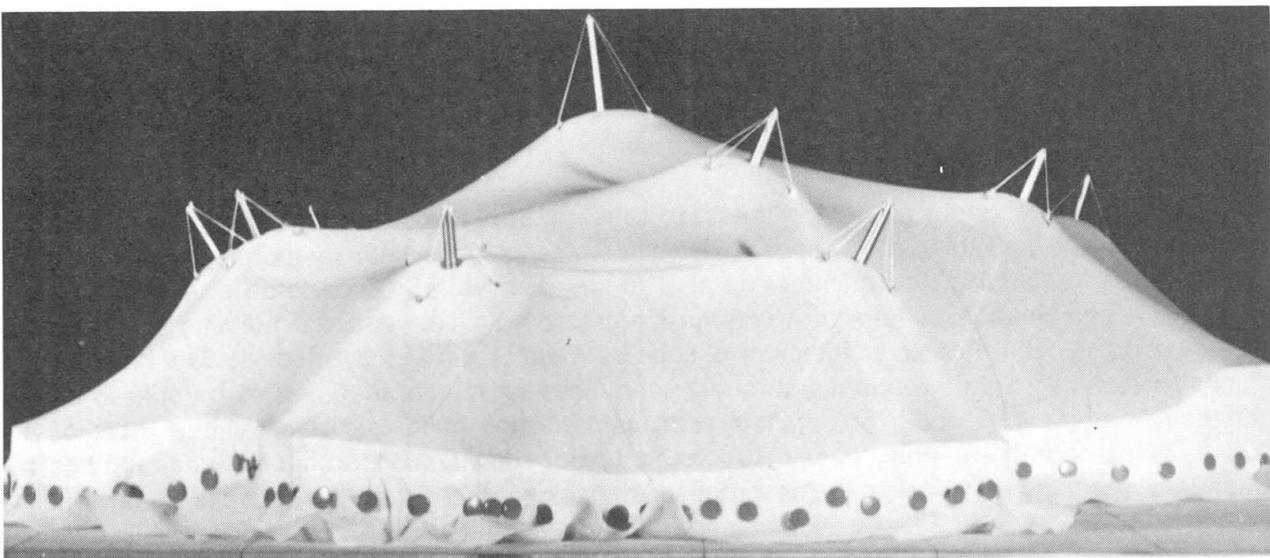
Figure 1: Use of physical modelling

In tension structures design using physical modelling there has always been a core model as a focus for all communication and decision making. Increasingly it is in a computer rather than on a table, and it is the achievement of this stage in the development of the design method which is being evolved now.

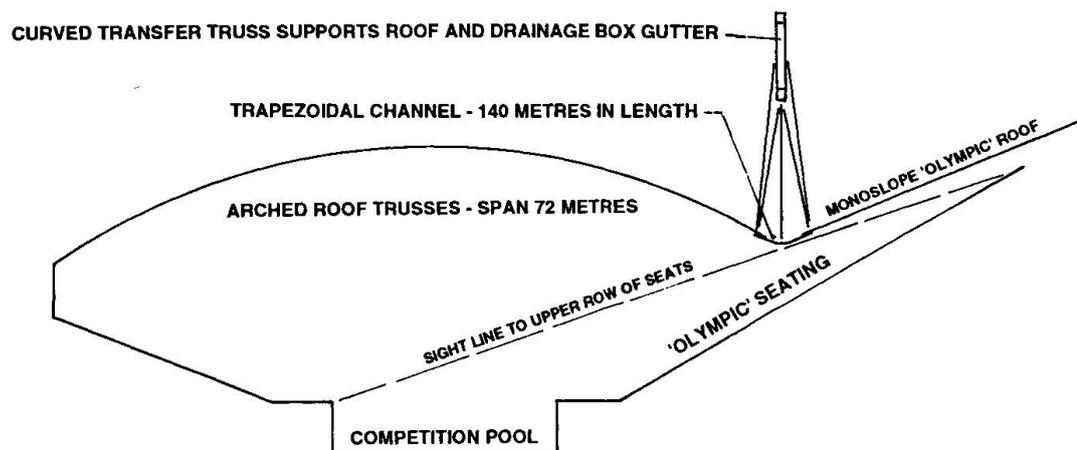
Fig.2 Sydney Aquatic Centre, Elevation View

The main pool area is roofed with an arched truss arrangement. In non-Olympic mode the curved main roof has a plan area of 2,575 m². A monoslope roof of plan area 1225 m² is provided above the additional Olympic seating area. A line of sight from the uppermost row of seating to the far side of the main competition pool has to clear the junction of the underside of the main and monoslope roof areas. A trapezoidal internal gutter is provided to permit this line of sight. See Figure 2.

The trapezoidal gutter and roof junction are supported from above by an external transfer arch. This arch is constructed of uniform radius steel box section with steel ties supporting the gutter, the curved main roof and the monoslope Olympic extension. The total roof weight is approximately 640 tonnes. The box section arch below the gutter bifurcates, providing both an aesthetically attractive feature and additional lateral stability.

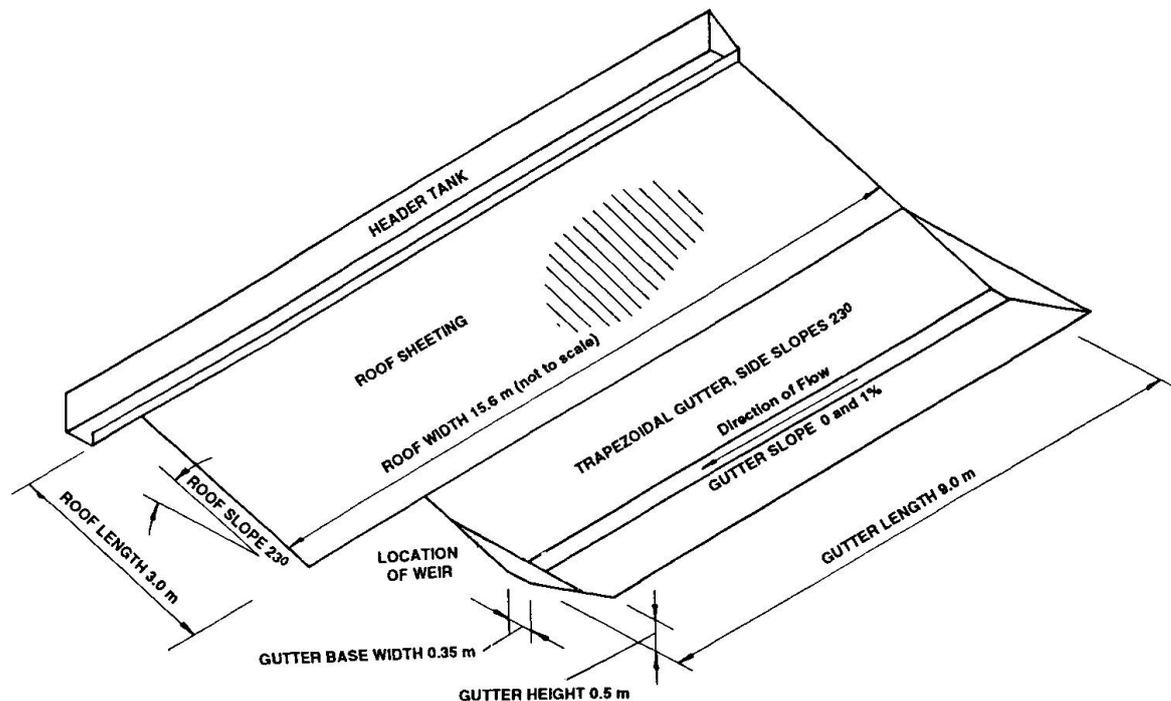
Fig.3 Model Roof and Gutter Configuration

For a design rainfall intensity of 313 mm/hour, the model was required to estimate the depth of flow on the roof sheeting and the maximum depth of flow in the trapezoidal gutter, assuming a free outfall. The effect of tie protrusions on the maximum gutter depth was also investigated. The 9 m long model gutter was built full-scale (1:1). The model roof and gutter configurations are shown in Figure 3. It was not possible to model an arched roof in the laboratory. To obtain a conservatively high estimate of prototype gutter depth a plane roof was used, inclined at the maximum slope of the arched structure. One disadvantage with this configuration was the likelihood of underestimating the maximum water depth on the roof sheeting. This was not considered critical in light of the very shallow depths measured on the model roof sheeting.

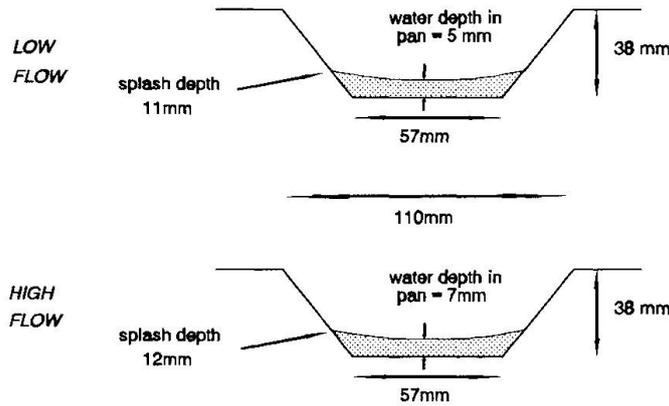
Fig.4 Depths of Flow on Roof Sheetting

The depth of flow on the model roof was independent of the gutter configuration, and was only influenced by the flow rate. Figure 4 shows the average measured depths of flow in the Alcan LT7 roof sheeting pans for the two flow rates. It was concluded that, for the steepest roof slope of 23° the sheeting profile was adequate to convey the design flowrates. Note that it was not possible to model raindrop impact and wind effects.

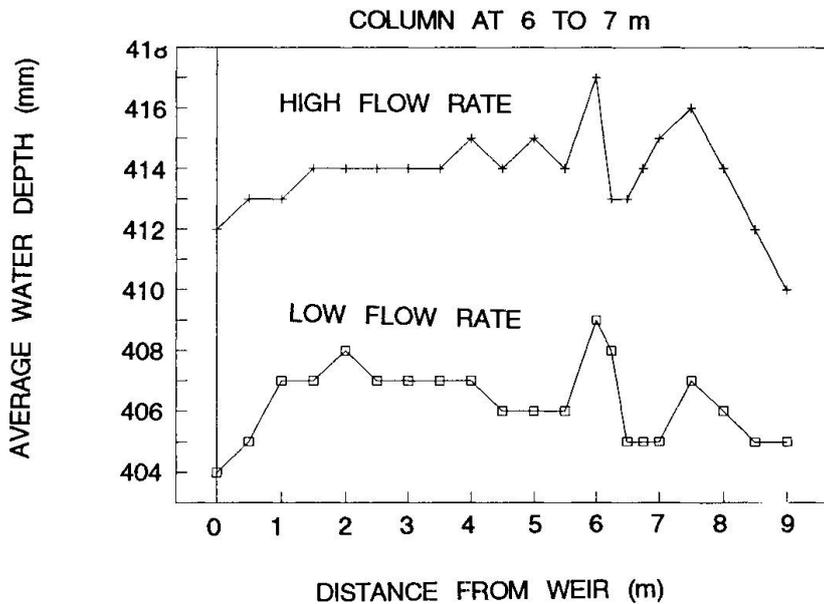
Fig.5 Horizontal Gutter

For a horizontal gutter, the maximum measured depth of flow was 417 mm (see Figure 5) which occurred with a tie protrusion located 6 to 7 m from the downstream weir. For a gutter with a 1% fall, the maximum measured depth of flow was 375 mm (see Figure 6). This occurred with a tie protrusion located 4 to 5 m from the downstream weir. The flows are spatially-varied and the location of the maximum depth will alter with gutter slope. Therefore it is not possible to directly interpolate these results for gutter slopes between 0 and 1%.

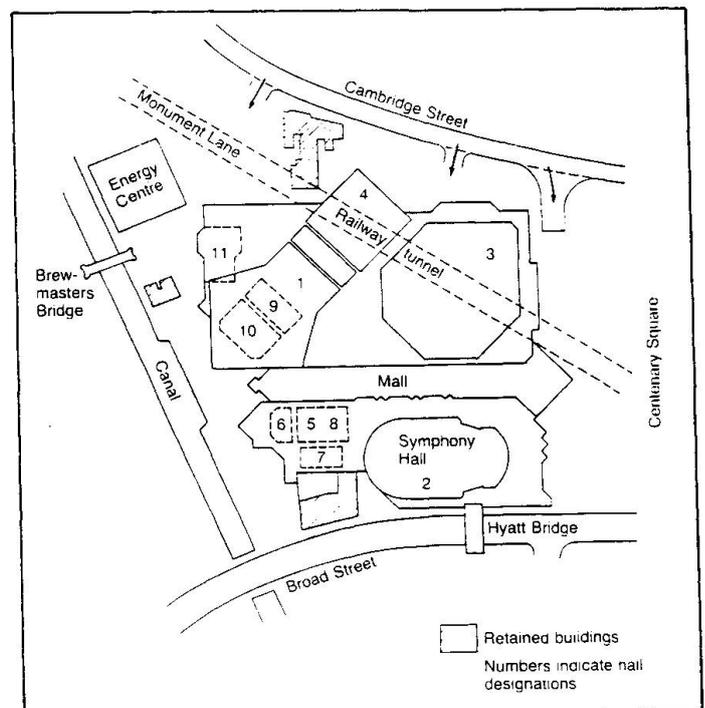
The two and a half hectare city centre site for the International Convention Centre is bisected by the Monument Lane Railway Tunnel. This brick lined, twin track tunnel was cut in 1854 by Robert Stephenson. It now carries Inter-City trains from London Euston northwards via Birmingham New Street. The influence of the railway tunnel and the relative compactness of the site for 50,000m² development have both had fundamental effects on the planning arrangement for the eleven hall complex, see Figure 1.

Fig.1 Plan: The Symphony Hall is located 35m from railway

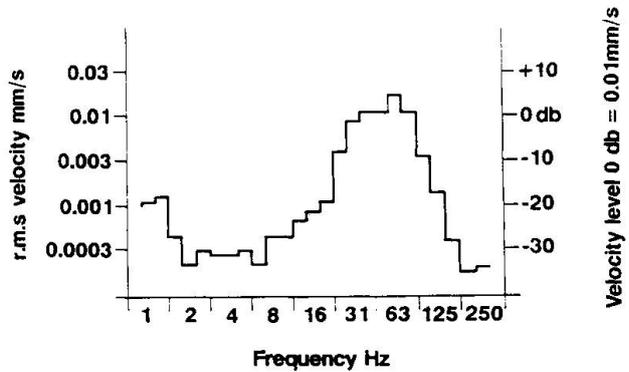
Fig.2 Typical ground vibration spectrum: measurements at 50m from tunnel.

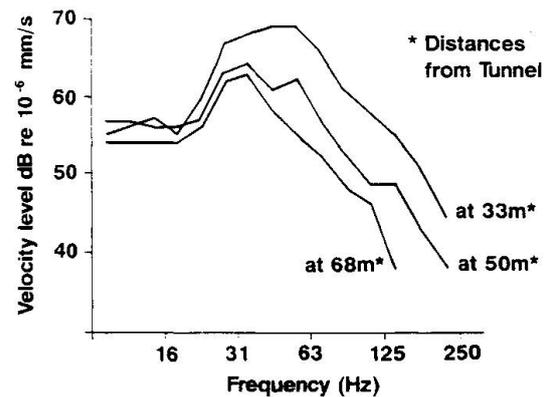
Examples of vibration velocity data from three boreholes are given in Figure 3. Although horizontal vibration levels were significant, the vertical component was found to dominate.

Fig.3 Borehole vibration data: Vibration at 33m, 50m and 68m from tunnel.

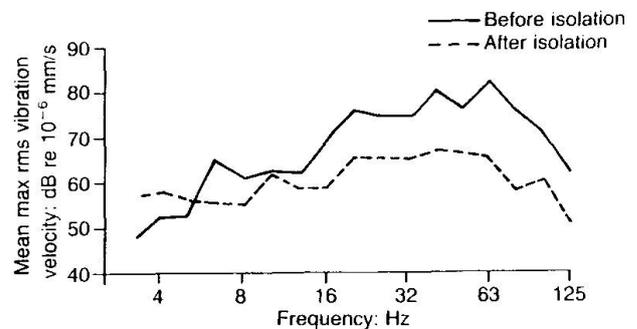
Early discussions with Civil Engineers from British Rail revealed that although major track level isolation was impractical, they had plans as a part of their cyclic maintenance plan to relay the track and sleepers in the tunnel during the construction period of the Centre. This offered a chance for under-sleeper isolation to be added. A sheet material manufactured by James Walker Ltd, which had been on trial in North Wales, had provided close to 10dB attenuation in the 63Hz octave band. It was felt that perhaps 6dB to 8dB might be achieved in the tunnel. In view of the wish to minimise transmission to the site, it was agreed that the tracks should be isolated. On site measurements have confirmed that a useful benefit has been achieved and Figure 4 shows results from a test train before and after installation beneath one of the lines. This installation provided a general, site wide lowering of vibration levels.

Fig.4 Rail isolation test train results: vibration velocity before and after isolation of rail sleepers.

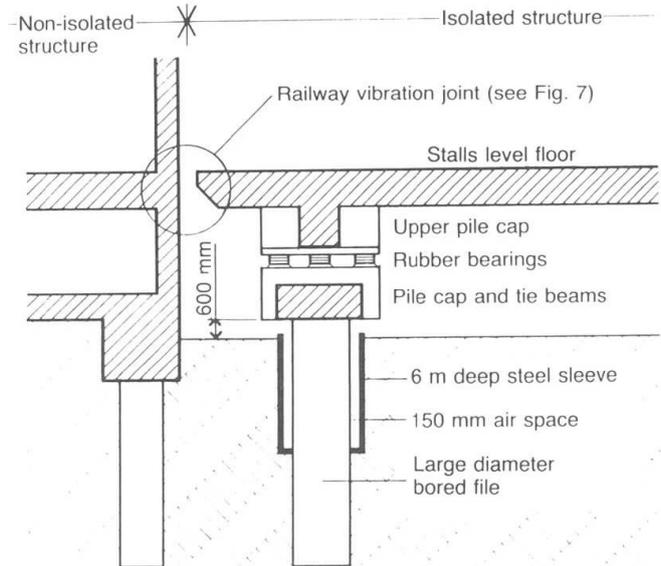
Fig.5 Isolated Symphony Hall foundations

Large diameter bored piles cast into the Rocksand satisfied the 'heavy' foundation requirements. It was also possible to decouple the top of the Symphony Hall piles from the surface wave. Six metres was determined as a maximum realistic depth for the decoupling. Many materials were considered as sleeves at the top of piles to provide a mismatch against vibration coupling. To achieve the benefit, sleeving material needed to be highly compliant. It was eventually decided to use an air void around the top of the 120 piles needed to support the Symphony Hall. The piles were formed using concentric steel tubes as permanent formwork.

The pile boring was then advanced by continuing drilling down through the inner steel tube to form the rock socket. The pile and substructure arrangement is shown in Figure 5.

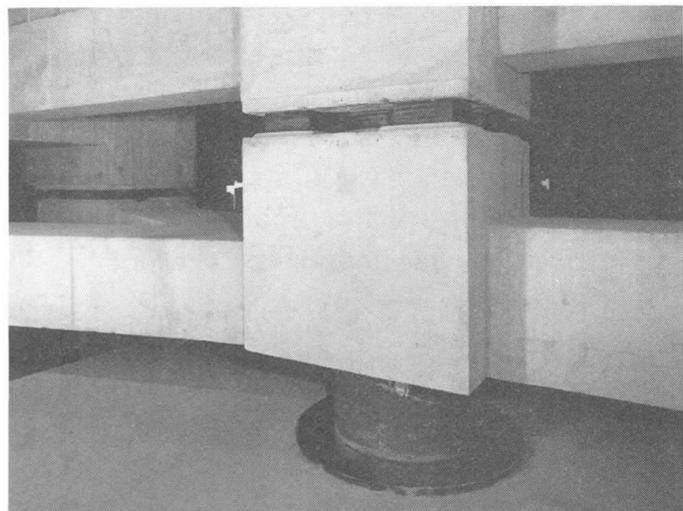
Fig 6. Symphony Hall foundations.

For the most noise critical halls, isolated superstructures are floated on twin layers of foundations, separated by a layer of bearings. Lower sets of beams restrain pile caps and they are always 600mm above the ground to maintain the integrity of ground isolation. Upper beam arrangements collect the superstructure loads together, see Figure 6.

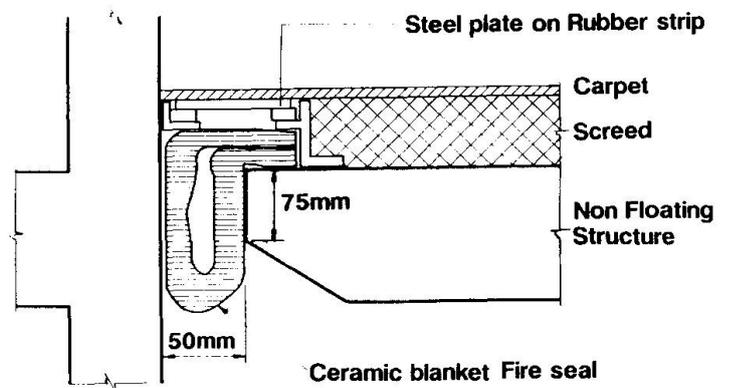
Where either isolated or non-isolated structure meet floated structures, a 50mm air space has been allowed. Total relative vertical settlement of as much as 12mm has been allowed across railway vibration isolation joints (RVJ's). Typically, joints have been designed to accommodate ± 6 mm of lateral movement.

The elevational area facing the floated structure has to be limited, slabs and walls are generally chamfered to a 75mm deep nosing. A series of special bridging details deals with the need to carry people over the joint, achieve fire separation, and account for settlement and bearing creep without vibration bridging. Folded foam or ceramic blanket is used to achieve fire ratings within isolation joints, see Figure 7. For waterproofing or facing, low modulus sealants or dry resilient seals have been included.

Fig.7 Railway vibration joint: isolation gaps separate all halls.

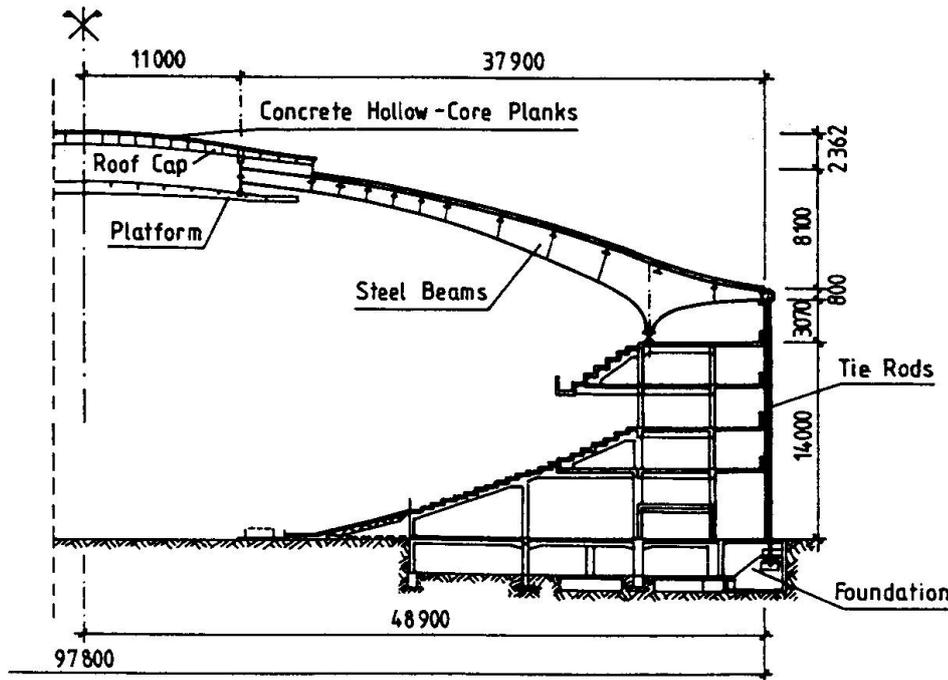
Fig. 1 Cross Section of the Westfalenhalle

The main structural roof elements consist of 20 riveted steel beams, which cantilever out to the centre of the roof, and are anchored at the rear by means of tie rods from the end of the arm down to the foundations (Fig. 1).

The tie rods each consist of 5 separate bars with diameters varying from 55 mm at the weakest beam to 110 mm at the strongest. The clear length of the tie rods from foundation level to the beam connection is 17,34 m.

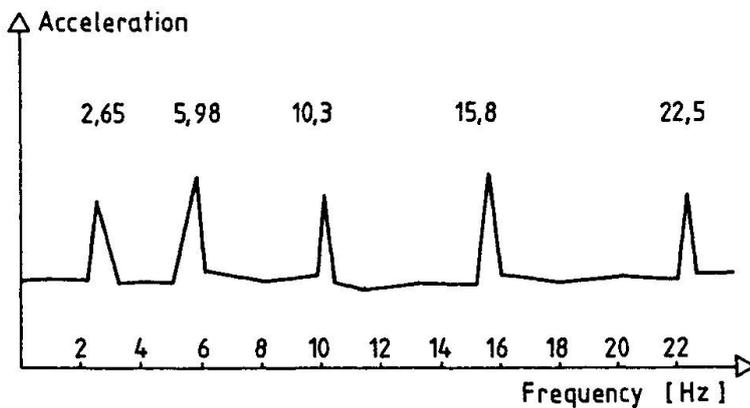
Fig. 2 Test Data (simplified) of a Tie Rod with 100 mm Diameter

The typical simplified test result for a tie rod with a diameter of 100 mm is shown in Fig. 2. The distinct peaks of the natural frequencies 1 to 5 are clearly shown.

First analysis of the test data led to an extremely disturbing result concerning tie rod forces, and thus roof loading. Flexible cable characteristics had been assumed for first analysis. Initially, this seemed to be appropriate for a frequency ratio of $f_2/f_1 = 2,26$, where $f_1 = 1$ st natural frequency, $f_2 = 2$ nd natural frequency. For a flexible cable this ratio is $f_2/f_1 = 2$ and for a simply supported bending member $f_2/f_1 = 4$.

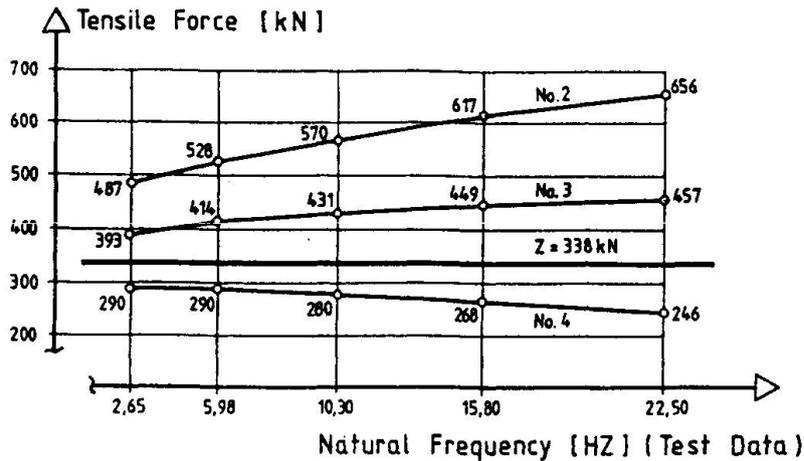
Fig. 3 Tensile Forces Z for various Support Conditions and actual Tie Rod Force

If all values of Z_n for support condition no. 2, 3 and 4 are determined from the test results, the results shown in Table 2 are obtained. All these values can be represented graphically (see Fig. 3).

By considering Table 1 and Fig. 3 it is obvious that the actual support condition and the actual tie rod force Z lie somewhere between support condition no. 3 and no. 4.

Because there is only one single actual tensile force Z for all measured f_n in the tie rod under consideration, the force Z must be a horizontal line between support condition no. 3 and no. 4 (see Fig. 3).
