Cable-Corrosion-Protection Systems for Cable-Supported Bridges in Japan

Manabu ITO

Kazuo TADA

Makoto KITAGAWA

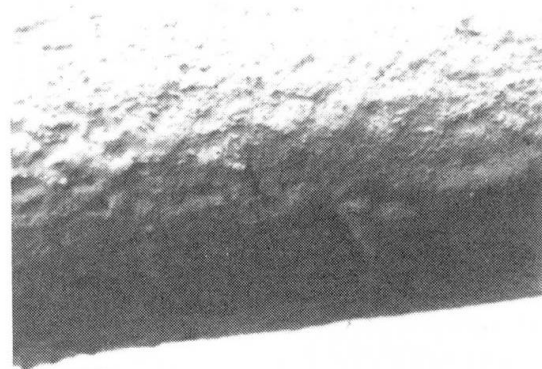
Photo 1 Cracks on plastic-covering (20 years after completion)

PWS-cables were applied, for example, in Toyosato Bridge, Kamome Bridge, Rokko Bridge, Suehiro Bridge and Yamatogawa Bridge, all of which were built in 1970s. The corrosion-protection for the PWS-cable was usually performed by a plastic-covering. The plastic-covering, in early 1970s, was done by a hand-lay-up method. This is to coat a fiber-reinforced-plastic (FRP) layer, on the cable on site. In the latter 1970s, a prefabricated-segment method was newly developed to improve the workability of a hand-lay-up method. This is to fabricate the FRP segments in the shop, and only to connect them on site to form the covering. But, for these works, an installation of temporary footway along each stay cable, a catwalk, is indispensable. At the same time, some expansion joints have to be installed on the covering with some intervals, because the difference of the expansion-and-contraction between the cable and covering has to be absorbed. In some cable-stayed bridges, lasting about 20 years, some damages are found like small cracks on the covering and some deterioration on expansion joints. Then, some repairing works are required for these plastic-coverings, at present.

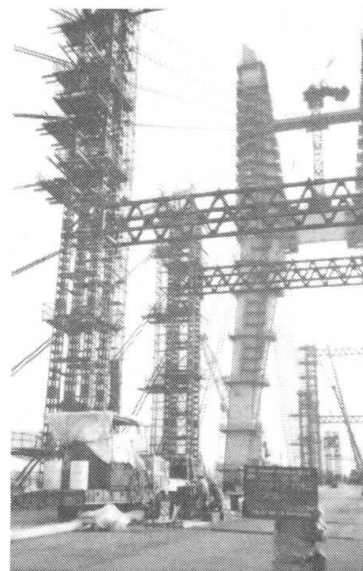
Photo. 2 Grouting of polybutadiene resin
(Iwakurojima Bridge)

2) Instead of cement milk, synthetic resin like polybutadiene was selected for the grout material. This method is not only good to solve the problem of hydrogen brittleness, but also good to protect the grout material from cracks, caused by the expansion-and-contraction of the cable, which is sometimes seen in the cement grout. But, this method is very expensive because of its large scaffoldings, and it also requires very severe quality-control, which makes the work on site complicated. This was applied to the Hitsuishijima Bridge and Iwakurojima Bridge.

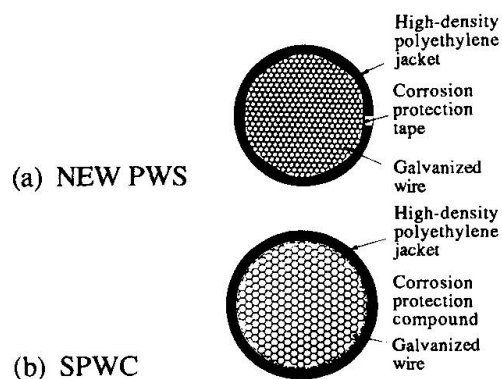
Fig. 2 Nongrout-Type-Cables

Based on the above background, nongrout-type cables, which does not need complicated grouting, have come into wide use in the Japanese steel cable-stayed bridges from late 1980s. In these cables, parallelly-bundled galvanized steel wires are tightly enveloped by PE-covering to isolate the cable from outside, in the completely quality-controlled shop. Both ends of the cable is anchored by fatigue-resistant end-fittings, for which several structures are manufactured by some companies. These cables are featured as follows.

(1) To enable the reeling of the cable, each wire is bundled with a lay-angle of not more than 4 degrees. The experiments show that this lay-angle will not deteriorate cable's properties like the Young's modulus, tensile strength, and fatigue strength, comparing with values of each wire.

(2) PE-envelope is completely shop-fabricated by a directly extruded PE jacket, after wrapping the bundled wires with a corrosion-protection tape or after coating wires with corrosion-protection
