Zeitschrift: IABSE reports = Rapports AIPC = IVBH Berichte

Band: 73/1/73/2 (1995)

Rubrik: Poster Session 2: Buildings

Buildings Bâtiments Hochbau

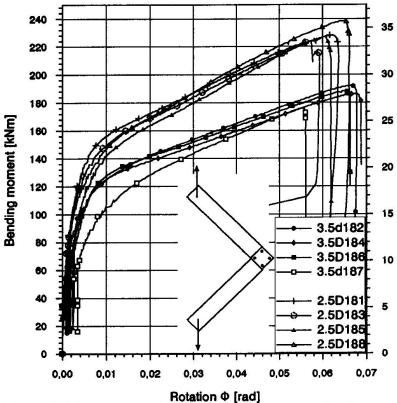
Figure 3: Moment-rotation relation of two tests series dvw reinforced prestressed timber joints, taken from [2].
