Zeitschrift: IABSE reports = Rapports AIPC = IVBH Berichte
Band: 73/1/73/2 (1995)

Artikel: Diagnosis and repair of buildings damaged by fire exposure
Autor: El-Nesr, Osama
DOI: <https://doi.org/10.5169/seals-55360>

Diagnosis and Repair of Buildings Damaged by Fire Exposure

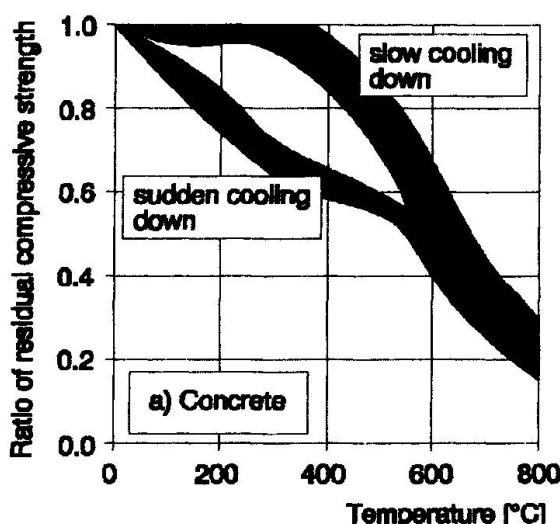
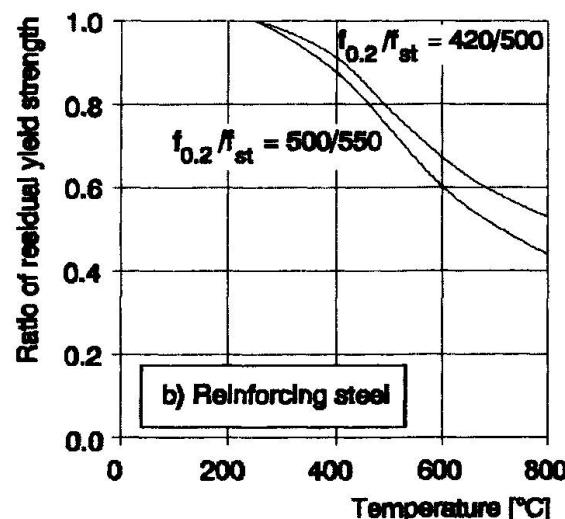
Fig. 1 Residual strengths of concrete and reinforcing steel as a function of temperature reached

The residual strength of concrete can be tested by the well known measures. The dependence of decreased strength on the temperature reached before as well as on the cooling down conditions can be taken from Fig. 1-a. As a rough solution, the decrease of the elastic modulus versus temperature may be taken as equal to that of strength.

The reduction of the modulus of elasticity may roughly be taken to be in the same range than for the yield stress, Fig. 1-b.
