Zeitschrift: IABSE reports = Rapports AIPC = IVBH Berichte
Band: 73/1/73/2 (1995)

Rubrik: Session A3: Inspection methods and monitoring

Inspection Methods and Monitoring
Méthodes d'inspection et de surveillance
Methoden für Inspektion und Ueberwachung

Sonic Tomography Analysis of Concrete Structures

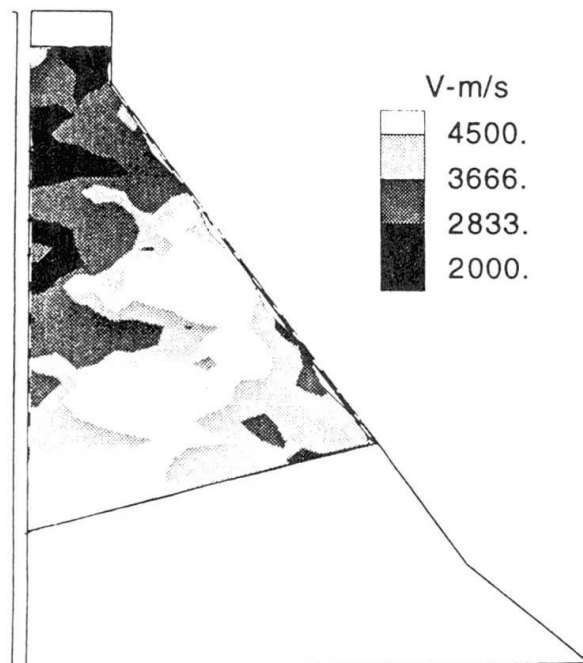
Fig.3b Distribution of sonic velocity.

The low velocity area on the top of downstream face reveals the extent of a damaged concrete visible from the outside, while the one on the upstream face coincides with the tidal zone. The interface between old and new concrete is however not visible on the image. This is probably due to a lack of data records on the downstream face (source and receivers on the donwstream face). Nevertheless, laboratory tests on concrete samples show a good correlation among resistance values, elastic moduli and velocities (Table 1).

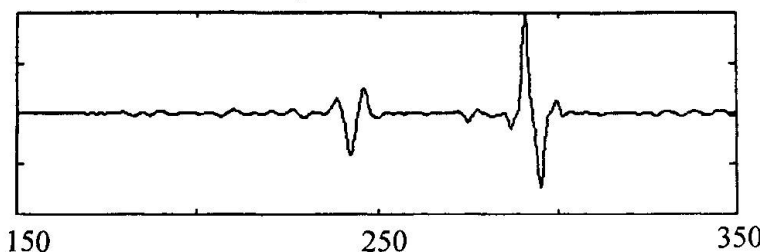
Fig. 9. Echo signal after Split Spectrum Processing versus time t [μ s].

Split spectrum processing was used to reduce material noise from single sample records thus enabling identification of specular echoes with good resolution. The signal from the 0.30 m thick slab (fig 8a) showed a clear echo after split spectrum processing (fig 9) as did the signal from the 20 cm slab. The echo in the signal from the 0.10 m slab could not be clearly identified.
