**Artikel:** From structural assessment to appropriate preservation strategies  
**Autor:** Vogel, Thomas  
**DOI:** <https://doi.org/10.5169/seals-55259>

## From Structural Assessment to Appropriate Preservation Strategies

**Thomas VOGEL**

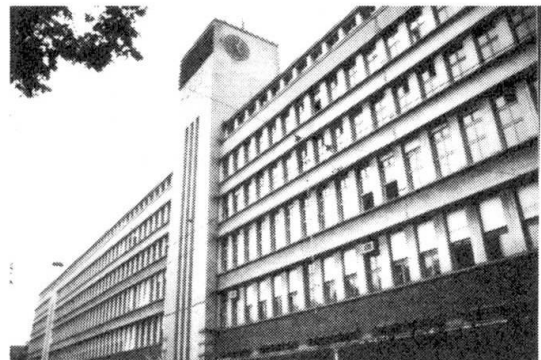
Fig. 2 SE-façade of the Sihlpost building

The main post office of Zurich built in 1928/29 with a structure designed by Robert Maillart was enlarged from 1986-92. Before offices of other postal and railway services are incorporated, the building including the exposed concrete façade (Fig. 2) is being presently restored.

Structural element	Concrete cover	Carbonation depth	Comment
Piers between window openings	27 - 55 mm	35 - 57 mm	increased carbonation risk
Lintels of recessed NW-façade	0 - 65 mm	28 - 56 mm	concrete spalling, first reinforcement layer corroded at any grade

The piers between window openings were repaired locally concentrating on corroding areas of reinforcement by a polymer-cement-concrete-(PCC) mortar. An elastic coating on the whole surface will complete the rehabilitation work.

- Removing of carbonated concrete following a corrosion criteria by high-water pressure.
- Replacing with spraying concrete.
- Levelling out of the surface by a PCC-mortar.
- Coating, able to bridge future cracks.

Since the building is regarded as a historical monument by the local authorities, an unchanged concrete surface with formwork texture was required. According to the different stages of deterioration and structural function, the following repair systems are used:

The recessed north-western façade was treated as follows:
