Artikel: From structural assessment to appropriate preservation strategies
Autor: Vogel, Thomas
DOI: <https://doi.org/10.5169/seals-55259>

From Structural Assessment to Appropriate Preservation Strategies

Thomas VOGEL
Associate Professor
Swiss Fed. Inst. of Technology
Zurich, Switzerland

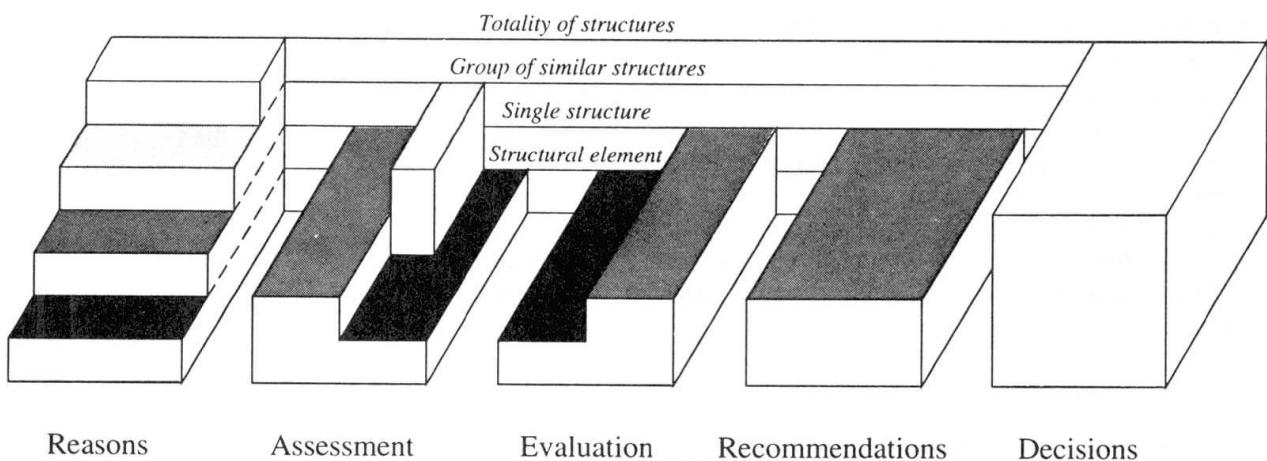
Fig. 1 Procedure with levels of considerations and decisions

On which level the procedures described hereafter are situated, is shown by Fig. 1.

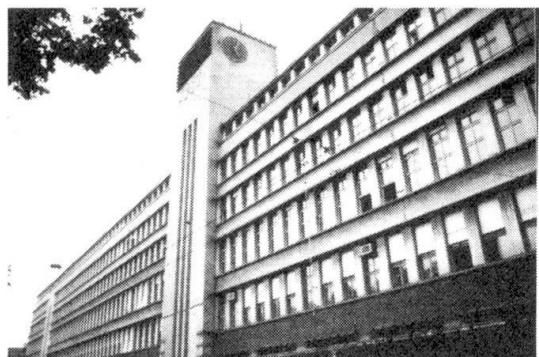
Fig. 2 SE-façade of the Sihlpost building

The main post office of Zurich built in 1928/29 with a structure designed by Robert Maillart was enlarged from 1986-92. Before offices of other postal and railway services are incorporated, the building including the exposed concrete façade (Fig. 2) is being presently restored.

Structural element	Concrete cover	Carbonation depth	Comment
Piers between window openings	27 - 55 mm	35 - 57 mm	increased carbonation risk
Lintels of recessed NW-façade	0 - 65 mm	28 - 56 mm	concrete spalling, first reinforcement layer corroded at any grade

The piers between window openings were repaired locally concentrating on corroding areas of reinforcement by a polymer-cement-concrete-(PCC) mortar. An elastic coating on the whole surface will complete the rehabilitation work.

- Removing of carbonated concrete following a corrosion criteria by high-water pressure.
- Replacing with spraying concrete.
- Levelling out of the surface by a PCC-mortar.
- Coating, able to bridge future cracks.

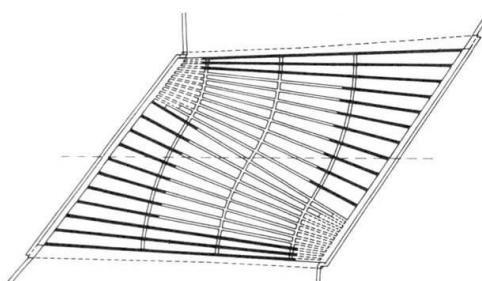
Fig. 3 Plan view of Dünnernbrücke

At Oensingen (SO) an access road to the Swiss national highway N1 crosses the Dünnern creek in a skew angle on a grillage, spanning 24 m with curved girders (Fig. 3) built in 1963/64.

Structural assessment showed a deteriorated slab due to de-icing salt ingress and lack of waterproofing, an insufficient capacity for shear forces and a minimal capacity for bending moments.

The beams were strengthened by steel plates glued on the underside in mid-span and diagonal prestressed bars on either side close to the abutments.

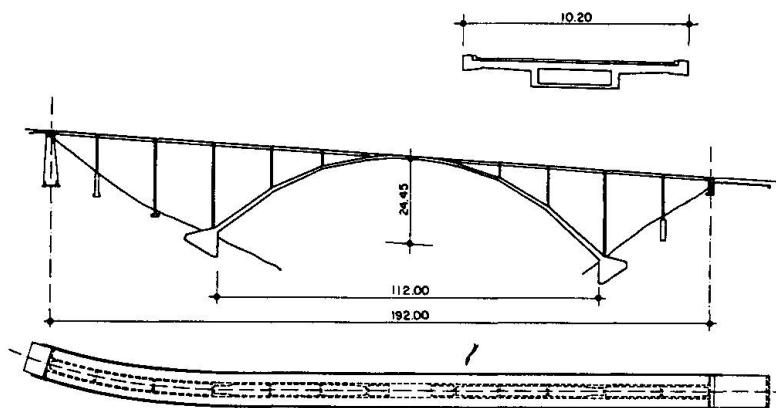
Fig. 4 Section, elevation and plan of Nanin Bridge

The Swiss national highway N13, traversing the Alps at the San Bernardino pass, crosses at its southern ramp the Moesa creek twice on elegant arch bridges designed by Christian Menn and built in 1966-68. In 1986/87 first preservation activities like removal of the interior formwork of the box girders, improving the drainage system and replacing the bearings took place.

In spite of severe deterioration of the steeper parts of the arches due to dropping water of the road draining system, the bridges still behave perfectly elastically and fulfil structural safety. In the transverse direction, however, the deck slab has inadequate load bearing capacity.

The actual rehabilitation started with the Cascella bridge in 1994 and will end up with the Nanin Bridge in 1996, including replacement of parapets and asphalt layer, strengthening of the deck slab by an additional concrete surfacing with additional reinforcement, fixing the downhill bearings to the abutments and enclosing the steeper parts of the arches with shotcrete on the lower and special cast concrete on the upper side.
