**Zeitschrift:** IABSE reports = Rapports AIPC = IVBH Berichte  
**Band:** 76 (1997)

**Artikel:** System reliability for condition evaluation of bridges  
**Autor:** Estes, Allen C. / Frangopol, Dan M.  
**DOI:** <https://doi.org/10.5169/seals-57459>

## System Reliability for Condition Evaluation of Bridges

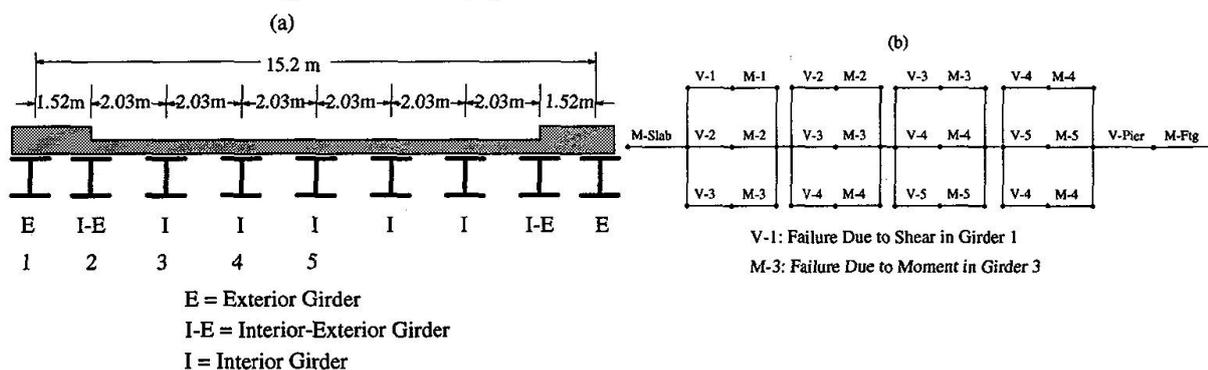
**Fig. 1** Colorado State Highway Bridge E-17-AH: (a) Designation of girders, and (b) Simplified series-parallel model

A time-dependent system reliability approach is applied to optimize the repair strategy for an existing highway bridge (Colorado State Highway Bridge E-17-AH). The bridge is on State Highway 33 in Denver, Colorado, and has three 13.36 m simply-supported steel-concrete composite spans. The 12.18 m wide roadway carries four lanes of traffic with an Average Daily Traffic (ADT) of 8500 vehicles. The deck is reinforced concrete and the steel girders are standard rolled shapes with simple-span supports. The interior span supports are reinforced concrete pier columns with a pier cap, four supporting square tapered columns, and individual column footings. The concrete abutments are supported by concrete piles cased in steel. A local railroad spur runs underneath the bridge. The cross section of the superstructure is shown in Fig. 1(a) where the girders are classified as exterior (E), interior-exterior (I-E), and interior (I).

Using 24 separate random variables, the intact bridge was analyzed with respect to 16 different failure modes including moment failure of the slab, moment and shear failure of the girders, and multiple failure modes of the pier cap, columns and footings. Limit state equations were developed and the reliability of each component was computed separately. The bridge system was modeled as a series-parallel model. Both the component reliabilities and the system reliability of the bridge were computed. A simplified system model for the bridge where it is assumed that the superstructure will not fail until three adjacent girders have failed is shown in Fig. 1(b). The simplifying assumptions, a more refined model, and a complete description of these calculations are given in Estes [5].

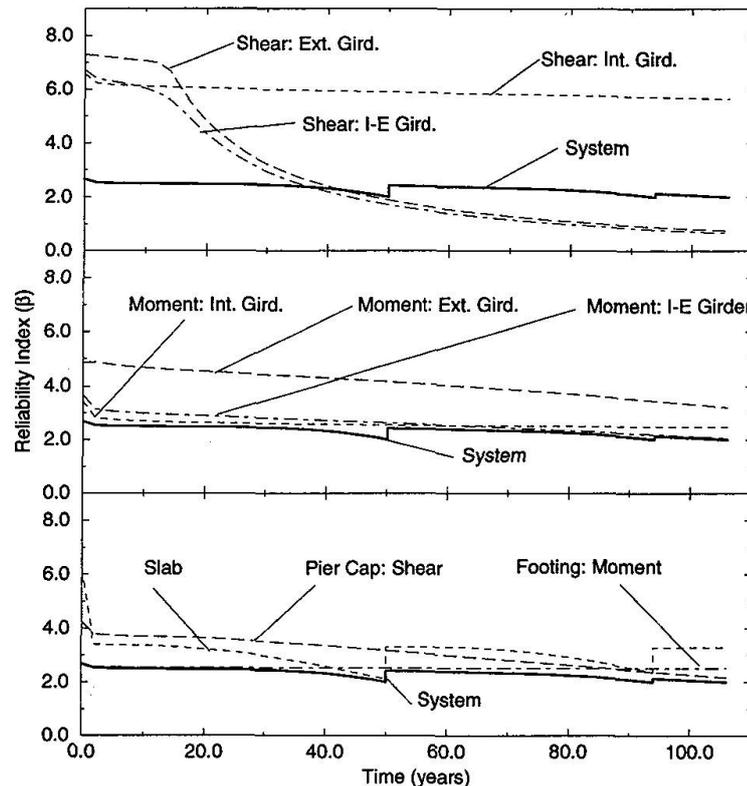
**Fig. 2** Results of repair option 1: Replace deck on Bridge E-17-AH using series-parallel system model requiring the failure of three adjacent girders

For option 1 (replace deck), Fig.2 shows the time-dependent reliabilities of the bridge system and of all components shown in Fig. 1(b). The deck is replaced when  $\beta_{system} \leq 2.0$ . Consequently, the deck is replaced twice at years 50 and 94 of the bridge life. At year 106, a deck replacement is not sufficient to improve  $\beta_{system}$  to a value larger than 2.0. Due to the parallel nature of the system, the reliability of some components are allowed to fall below  $\beta_{T,system\ life} = 2.0$ . Due to varying deterioration rates, the critical component early in the life of the structure is not necessarily the most important later on.

Using the results of NDE inspections, the reliability of the girders, the deck, and ultimately the system are updated. Using the same repair options listed earlier, Fig. 6 shows the results of Option 1: Replace the Deck. Fig. 6 can be compared to Fig. 2 which showed the time-dependent reliability of the bridge components and bridge system when the deck was replaced twice using the original deterioration models. Despite the updated inspection results, the figures are quite similar, except for the reliabilities with respect to girder shear. The girder reliabilities with respect to moment are close to the original model. The moment capacity is dependent on the plastic section modulus which is less sensitive to the small changes in the thickness loss. In Fig. 6, the slab is replaced at year 52 and year 98, and at year 108, a slab repair is no longer sufficient to raise the system reliability above  $\beta_{min}=2.0$ .

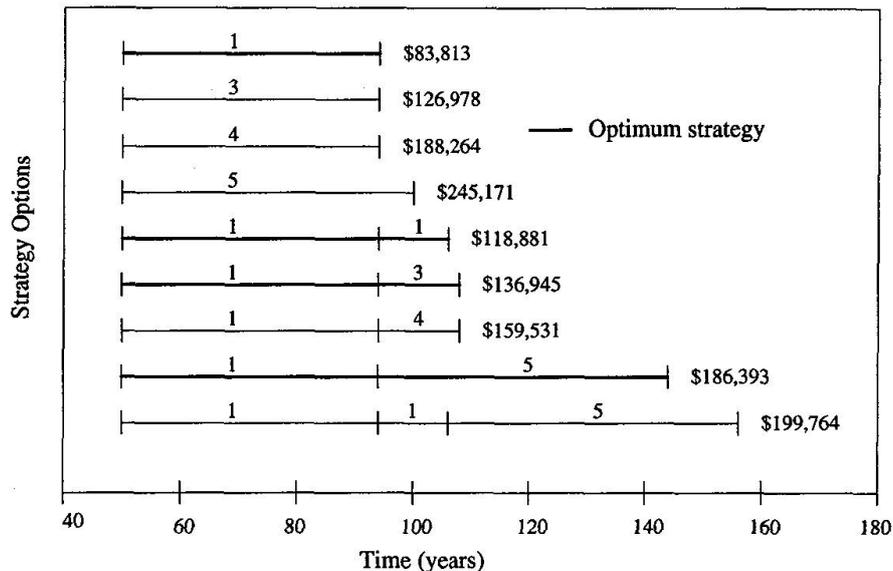
*Fig. 3 Strategy options and associated costs*

Let's assume the bridge is placed in service in 1996. Accounting for all combinations of options and using an assumed discount rate of 2%, the possible repair strategies and their associated present value costs are shown in Fig. 3. The analysis continued until replacement of the bridge (i.e., option 5) becomes the only available solution. From Fig. 3, the optimum strategy can be determined for the expected life of the bridge. For example, for a life of 50 years, no action should be taken; for 50-94 years, replace the deck at year 50 (\$83,813); 94-106 years, replace the deck at year 50 and year 94 (\$118,881); 106-108 years, replace the slab at year 50 then replace the exterior two girders and slab at year 94 (\$136,945); and after 108 years, replace the slab at year 50 then replace the bridge at year 94 (\$186,393).

With regard to the reliability of the system, the girder reliabilities do not dominate the system. The reduced girder corrosion rate uncertainty improves the reliability of the individual girders, but has little to no effect on the system. The slab, which is deteriorating more rapidly than the other critical failure modes, eventually dominates the reliability of the system. The effects of longer chloride initiation time  $T_I$  and increased uncertainty in the corrosion rate  $r_{corr}$  offset each other. As a result, the minimum system reliability  $\beta_{min} = 2.0$  is violated after 52 years of service, which is very close to the 50 years of service in the earlier model. Again, accounting for all relevant repair possibilities and using a discount rate of 2%, Fig. 7 shows all feasible strategy options and their associated costs which can be compared to Fig. 3 using the original model.

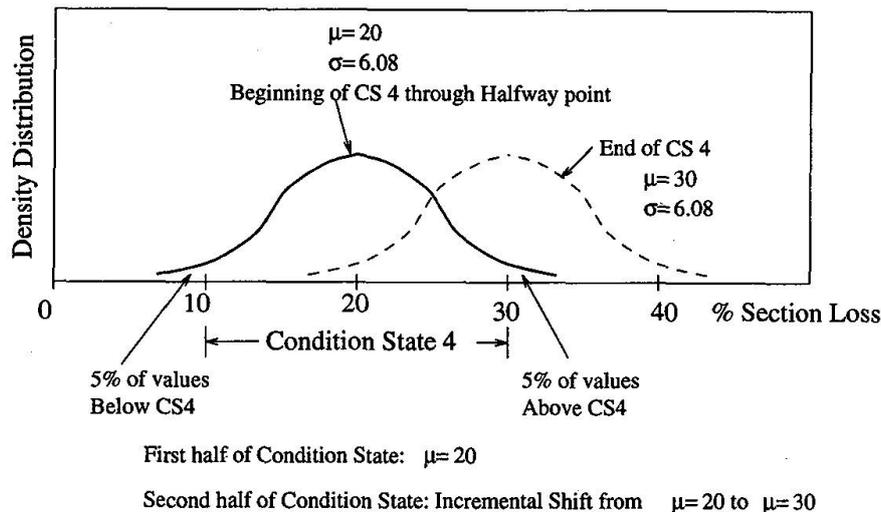
**Fig. 4** Density distribution of deterioration for Element 107 in Condition State 4 when inspectors are correct 90% of the time.

The parameters of random variables cannot be obtained directly from a visual inspection. Some assumptions must be made regarding the accuracy of the results and quality of the information provided by the inspectors. This study assumes that condition state deterioration over time is linear and that the deterioration intensity is normally distributed. It is further assumed that when a bridge element is at the halfway point of a specific condition state, the mean value of the normal distribution is at the halfway point of the condition state definition (see Fig. 4).

The standard deviation is determined by the assumed quality of the inspection program. If the inspector is believed to be correct 90% of the time when the member is at the halfway point of the condition state, then 90% of the values in the normal distribution will be within the values prescribed by the condition state. To make this assumption conservative, the condition state is assumed to begin at the halfway point and shifts progressively to the right as shown in Fig. 4. If the element remains in the condition state longer than expected, the distribution will remain at the far right position until an inspection reveals a switch to the next condition state. The exception will be for the first and final condition states where a lognormal distribution is used.

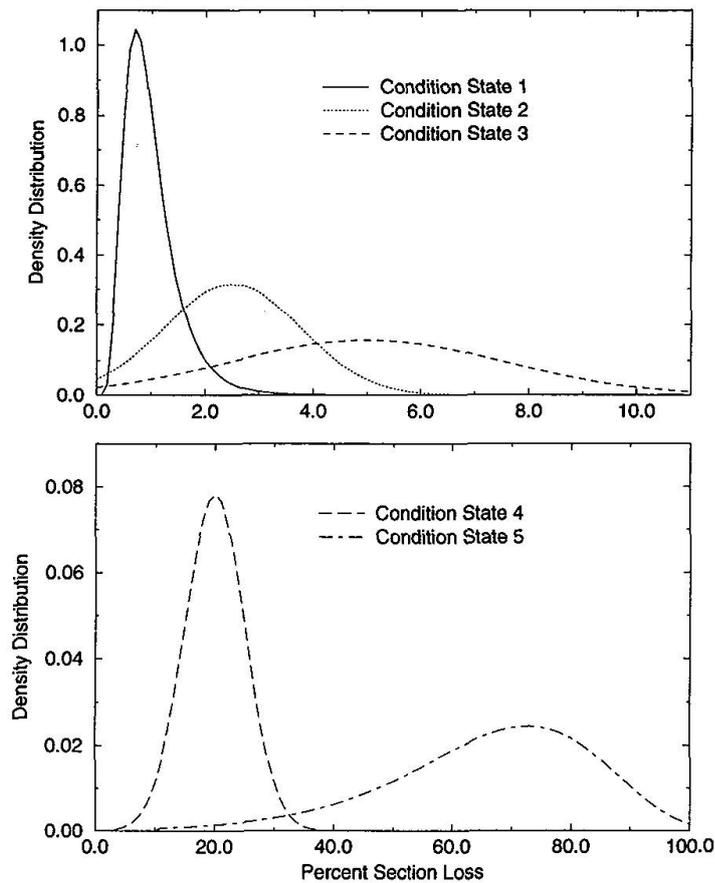
**Fig. 5** Density distributions associated with Condition State (CS) ratings CS1-CS5 for Element 107: painted open steel girders, Inspection Category A

This study considered three different qualities of inspection programs, A, B, and C, where the inspectors were provided the correct rating 95%, 85%, and 75% of the time, respectively. The quality of the inspection program was determined based on seven criteria [5] which included inspector training, a quality assurance program, and inspector experience. The density distributions associated with condition states 1 through 5 for Inspection Category A and Element 107 as listed in Table 1 are shown in Fig. 5. Condition states 1, 2, and 3 were modified to reflect section losses of 0-2%, 0-5%, and 0-10%, respectively. Once the parameters of the random variables which describe the percent section loss for the corroding steel girders are defined, the area of the web and the plastic section modulus at the time of inspection can be computed. With the revised shear and moment capacities of the girders, the updated reliability of the bridge girders is computed. Assuming linear condition state deterioration over time, the future performance of the structure is predicted.

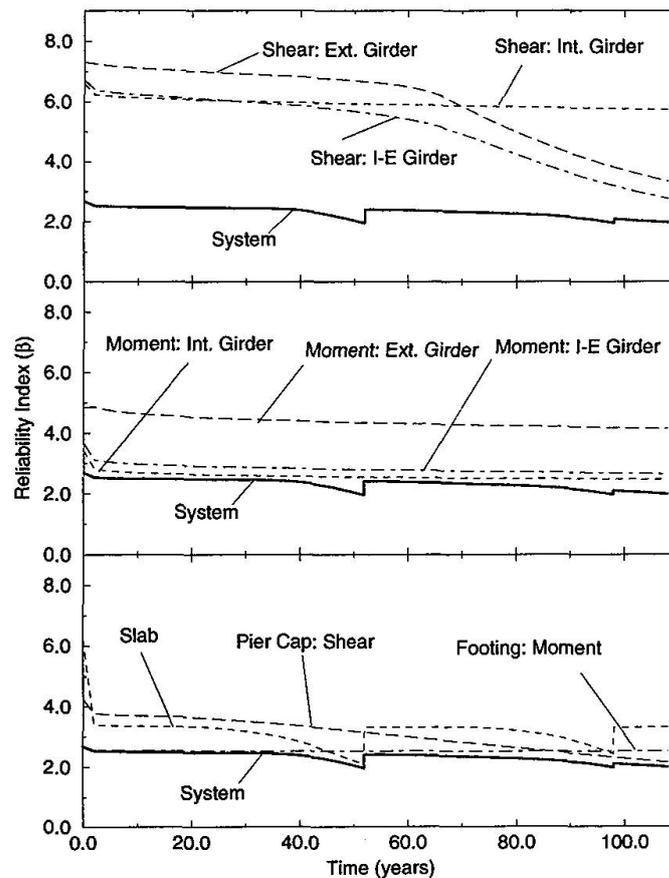
**Fig. 6** Updated results of repair option 1 on Bridge E-17-AH using simplified series-parallel model requiring the failure of three adjacent girders

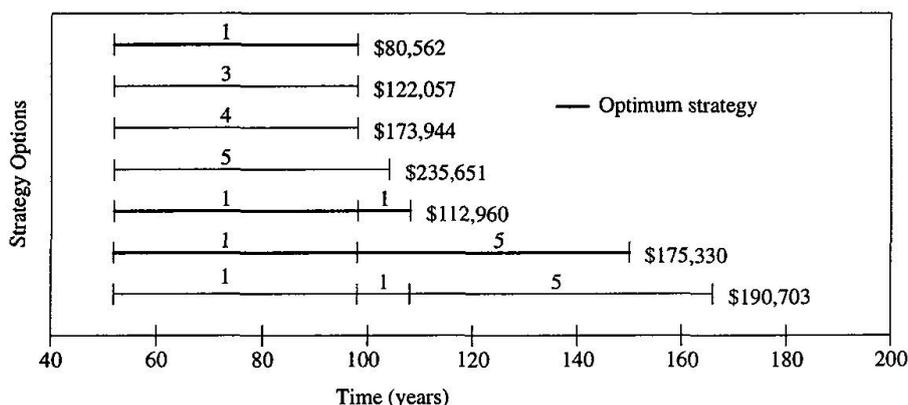
**Fig. 7** Updated strategy options and costs (2% discount rate) for Bridge E-17-AH using simplified series-parallel model requiring the failure of three adjacent girders

As a result, the updated optimum strategy is as follows: for a life of 52 years, no action should be taken; for 52-98 years, replace the deck at year 52 (\$80,562); 98-108 years, replace the deck at year 52 and replace the deck again at year 98 (\$112,960); and after 108 years, replace the slab at year 52 and replace the bridge at year 108 (\$175,330). Updated inspection results would not always produce such minor changes in strategy. The lack of change in this update is due to the compensating differences in the deck results where the positive effect of an increased chloride initiation time was offset by a more uncertain corrosion rate. If the slab had been deteriorating more slowly and the girders more rapidly than the model suggested, then the updated lifetime bridge repair strategy would have been quite different.
