**Zeitschrift:** IABSE reports = Rapports AIPC = IVBH Berichte  
**Band:** 76 (1997)

**Artikel:** System reliability for condition evaluation of bridges  
**Autor:** Estes, Allen C. / Frangopol, Dan M.  
**DOI:** <https://doi.org/10.5169/seals-57459>

## System Reliability for Condition Evaluation of Bridges

This study proposes a methodology for condition evaluation of existing highway bridges based on system reliability. The technique is illustrated using State Highway Bridge E-17-AH, located in the metro Denver area of Colorado. An optimum lifetime repair strategy is developed for the bridge by minimizing the expected lifetime cost and maintaining a prescribed level of system safety throughout the life of the bridge. This repair strategy is only as valid as the assumptions that were made when the bridge was placed in service. The repair strategy must be updated and revised throughout the life of the bridge based on the results of periodic inspections. The methodology for revising the repair strategy for Bridge E-17-AH is developed based on both the mandatory biennial visual inspections and some specific non-destructive evaluation (NDE) testing.

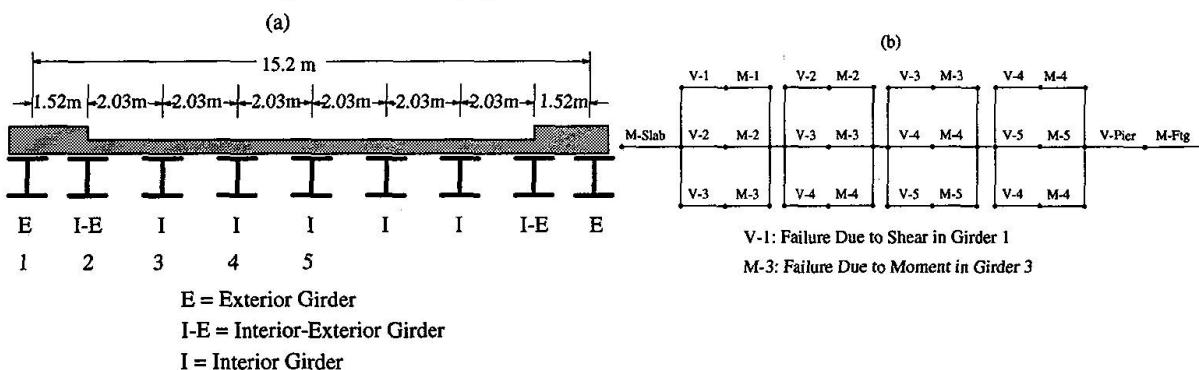
A time-dependent system reliability approach is applied to optimize the repair strategy for an existing highway bridge (Colorado State Highway Bridge E-17-AH). The bridge is on State Highway 33 in Denver, Colorado, and has three 13.36 m simply-supported steel-concrete composite spans. The 12.18 m wide roadway carries four lanes of traffic with an Average Daily Traffic (ADT) of 8500 vehicles. The deck is reinforced concrete and the steel girders are standard rolled shapes with simple-span supports. The interior span supports are reinforced concrete pier columns with a pier cap, four supporting square tapered columns, and individual column footings. The concrete abutments are supported by concrete piles cased in steel. A local railroad spur runs underneath the bridge. The cross section of the superstructure is shown in Fig. 1(a) where the girders are classified as exterior (E), interior-exterior (I-E), and interior (I).

**Fig. 1 Colorado State Highway Bridge E-17-AH: (a) Designation of girders, and (b) Simplified series-parallel model**

For option 1 (replace deck), Fig. 2 shows the time-dependent reliabilities of the bridge system and of all components shown in Fig. 1(b). The deck is replaced when  $\beta_{system} \leq 2.0$ . Consequently, the deck is replaced twice at years 50 and 94 of the bridge life. At year 106, a deck replacement is not sufficient to improve  $\beta_{system}$  to a value larger than 2.0. Due to the parallel nature of the system, the reliability of some components are allowed to fall below  $\beta_{T,system\ life} = 2.0$ . Due to varying deterioration rates, the critical component early in the life of the structure is not necessarily the most important later on.

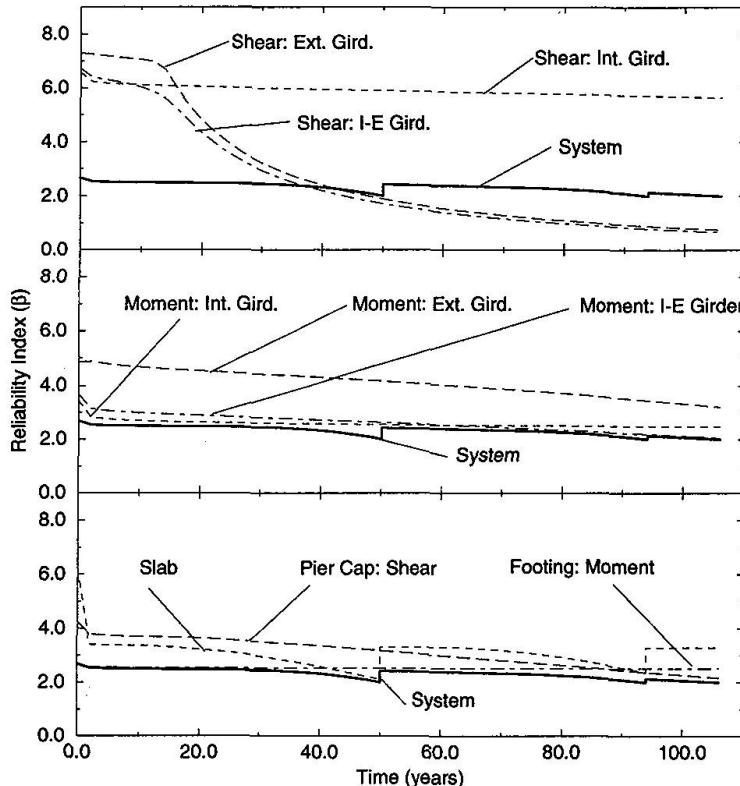
**Fig. 2 Results of repair option 1: Replace deck on Bridge E-17-AH using series-parallel system model requiring the failure of three adjacent girders**

Using the results of NDE inspections, the reliability of the girders, the deck, and ultimately the system are updated. Using the same repair options listed earlier, Fig. 6 shows the results of Option 1: Replace the Deck. Fig. 6 can be compared to Fig. 2 which showed the time-dependent reliability of the bridge components and bridge system when the deck was replaced twice using the original deterioration models. Despite the updated inspection results, the figures are quite similar, except for the reliabilities with respect to girder shear. The girder reliabilities with respect to moment are close to the original model. The moment capacity is dependent on the plastic section modulus which is less sensitive to the small changes in the thickness loss. In Fig. 6, the slab is replaced at year 52 and year 98, and at year 108, a slab repair is no longer sufficient to raise the system reliability above  $\beta_{min} = 2.0$ .

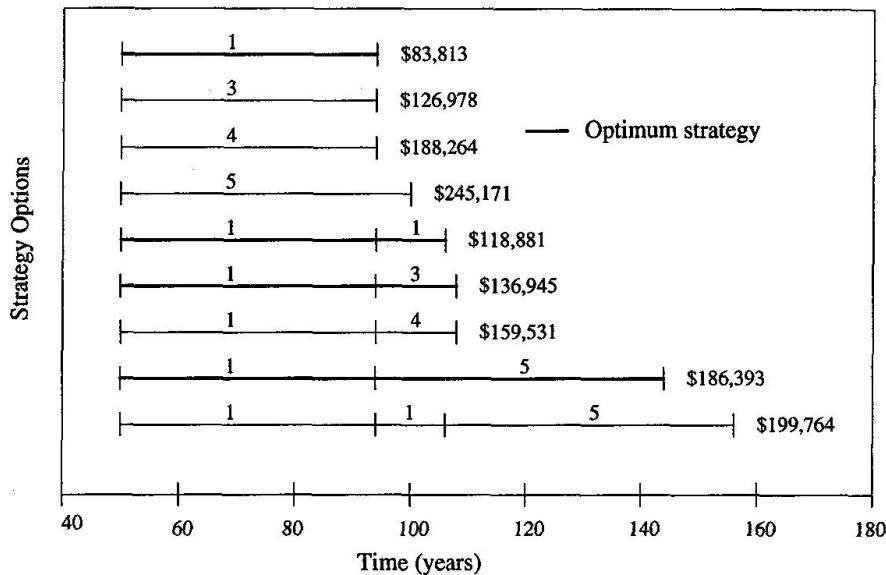
Let's assume the bridge is placed in service in 1996. Accounting for all combinations of options and using an assumed discount rate of 2%, the possible repair strategies and their associated present value costs are shown in Fig. 3. The analysis continued until replacement of the bridge (i.e., option 5) becomes the only available solution. From Fig. 3, the optimum strategy can be determined for the expected life of the bridge. For example, for a life of 50 years, no action should be taken; for 50-94 years, replace the deck at year 50 (\$83,813); 94-106 years, replace the deck at year 50 and year 94 (\$118,881); 106-108 years, replace the slab at year 50 then replace the exterior two girders and slab at year 94 (\$136,945); and after 108 years, replace the slab at year 50 then replace the bridge at year 94 (\$186,393).

*Fig. 3 Strategy options and associated costs*

With regard to the reliability of the system, the girder reliabilities do not dominate the system. The reduced girder corrosion rate uncertainty improves the reliability of the individual girders, but has little to no effect on the system. The slab, which is deteriorating more rapidly than the other critical failure modes, eventually dominates the reliability of the system. The effects of longer chloride initiation time  $T_I$  and increased uncertainty in the corrosion rate  $r_{corr}$  offset each other. As a result, the minimum system reliability  $\beta_{min} = 2.0$  is violated after 52 years of service, which is very close to the 50 years of service in the earlier model. Again, accounting for all relevant repair possibilities and using a discount rate of 2%, Fig. 7 shows all feasible strategy options and their associated costs which can be compared to Fig. 3 using the original model.

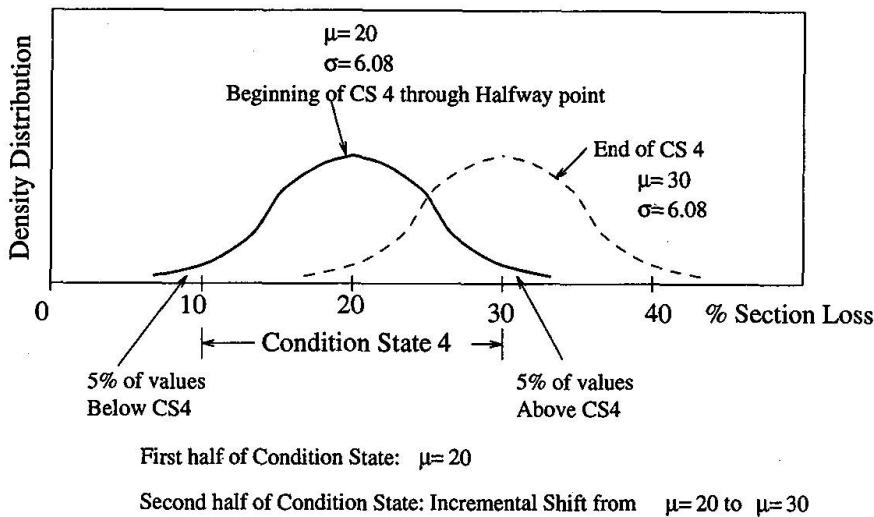
The parameters of random variables cannot be obtained directly from a visual inspection. Some assumptions must be made regarding the accuracy of the results and quality of the information provided by the inspectors. This study assumes that condition state deterioration over time is linear and that the deterioration intensity is normally distributed. It is further assumed that when a bridge element is at the halfway point of a specific condition state, the mean value of the normal distribution is at the halfway point of the condition state definition (see Fig. 4).

The standard deviation is determined by the assumed quality of the inspection program. If the inspector is believed to be correct 90% of the time when the member is at the halfway point of the condition state, then 90% of the values in the normal distribution will be within the values prescribed by the condition state. To make this assumption conservative, the condition state is assumed to begin at the halfway point and shifts progressively to the right as shown in Fig. 4. If the element remains in the condition state longer than expected, the distribution will remain at the far right position until an inspection reveals a switch to the next condition state. The exception will be for the first and final condition states where a lognormal distribution is used.

**Fig. 4** Density distribution of deterioration for Element 107 in Condition State 4 when inspectors are correct 90% of the time.

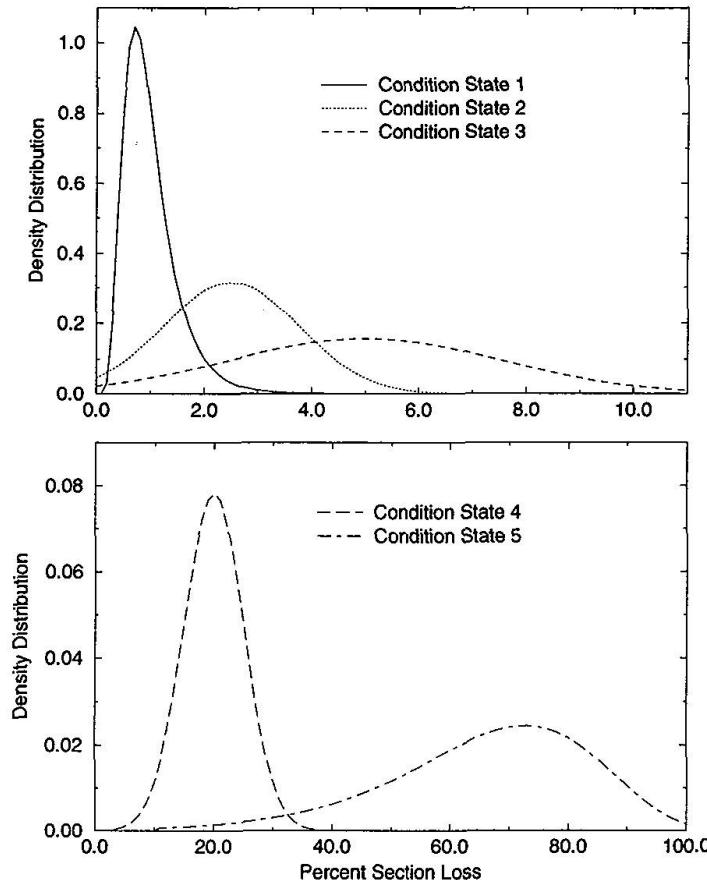
This study considered three different qualities of inspection programs, A, B, and C, where the inspectors were provided the correct rating 95%, 85%, and 75% of the time, respectively. The quality of the inspection program was determined based on seven criteria [5] which included inspector training, a quality assurance program, and inspector experience. The density distributions associated with condition states 1 through 5 for Inspection Category A and Element 107 as listed in Table 1 are shown in Fig. 5. Condition states 1, 2, and 3 were modified to reflect section losses of 0-2%, 0-5%, and 0-10%, respectively. Once the parameters of the random variables which describe the percent section loss for the corroding steel girders are defined, the area of the web and the plastic section modulus at the time of inspection can be computed. With the revised shear and moment capacities of the girders, the updated reliability of the bridge girders is computed. Assuming linear condition state deterioration over time, the future performance of the structure is predicted.

**Fig. 5** Density distributions associated with Condition State (CS) ratings CS1-CS5 for Element 107: painted open steel girders, Inspection Category A

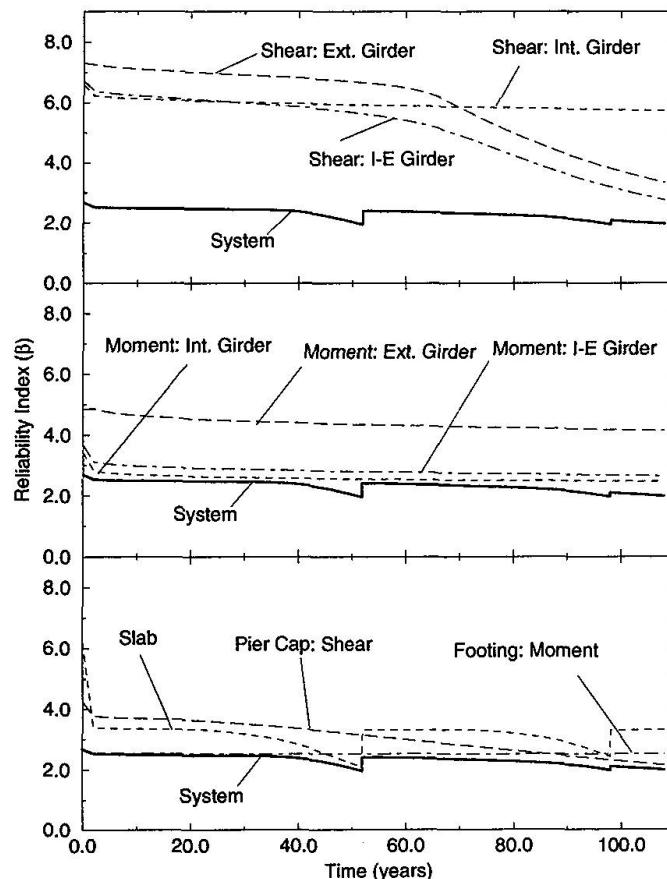
Fig. 6 Updated results of repair option 1 on Bridge E-17-AH using simplified series-parallel model requiring the failure of three adjacent girders

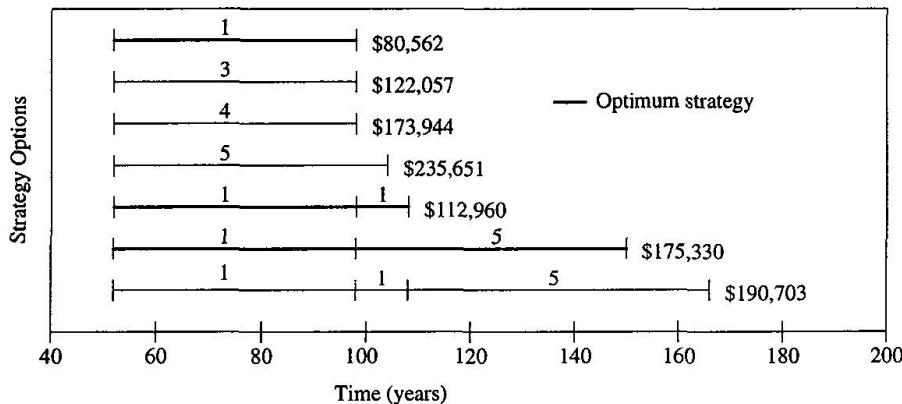
**Fig. 7** Updated strategy options and costs (2% discount rate) for Bridge E-17-AH using simplified series-parallel model requiring the failure of three adjacent girders

As a result, the updated optimum strategy is as follows: for a life of 52 years, no action should be taken; for 52-98 years, replace the deck at year 52 (\$80,562); 98-108 years, replace the deck at year 52 and replace the deck again at year 98 (\$112,960); and after 108 years, replace the slab at year 52 and replace the bridge at year 108 (\$175,330). Updated inspection results would not always produce such minor changes in strategy. The lack of change in this update is due to the compensating differences in the deck results where the positive effect of an increased chloride initiation time was offset by a more uncertain corrosion rate. If the slab had been deteriorating more slowly and the girders more rapidly than the model suggested, then the updated lifetime bridge repair strategy would have been quite different.
