Artikel: System reliability for condition evaluation of bridges

Autor: Estes, Allen C. / Frangopol, Dan M. DOI: https://doi.org/10.5169/seals-57459

System Reliability for Condition Evaluation of Bridges

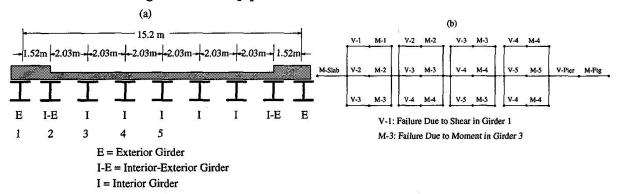
Fig. 1 Colorado State Highway Bridge E-17-AH: (a) Designation of girders, and (b) Simplified series-parallel model

A time-dependent system reliability approach is applied to optimize the repair strategy for an existing highway bridge (Colorado State Highway Bridge E-17-AH). The bridge is on State Highway 33 in Denver, Colorado, and has three 13.36 m simply-supported steel-concrete composite spans. The 12.18 m wide roadway carries four lanes of traffic with an Average Daily Traffic (ADT) of 8500 vehicles. The deck is reinforced concrete and the steel girders are standard rolled shapes with simple-span supports. The interior span supports are reinforced concrete pier columns with a pier cap, four supporting square tapered columns, and individual column footings. The concrete abutments are supported by concrete piles cased in steel. A local railroad spur runs underneath the bridge. The cross section of the superstructure is shown in Fig.1(a) where the girders are classified as exterior (E), interior-exterior (I-E), and interior (I).

Using 24 separate random variables, the intact bridge was analyzed with respect to 16 different failure modes including moment failure of the slab, moment and shear failure of the girders, and multiple failure modes of the pier cap, columns and footings. Limit state equations were developed and the reliability of each component was computed separately. The bridge system was modeled as a series-parallel model. Both the component reliabilities and the system reliability of the bridge were computed. A simplified system model for the bridge where it is assumed that the superstructure will not fail until three adjacent girders have failed is shown in Fig. 1(b). The simplifying assumptions, a more refined model, and a complete description of these calculations are given in Estes [5].

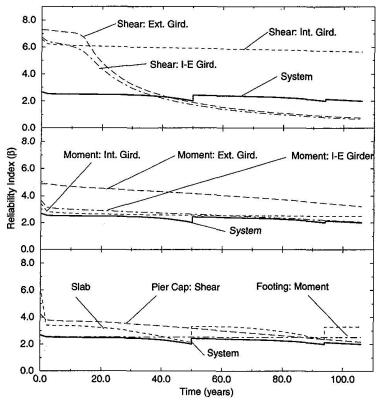
Fig. 2 Results of repair option 1: Replace deck on Bridge E-17-AH using series-parallel system model requiring the failure of three adjacent girders

For option 1 (replace deck), Fig.2 shows the time-dependent reliabilities of the bridge system and of all components shown in Fig. 1(b). The deck is replaced when $\beta_{system} \le 2.0$. Consequently, the deck is replaced twice at years 50 and 94 of the bridge life. At year 106, a deck replacement is not sufficient to improve β_{system} to a value larger than 2.0. Due to the parallel nature of the system, the reliability of some components are allowed to fall below $\beta_{T,system life} = 2.0$. Due to varying deterioration rates, the critical component early in the life of the structure is not necessarily the most important later on.

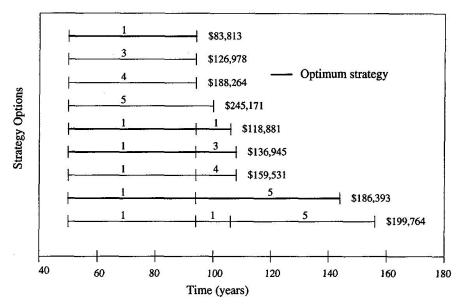
Fig. 3 Strategy options and associated costs

Let's assume the bridge is placed in service in 1996. Accounting for all combinations of options and using an assumed discount rate of 2%, the possible repair strategies and their associated present value costs are shown in Fig. 3. The analysis continued until replacement of the bridge (i.e., option 5) becomes the only available solution. From Fig. 3, the optimum strategy can be determined for the expected life of the bridge. For example, for a life of 50 years, no action should be taken; for 50-94 years, replace the deck at year 50 (\$83,813); 94-106 years, replace the deck at year 50 and year 94 (\$118,881); 106-108 years, replace the slab at year 50 then replace the exterior two girders and slab at year 94 (\$136,945); and after 108 years, replace the slab at year 50 then replace the bridge at year 94 (\$186,393).

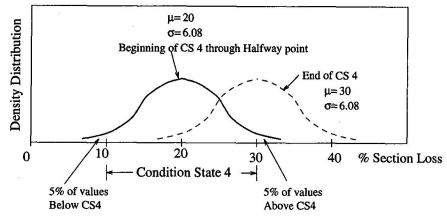
First half of Condition State: µ= 20

Second half of Condition State: Incremental Shift from μ = 20 to μ = 30

Fig. 4 Density distribution of deterioration for Element 107 in Condition State 4 when inspectors are correct 90% of the time.

The parameters of random variables cannot be obtained directly from a visual inspection. Some assumptions must be made regarding the accuracy of the results and quality of the information provided by the inspectors. This study assumes that condition state deterioration over time is linear and that the deterioration intensity is normally distributed. It is further assumed that when a bridge element is at the halfway point of a specific condition state, the mean value of the normal distribution is at the halfway point of the condition state definition (see Fig. 4).

The standard deviation is determined by the assumed quality of the inspection program. If the inspector is believed to be correct 90% of the time when the member is at the halfway point of the condition state, then 90% of the values in the normal distribution will be within the values prescribed by the condition state. To make this assumption conservative, the condition state is assumed to begin at the halfway point and shifts progressively to the right as shown in Fig. 4. If the element remains in the condition state longer than expected, the distribution will remain at the far right position until an inspection reveals a switch to the next condition state. The exception will be for the first and final condition states where a lognormal distribution is used.

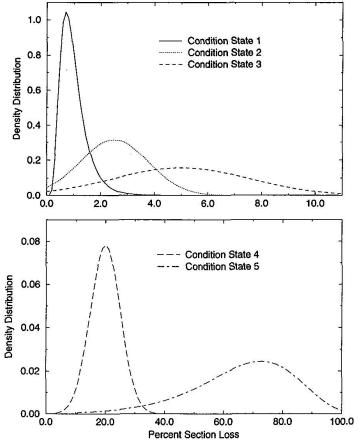
Fig. 5 Density distributions associated with Condition State (CS) ratings CS1-CS5 for Element 107: painted open steel girders, Inspection Category A

This study considered three different qualities of inspection programs, A, B, and C, where the inspectors were provided the correct rating 95%, 85%, and 75% of the time, respectively. The quality of the inspection program was determined based on seven criteria [5] which included inspector training, a quality assurance program, and inspector experience. The density distributions associated with condition states 1 through 5 for Inspection Category A and Element 107 as listed in Table 1 are shown in Fig. 5. Condition states 1, 2, and 3 were modified to reflect section losses of 0-2%, 0-5%, and 0-10%, respectively. Once the parameters of the random variables which describe the percent section loss for the corroding steel girders are defined, the area of the web and the plastic section modulus at the time of inspection can be computed. With the revised shear and moment capacities of the girders, the updated reliability of the bridge girders is computed. Assuming linear condition state deterioration over time, the future performance of the structure is predicted.

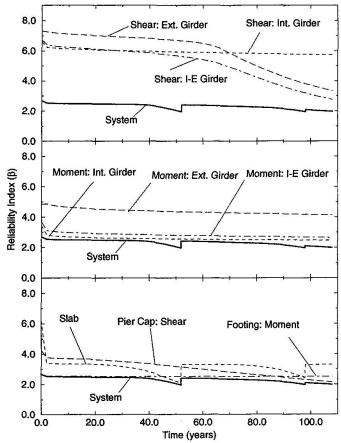
Fig. 6 Updated results of repair option 1 on Bridge E-17-AH using simplified series-parallel model requiring the failure of three adjacent girders

Using the results of NDE inspections, the reliability of the girders, the deck, and ultimately the system are updated. Using the same repair options listed earlier, Fig. 6 shows the results of Option 1: Replace the Deck. Fig. 6 can be compared to Fig. 2 which showed the time-dependent reliability of the bridge components and bridge system when the deck was replaced twice using the original deterioration models. Despite the updated inspection results, the figures are quite similar, except for the reliabilities with respect to girder shear. The girder reliabilities with respect to moment are close to the original model. The moment capacity is dependent on the plastic section modulus which is less sensitive to the small changes in the thickness loss. In Fig. 6, the slab is replaced at year 52 and year 98, and at year 108, a slab repair is no longer sufficient to raise the system reliability above $\beta_{min}=2.0$.

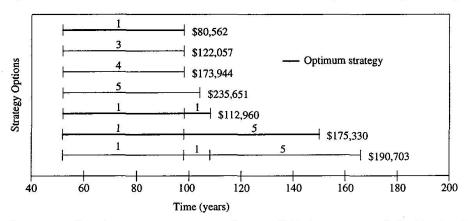
Fig. 7 Updated strategy options and costs (2% discount rate) for Bridge E-17-AH using simplified series-parallel model requiring the failure of three adjacent girders

With regard to the reliability of the system, the girder reliabilities do not dominate the system. The reduced girder corrosion rate uncertainty improves the reliability of the individual girders, but has little to no effect on the system. The slab, which is deteriorating more rapidly than the other critical failure modes, eventually dominates the reliability of the system. The effects of longer chloride initiation time T_I and increased uncertainty in the corrosion rate r_{corr} offset each other. As a result, the minimum system reliability $\beta_{min} = 2.0$ is violated after 52 years of service, which is very close to the 50 years of service in the earlier model. Again, accounting for all relevant repair possibilities and using a discount rate of 2%, Fig. 7 shows all feasible strategy options and their associated costs which can be compared to Fig. 3 using the original model.

As a result, the updated optimum strategy is as follows: for a life of 52 years, no action should be taken; for 52-98 years, replace the deck at year 52 (\$80,562); 98-108 years, replace the deck at year 52 and replace the deck again at year 98 (\$112,960); and after 108 years, replace the slab at year 52 and replace the bridge at year 108 (\$175,330). Updated inspection results would not always produce such minor changes in strategy. The lack of change in this update is due to the compensating differences in the deck results where the positive effect of an increased chloride initiation time was offset by a more uncertain corrosion rate. If the slab had been deteriorating more slowly and the girders more rapidly than the model suggested, then the updated lifetime bridge repair strategy would have been quite different.
