Artikel: Inspection of bridges with orthotropic steel decks with particular

attention to fatigue

Autor: Leendertz, J.S. / Weijde, Henk v.d. / Kolstein, Henk

Inspection of Bridges with Orthotropic Steel Decks with Particular Attention to Fatigue

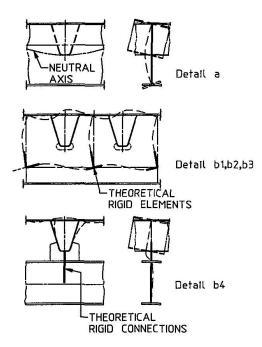
Fig. 6 Closed stiffener connections and structural behaviour

Fig.6 shows both the connections and their structural behaviour. Two groups are distinguished:

- a. Troughs fitted between the crossbeams
- b. Continuous troughs passing through cut outs with cope holes

Usually Group "a" connections are applied in structures with shallow crossbeams, where cut outs cause a too low shear capacity of the crossbeam. In the past, the detail with fillet welds showed many fatigue cracks. The details with full penetration welds show a much better fatigue performance.

The Group "b" connections are applied in structures with deeper crossbeams, diaphragms of Box Girder Bridges, "Floating Deck" structures. The following subdivision can be made:

"b1": Continuous troughs passing through a cut out with close fit and welded around with fillet welds; "b2": Continuous trough passing through a cut out with an oval shape or similar;

"b3": Continuous trough passing through a cut out with additional cope holes with varying radius, the so-called "Haibach cut out" [4] or a similar shape; "b4": Continuous trough supported by a counterfitted support plate, welded around the bottom of the trough. Further the support is welded to an I-beam.

In plane, the cut out causes a "Vierendeel Effect" if the depth of the cut out is substantially, compared to the depth of the crossbeam or diaphragm [5,6,7]. This is likely to occur if the detail is applied in Crossbeams Type I and III bridge structures (see Fig.6). Further all details are subjected to locally applied forces and a contraction effect of the bottom of the stiffener caused by bending moments at the stiffener supports [8].

Passing vehicles generate bending and shear in the stiffeners, which deflect subsequently and makes the supports of the stiffeners rotate (see Fig.6). The rotation of this connection causes an out of plane movement of the crossbeam web. This phenomenon takes place in all types of stiffeners. The connection "b2" has been investigated in ECSC research Phase 3 and 4. In [2,3] the fatigue behaviour has been reported for various types of stiffeners and cut outs. The fatigue strength of details "b2" has been investigated under simultaneous vertical forces with out of plane bending in the web plate. Fig.12 shows for three test specimens the stress results of FE analyses under equal vertical load and out of plane rotation.

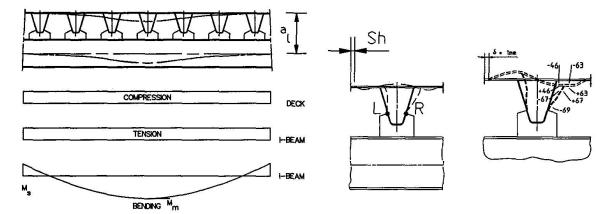
Fig. 9 Model of floating deck crossbeam

In the "Floating Deck" structure as shown in Fig.9 [1,10], the end of the I-beam is restrained by the lever system, which generates a compression in the deck and a tension in the I-beam. The horizontal compression and tension forces at a distance a_l are balancing the bending moment M_S at the support. The normal forces in the deck and the I-beam, the rotations in the I-beam and the shear deformation in the I-beam cause the deck shifting over a distance S_h with respect to the I-beam as shown in Fig.10. Asymmetrical loads cause in some locations larger shifts S_h [10].

The shift S_h generates normal forces and bending moments in the trough web. Fig.11 shows the nominal stresses in the trough web and the deckplate caused by the shift S_h of 1mm. The shifts S_h for a set of beams of with depths are shown in [10]. Realistic values of S_h under maximum crossbeam loading vary from 0.1 - 3.3 mm. In real structures these stresses must be multiplied with a stress concentration factor in order to find the Hot Spot Stresses which are relevant for fatigue.

It is obvious that these stresses which mainly are governed by bending effects in the deck plate and trough web, can not be neglected. The stress concentration factors related to the bottom connection are assumed to be higher than the stress concentration factors related to the trough to deck connection. If however the stresses due to the wheel loading on the deck are added, high stress amplitudes may occur due to the combination of both effects.
