**Artikel:** Inspection of bridges with orthotropic steel decks with particular attention to fatigue  
**Autor:** Leendertz, J.S. / Weijde, Henk v.d. / Kolstein, Henk  
**DOI:** <https://doi.org/10.5169/seals-57460>

## Inspection of Bridges with Orthotropic Steel Decks with Particular Attention to Fatigue

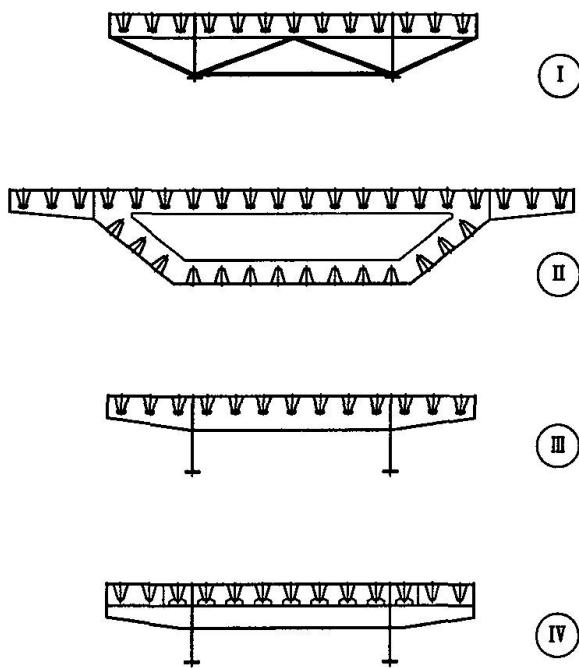
Fig. 4 Structural types of bridges

Fig.4 shows four load carrying systems. For simplicity only systems with continuous closed stiffeners are shown. **Type I** is a plate girder bridge with crossbeams that consists of a truss and a top cord acting as a continuous beam with short spans. The continuous beam transfers the loads by bending and shear to the truss nodes. The truss is supported by the main girders. **Type II** is a box girder bridge. The diaphragm of the box acts as a deep crossbeam that transfers the loads to the inclined and vertical webs of the box girder. **Type III** is a conventional crossbeam with cantilevers that are supported by the main girders. **Type IV** is an I-shaped crossbeam that receives the loads from the supports of the closed stiffeners. The shear connections in the cantilever sections cause a rotational spring using the axial stiffnesses of the deck plate and the I-beam and a lever arm. This is called the "Floating Deck Structure" and is used in a few bridges in the Netherlands [1]. It has been developed for its easy of assembly.

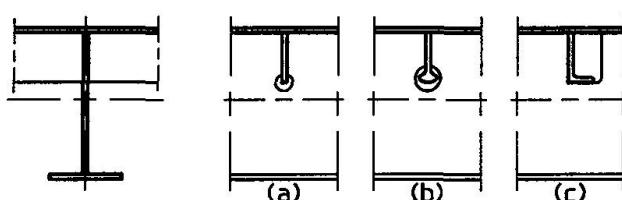
Fig. 5 Crossbeam connections with continuous open stiffeners

Because the influence lines show short distances between the zero-crossings a rather unfavourable connection is submitted to many cycles caused by the wheel loads. Fig.5 shows the connections of continuous open stiffeners to the crossbeams. In the connections shown, cope holes have been used for fitting purposes. The cope hole causes a discontinuity in the crossbeam. In Fig.5 type (a) and (b) it causes a local stress concentration, but in Fig.5 type (c) a "Vierendeel" effect with additional bending is to be expected. This effect will be explained later in conjunction with the closed stiffener connections.

type (a) and (b) it causes a local stress concentration, but in Fig.5 type (c) a "Vierendeel" effect with additional bending is to be expected. This effect will be explained later in conjunction with the closed stiffener connections.

In two plate girder bridges with open stiffeners and truss diaphragms cracks have been found in the stiffener to crossbeam connections [11]. Here the bulb stiffeners pass through circular cut outs as shown in Fig.5(b).

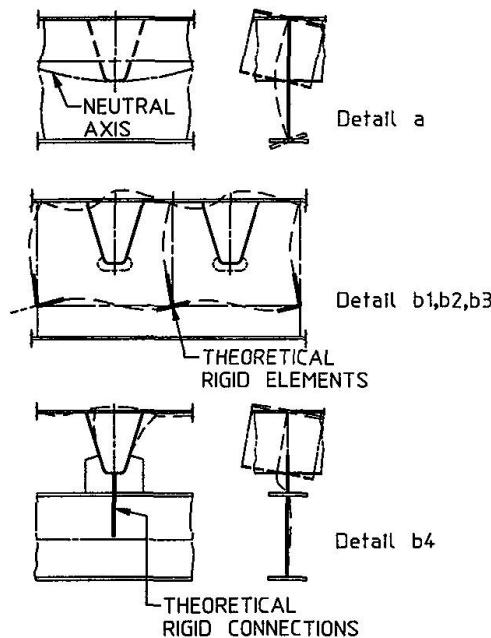
**Fig. 6** Closed stiffener connections and structural behaviour

Fig.6 shows both the connections and their structural behaviour. Two groups are distinguished:

- a. Troughs fitted between the crossbeams
- b. Continuous troughs passing through cut outs with cope holes

Usually Group "a" connections are applied in structures with shallow crossbeams, where cut outs cause a too low shear capacity of the crossbeam. In the past, the detail with fillet welds showed many fatigue cracks. The details with full penetration welds show a much better fatigue performance.

The Group "b" connections are applied in structures with deeper crossbeams, diaphragms of Box Girder Bridges, "Floating Deck" structures. The following subdivision can be made:

- "b1": Continuous troughs passing through a cut out with close fit and welded around with fillet welds;
- "b2": Continuous trough passing through a cut out with an oval shape or similar;
- "b3": Continuous trough passing through a cut out with additional cope holes with varying radius, the so-called "Haibach cut out" [4] or a similar shape;
- "b4": Continuous trough supported by a counter-fitted support plate, welded around the bottom of the trough. Further the support is welded to an I-beam.

In plane, the cut out causes a "Vierendeel Effect" if the depth of the cut out is substantially, compared to the depth of the crossbeam or diaphragm [5,6,7]. This is likely to occur if the detail is applied in Crossbeams Type I and III bridge structures (see Fig.6). Further all details are subjected to locally applied forces and a contraction effect of the bottom of the stiffener caused by bending moments at the stiffener supports [8].

Passing vehicles generate bending and shear in the stiffeners, which deflect subsequently and makes the supports of the stiffeners rotate (see Fig. 6). The rotation of this connection causes an out of plane movement of the crossbeam web. This phenomenon takes place in all types of stiffeners. The connection "b2" has been investigated in ECSC research Phase 3 and 4. In [2,3] the fatigue behaviour has been reported for various types of stiffeners and cut outs. The fatigue strength of details "b2" has been investigated under simultaneous vertical forces with out of plane bending in the web plate. Fig. 12 shows for three test specimens the stress results of FE analyses under equal vertical load and out of plane rotation.

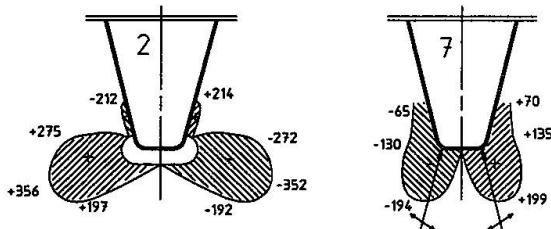
Fig. 8 Principal stress distributions around cut out and continuous weld ( $N/mm^2$ )

Fig.8 shows the results of FE-analyses with for a test specimen [3,7,9] the principal stresses around the cut out for crossbeam to trough nr. 2 (detail "b2") connection and a fully welded around crossbeam to trough nr. 7 (detail "b1") connection under the same but symmetrical bending and shear loads. The model consists of shell elements, which ignores the effect of the plate and weld dimensions in the neighbourhood of the welds. The arrows show the direction of the principal stresses at a specific location. Near to the welds the stress levels reach approximately the same level, but the direction with respect to the weld is completely different. Fatigue tests on a true scale specimen [3] showed a better performance for the connection of trough nr.7.

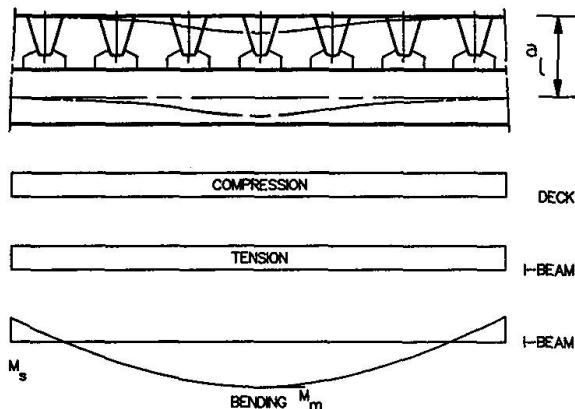
Fig. 9 Model of floating deck crossbeam

In the "Floating Deck" structure as shown in Fig.9 [1,10], the end of the I-beam is restrained by the lever system, which generates a compression in the deck and a tension in the I-beam. The horizontal compression and tension forces at a distance  $a_1$  are balancing the bending moment  $M_s$  at the support. The normal forces in the deck and the I-beam, the rotations in the I-beam and the shear deformation in the I-beam cause the deck shifting over a distance  $S_h$  with respect to the I-beam as shown in Fig.10. Asymmetrical loads cause in some locations larger shifts  $S_h$  [10].

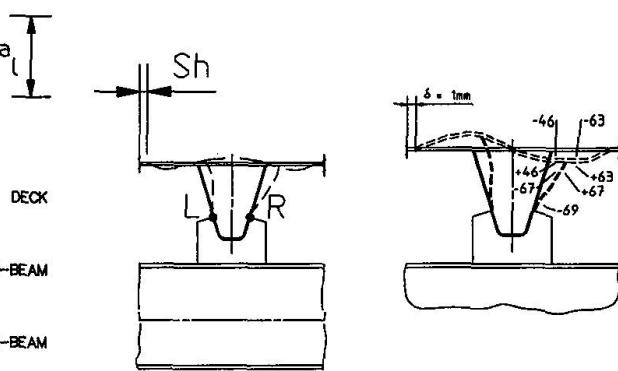
Fig. 10 Horizontal shift  $S_h$  Fig. 11 Stresses at a shift  $S_h$  of 1 mm ( $N/mm^2$ )

The shift  $S_h$  generates normal forces and bending moments in the trough web. Fig.11 shows the nominal stresses in the trough web and the deckplate caused by the shift  $S_h$  of 1mm. The shifts  $S_h$  for a set of beams of with depths are shown in [10]. Realistic values of  $S_h$  under maximum crossbeam loading vary from 0.1 - 3.3 mm. In real structures these stresses must be multiplied with a stress concentration factor in order to find the Hot Spot Stresses which are relevant for fatigue.

It is obvious that these stresses which mainly are governed by bending effects in the deck plate and trough web, can not be neglected. The stress concentration factors related to the bottom connection are assumed to be higher than the stress concentration factors related to the trough to deck connection. If however the stresses due to the wheel loading on the deck are added, high stress amplitudes may occur due to the combination of both effects.

In two bridges with the "Floating Deck" structure [1,9] some cracks were found in the longitudinal trough to deck weld (location 3) in the crossbeam neighbourhood of the crossbeam during a resurfacing operation [11]. Fig. 18 shows the relevant locations for fatigue which relate to the stresses in Fig 11. In the inspected bridges the deck plate had a thickness of 10 mm. No other cracks were found. The lack of time and the obtained insight in the mechanism led to the decision that the crack and the original weld were ground and replaced by a weld of 80% penetration, which had to be made in an overhead position. During repair the bridge was closed for all traffic.

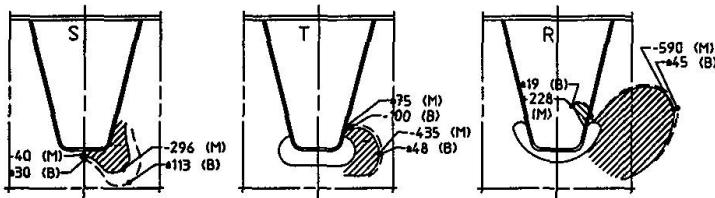
Fig. 12 Stress distributions under vertical load in combination with out of plane bending ( $N/mm^2$ )

The stresses shown are the membrane stresses (M) and the out of plane bending stresses (B) for test specimens at the Stevin Laboratory (NL) as reported in [2]. The models consisted of shell elements, which means that the stresses in the neighbourhood of the trough to crossbeam connection do not include the weld and plate dimension effects [9]. Nevertheless it is obvious that in this case, the rigid support not far below the trough to crossbeam web connection causes in the detail "b1" (S) much higher bending stresses than in the details "b2" (T) and "b3" (R). The types "b1"; "b2" and "b3" refer to the detail categories of Section 4.2. The tests in the Stevin laboratory showed a better fatigue strength for the type "S", if compared to the types "T" and "R". The V-shaped stiffener connection tested at TRL (UK) however showed a lower fatigue strength. The results have been reported in [2].

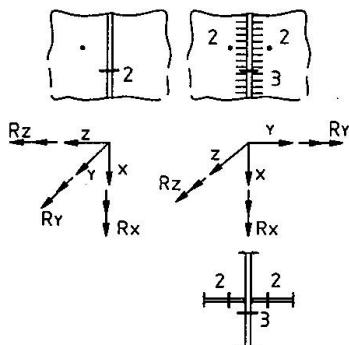
Fig. 13 Fatigue locations and degrees of freedom detail "a"

As a simplification, most of the details used in real structures can be reduced to 2 types of welded details, those with and without cope holes, see Groups "a" and "b" in Section 4.2. The combination of relevant degrees of freedom and the critical locations can be derived from the mechanical behaviour. Fig.13 and Fig.14 show the relevant degrees of freedom and critical fatigue locations for details without and with cope holes, Groups "a" and "b", respectively. Particular attention must be paid to the relevant influence lines and the stress concentration factors related to a degree of freedom and stresses in a specific location.

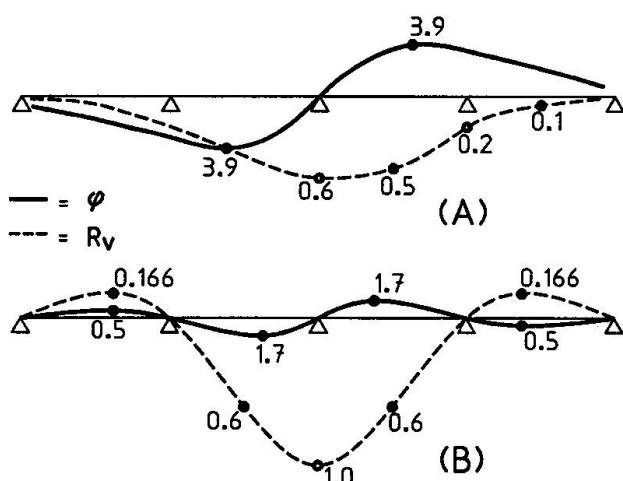
Fig. 15 Influence lines for stiffener support rotations ( $\phi$ ) and reactions ( $R_v$ )

Fig.15 shows the influence lines for rotations ( $\phi$ ) and crossbeam loading ( $R_v$ ) of the middle trough stiffener support due to wheel loads. Lines (A) show the results for more flexible crossbeams and (B) for more rigid crossbeams. Rigid crossbeams show higher loading than flexible crossbeams, but the amount of cycles under unit loads is higher. This effect applies as well for vehicle loads.

Flexible crossbeams show larger rotations, but a smaller amount of cycles than rigid crossbeams. It may be expected that in many cases open stiffeners will tend to have an influence line of type (B) which applies for closed stiffeners in box girder bridges too.

Closed stiffeners near crossbeam mid-span in plate girder bridges will act according a line between (A) and (B), depending on the vertical stiffness of the crossbeam. Near the supports they will tend to behave like (B).

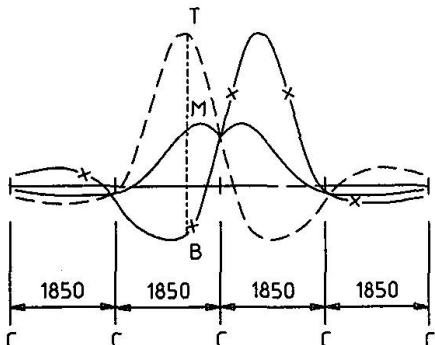
Fig. 16 Influence line stresses outer side web plate location "P"

Fig.16 shows for a 1kN wheel load the influence lines for the stresses in location "P".

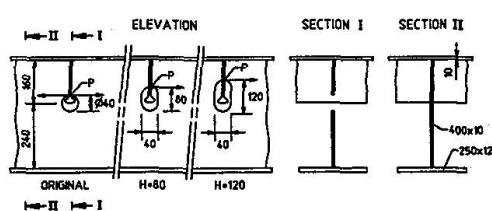
Fig. 17 Original detail and investigated cope holes and stresses for location "P"

Fig.17 shows the investigated details and stress locations. The out of plane bending of the crossbeam web showed to be of large importance. Two alternative cut outs with a larger depth have been investigated. The H=80 cut out has been selected as solution for the repair, because it showed a reduction of the stress amplitudes to 78% and proved to have the required shear capacity.
