Artikel: Inspection of bridges with orthotropic steel decks with particular attention to fatigue
Autor: Leendertz, J.S. / Weijde, Henk v.d. / Kolstein, Henk
DOI: <https://doi.org/10.5169/seals-57460>

Inspection of Bridges with Orthotropic Steel Decks with Particular Attention to Fatigue

Summary

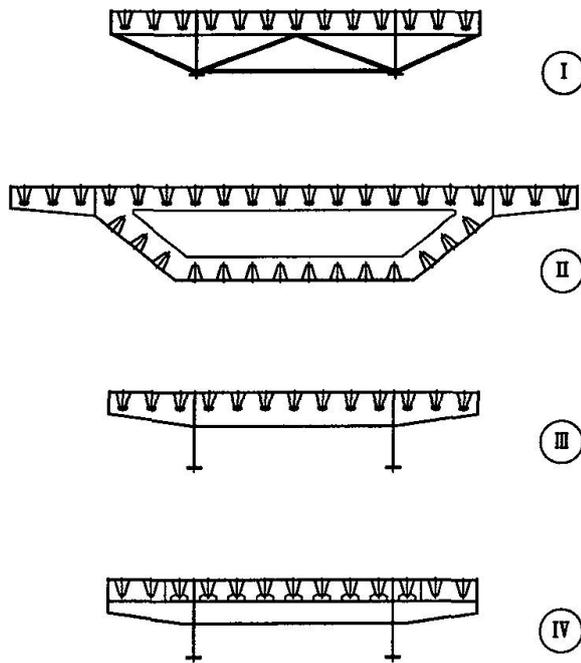
Fig. 4 Structural types of bridges

Fig.4 shows four load carrying systems. For simplicity only systems with continuous closed stiffeners are shown. Type I is a plate girder bridge with crossbeams that consists of a truss and a top cord acting as a continuous beam with short spans. The continuous beam transfers the loads by bending and shear to the truss nodes. The truss is supported by the main girders. Type II is a box girder bridge. The diaphragm of the box acts as a deep crossbeam that transfers the loads to the inclined and vertical webs of the box girder. Type III is a conventional crossbeam with cantilevers that are supported by the main girders. Type IV is an I-shaped crossbeam that receives the loads from the supports of the closed stiffeners. The shear connections in the cantilever sections cause a rotational spring using the axial stiffnesses of the deck plate and the I-beam and a lever arm. This is called the "Floating Deck Structure" and is used in a few bridges in the Netherlands [1]. It has been developed for its easy of assembly.

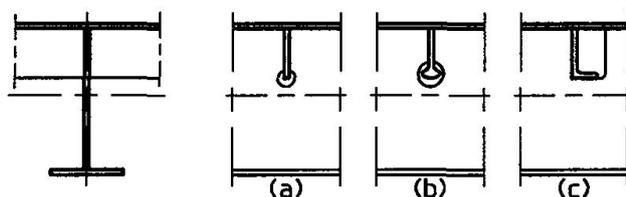
Fig. 5 Crossbeam connections with continuous open stiffeners

Because the influence lines show short distances between the zero-crossings a rather unfavourable connection is submitted to many cycles caused by the wheel loads. Fig.5 shows the connections of continuous open stiffeners to the crossbeams. In the connections shown, cope holes have been used for fitting purposes. The cope hole causes a discontinuity in the crossbeam. In Fig.5 type (a) and (b) it causes a local stress concentration, but in Fig.5 type (c) a "Vierendeel" effect with additional bending is to be expected. This effect will be explained later in conjunction with the closed stiffener connections.

In two plate girder bridges with open stiffeners and truss diaphragms cracks have been found in the stiffener to crossbeam connections [11]. Here the bulb stiffeners pass through circular cut outs as shown in Fig.5(b).

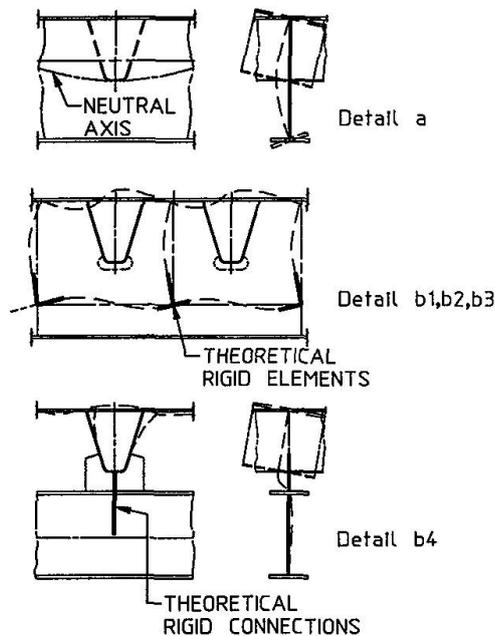
Fig. 6 Closed stiffener connections and structural behaviour

Fig.6 shows both the connections and their structural behaviour. Two groups are distinguished:

- a. Troughs fitted between the crossbeams
- b. Continuous troughs passing through cut outs with cope holes

Usually Group "a" connections are applied in structures with shallow crossbeams, where cut outs cause a too low shear capacity of the crossbeam. In the past, the detail with fillet welds showed many fatigue cracks. The details with full penetration welds show a much better fatigue performance.

The Group "b" connections are applied in structures with deeper crossbeams, diaphragms of Box Girder Bridges, "Floating Deck" structures. The following subdivision can be made:

- "b1": Continuous troughs passing through a cut out with close fit and welded around with fillet welds;
- "b2": Continuous trough passing through a cut out with an oval shape or similar;
- "b3": Continuous trough passing through a cut out with additional cope holes with varying radius, the so-called "Haibach cut out" [4] or a similar shape;
- "b4": Continuous trough supported by a counter-fitted support plate, welded around the bottom of the trough. Further the support is welded to an I-beam.

In plane, the cut out causes a "Vierendeel Effect" if the depth of the cut out is substantially, compared to the depth of the crossbeam or diaphragm [5,6,7]. This is likely to occur if the detail is applied in Crossbeams Type I and III bridge structures (see Fig.6). Further all details are subjected to locally applied forces and a contraction effect of the bottom of the stiffener caused by bending moments at the stiffener supports [8].

Passing vehicles generate bending and shear in the stiffeners, which deflect subsequently and makes the supports of the stiffeners rotate (see Fig.6). The rotation of this connection causes an out of plane movement of the crossbeam web. This phenomenon takes place in all types of stiffeners. The connection "b2" has been investigated in ECSC research Phase 3 and 4. In [2,3] the fatigue behaviour has been reported for various types of stiffeners and cut outs. The fatigue strength of details "b2" has been investigated under simultaneous vertical forces with out of plane bending in the web plate. Fig.12 shows for three test specimens the stress results of FE analyses under equal vertical load and out of plane rotation.

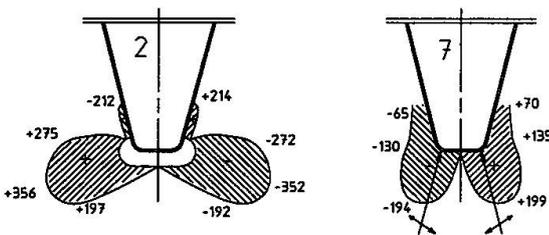
Fig. 8 Principal stress distributions around cut out and continuous weld (N/mm^2)

Fig.8 shows the results of FE-analyses with for a test specimen [3,7,9] the principal stresses around the cut out for crossbeam to trough nr. 2 (detail "b2") connection and a fully welded around crossbeam to trough nr. 7 (detail "b1") connection under the same but symmetrical bending and shear loads. The model consists of shell elements, which ignores the effect of the plate and weld dimensions in the neighbourhood of the welds. The arrows show the direction of the principal stresses at a specific location. Near to the welds the stress levels reach approximately the same level, but the direction with respect to the weld is completely different. Fatigue tests on a true scale specimen [3] showed a better performance for the connection of trough nr.7.

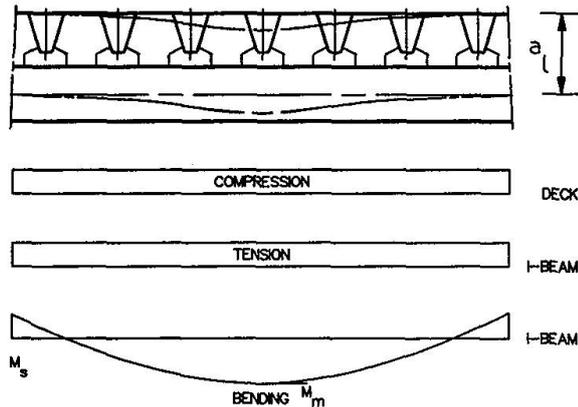
Fig. 9 Model of floating deck crossbeam

In the "Floating Deck" structure as shown in Fig.9 [1,10], the end of the I-beam is restrained by the lever system, which generates a compression in the deck and a tension in the I-beam. The horizontal compression and tension forces at a distance a_1 are balancing the bending moment M_S at the support. The normal forces in the deck and the I-beam, the rotations in the I-beam and the shear deformation in the I-beam cause the deck shifting over a distance S_h with respect to the I-beam as shown in Fig.10. Asymmetrical loads cause in some locations larger shifts S_h [10].

The shift S_h generates normal forces and bending moments in the trough web. Fig.11 shows the nominal stresses in the trough web and the deckplate caused by the shift S_h of 1mm. The shifts S_h for a set of beams of with depths are shown in [10]. Realistic values of S_h under maximum crossbeam loading vary from 0.1 - 3.3 mm. In real structures these stresses must be multiplied with a stress concentration factor in order to find the Hot Spot Stresses which are relevant for fatigue.

It is obvious that these stresses which mainly are governed by bending effects in the deck plate and trough web, can not be neglected. The stress concentration factors related to the bottom connection are assumed to be higher than the stress concentration factors related to the trough to deck connection. If however the stresses due to the wheel loading on the deck are added, high stress amplitudes may occur due to the combination of both effects.

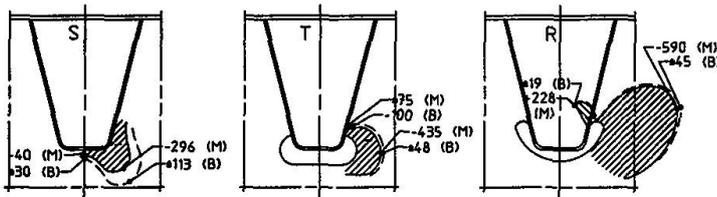
Fig. 12 Stress distributions under vertical load in combination with out of plane bending (N/mm^2)

The stresses shown are the membrane stresses (M) and the out of plane bending stresses (B) for test specimens at the Stevin Laboratory (NL) as reported in [2]. The models consisted of shell elements, which means that the stresses in the neighbourhood of the trough to crossbeam connection do not include the weld and plate dimension effects [9]. Nevertheless it is obvious that in this case, the rigid support not far below the trough to crossbeam web connection causes in the detail "b1" (S) much higher bending stresses than in the details "b2" (T) and "b3" (R). The types "b1", "b2" and "b3" refer to the detail categories of Section 4.2. The tests in the Stevin laboratory showed a better fatigue strength for the type "S", if compared to the types "T" and "R". The V-shaped stiffener connection tested at TRL (UK) however showed a lower fatigue strength. The results have been reported in [2].

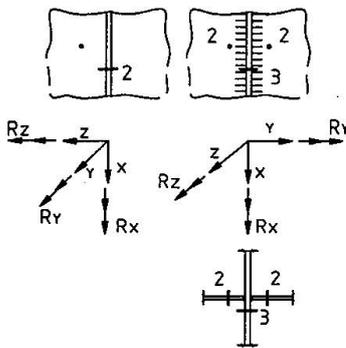
Fig. 13 Fatigue locations and degrees of freedom detail "a"

As a simplification, most of the details used in real structures can be reduced to 2 types of welded details, those with and without cope holes, see Groups "a" and "b" in Section 4.2. The combination of relevant degrees of freedom and the critical locations can be derived from the mechanical behaviour. Fig.13 and Fig.14 show the relevant degrees of freedom and critical fatigue locations for details without and with cope holes, Groups "a" and "b", respectively. Particular attention must be paid to the relevant influence lines and the stress concentration factors related to a degree of freedom and stresses in a specific location.

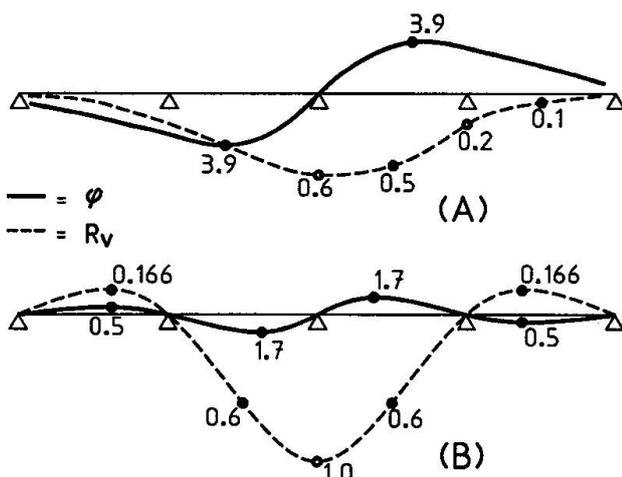
Fig. 15 Influence lines for stiffener support rotations (ϕ) and reactions (R_v)

Fig.15 shows the influence lines for rotations (ϕ) and crossbeam loading (R_v) of the middle trough stiffener support due to wheel loads. Lines (A) show the results for more flexible crossbeams and a (B) for more rigid crossbeams. Rigid crossbeams show higher loading than flexible crossbeams, but the amount of cycles under unit loads is higher. This effect applies as well for vehicle loads.

Flexible crossbeams show larger rotations, but a smaller amount of cycles than rigid crossbeams. It may be expected that in many cases open stiffeners will tend to have an influence line of type (B) which applies for closed stiffeners in box girder bridges too.

Closed stiffeners near crossbeam mid-span in plate girder bridges will act according a line between (A) and (B), depending on the vertical stiffness of the crossbeam. Near the supports they will tend to behave like (B).

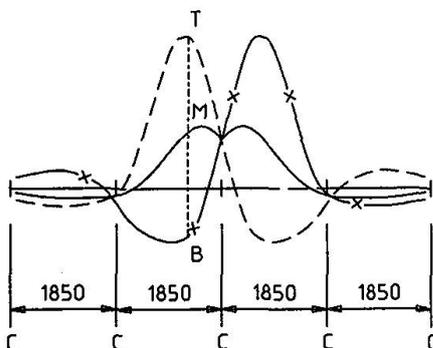
Fig. 16 Influence line stresses outer side web plate location "P"

Fig.16 shows for a 1kN wheel load the influence lines for the stresses in location "P".

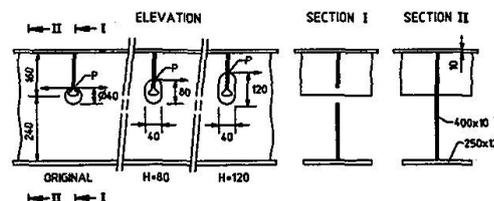
Fig. 17 Original detail and investigated cope holes and stresses for location "P"

Fig.17 shows the investigated details and stress locations. The out of plane bending of the crossbeam web showed to be of large importance. Two alternative cut outs with a larger depth have been investigated. The H=80 cut out has been selected as solution for the repair, because it showed a reduction of the stress amplitudes to 78% and proved to have the required shear capacity.

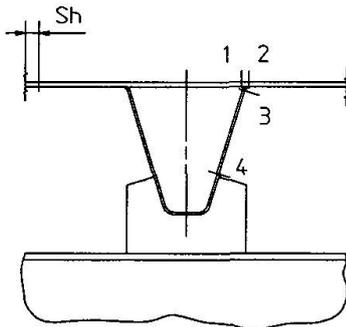
Fig. 18 Relevant locations for fatigue

In two bridges with the "Floating Deck" structure [1,9] some cracks were found in the longitudinal trough to deck weld (location 3) in the crossbeam neighbourhood of the crossbeam during a resurfacing operation [11]. Fig. 18 shows the relevant locations for fatigue which relate to the stresses in Fig 11. In the inspected bridges the deck plate had a thickness of 10 mm. No other cracks were found. The lack of time and the obtained insight in the mechanism led to the decision that the crack and the original weld were ground and replaced by a weld of 80% penetration, which had to be made in an overhead position. During repair the bridge was closed for all traffic.
