**Artikel:** Some remarks on the design of timber composite structures exposed to fire  
**Autor:** Piazza, Maurizio / Cont, Sergio / Zanon, Paolo  
**DOI:** <https://doi.org/10.5169/seals-1003>

## Some Remarks on the Design of Timber Composite Structures Exposed to Fire

### Summary

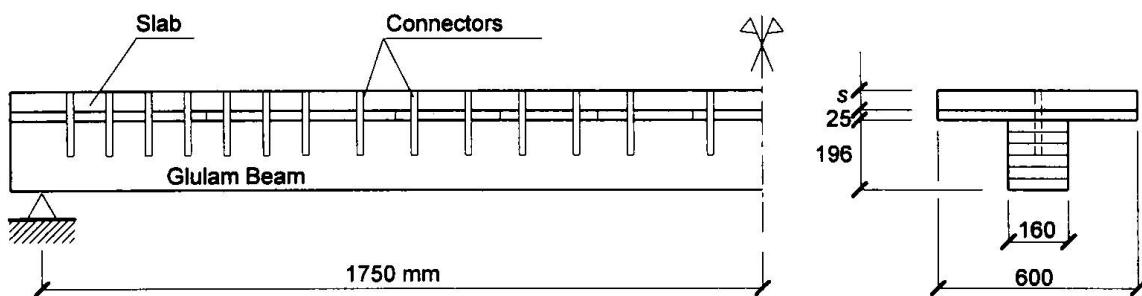
Fig. 1 - Full size samples of the tested timber-based composite structure.

Tests were carried out on four timber-based composite structures, made with glulam timber beams of spruce (*Picea abies Karst.*), from the same production lot, with a cross-section of 160 x 196 mm. Such a choice was compulsory in order to achieve consistent data from the point of view of thermal decay. Elastic modulus characterization tests were, of course, carried out on each single beam as well as on the assembled composite structures, prior to the physical tests inside the furnace. These tests made also it possible to accurately check at room temperature the numerical model used for the structure's static analysis. The length of each structure is equal to  $\approx 3.50$  m, the centre distance between timber beams of the floor (slab width of the specimen) is equal to 0.60 m (Fig. 1). All samples were assembled by means of glued steel connectors [7], except the S3 specimen for which screws\* (inserted without pre-drilling) were used. Some single timber beams<sup>(1)</sup> were also tested for comparison purpose (Table I).

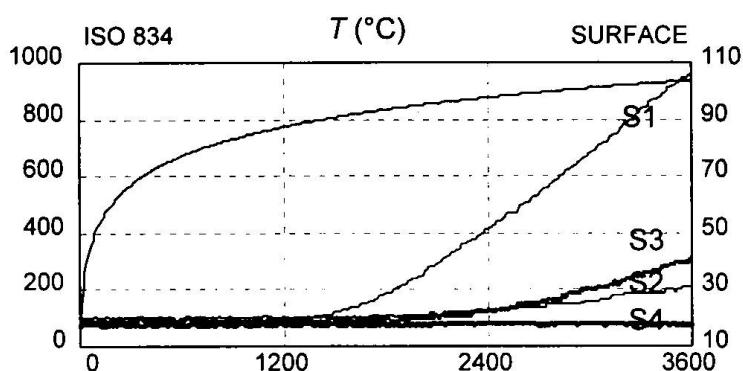
Fig. 2 - Maximum temperatures at the unexposed floor surfaces.

The physical data collected during each fire test included temperature data (inside the furnace, on the slab to quantify the degree of insulation provided by each floor, in the connectors to see that the temperature threshold, at which point the glue softens, was not exceeded and inside the timber beam at different depths) and floor displacements (see [3]): this was done not only for checking the mathematical models, but also for comparing similar models with those proposed by current standards, in particular ENV 1995 [1] and Italian U.N.I. 9504 [2]. Due to lack of space, only the diagrams of maximum temperatures read on the top surface of the slabs are reported in Fig. 2, as a function of time (in seconds). At a first glance, it is immediately evident how the floor comprising a concrete slab (50 mm thick) and wooden boards (25 mm) is also able to guarantee the insulation requirement with sufficient safety for 60 minutes exposure to fire ( $T_{max}=105$  °C). The same result could be obtained by the concrete slab alone, but with a  $\approx 100$  mm thickness.

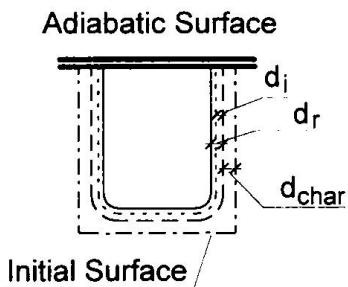
The simplified cross-section of timber beam for the "engineering" type decay model, used to simulate the physical tests that have been carried out up till now, could possibly be that proposed in Fig. 3. The following variables are given in the same figure:

- $d_{ef} = d_{char} + d_{add}$ , where  $d_{add} = d_r$  (during fire) or  $d_{add} = d_i$  (after fire, at room temperature);
- $d_i$  = thickness of the layer subject only to irreversible decay phenomena;
- $d_r$  = thickness of the layer subject to irreversible and reversible decay phenomena.

Fig. 3 - The "effective cross-section" method [1], applied also for the residual timber section.

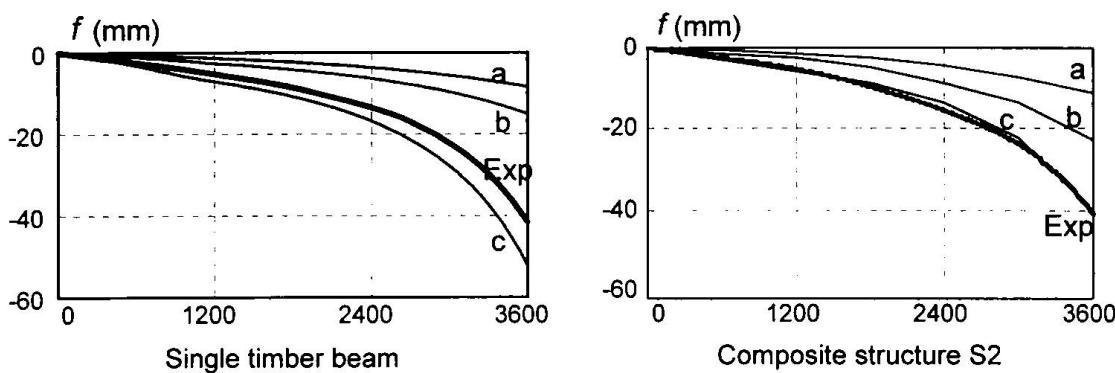
of composite structures that were being studied. The excellent behaviour of the simple decay model described above, can be seen clearly in Fig. 4, where curves *a* (according to [2]), curves *b* (according to the "effective cross section" method of ref. [1]) and, lastly, curves *c* (according to the decay model of Fig. 3) are compared with experimental curves *Exp*. As it can be seen, the decay models currently proposed by standards and based only upon the assumption of a charring rate [2] are unable to predict the behaviour of a composite structure during a fire.

Fig. 4 - Diagrams deflection vs. time (seconds).

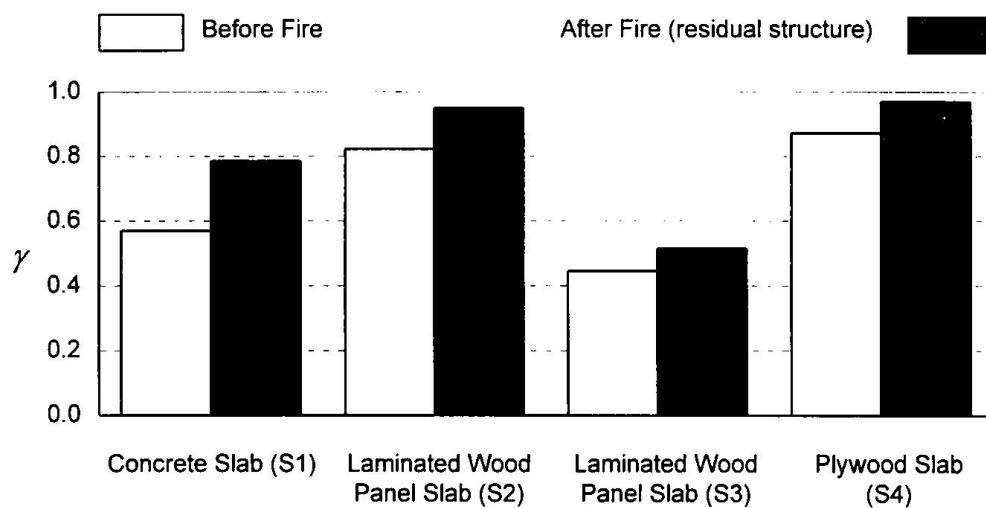
The parameters  $(E \cdot J)$  in the preceding formula are the bending stiffness of the beams simply in parallel (suffix  $b$ ), of the composite beams with rigid connection (suffix  $\infty$ ) or with the actual connection (apex  $*$ ) at the same service load. The limit values of  $\gamma$  are recognisable for the value  $\gamma=0$  (connection with no stiffness) and for  $\gamma=1$  (rigid connection). It is to be noted that the values of the parameter  $\gamma$  are to be referred to a particular loading arrangement and to a specific load value. If the real displacement values are analysed for the composite structures under investigation before and after the fire test, without variation of loads, the diagram in Fig. 5 can be obtained. The *efficiency* of the connection at service load  $\gamma_{sl}$  has increased for all structures and this is a direct consequence of the connection behaviour, nearly unchanged during the fire event as imposed at the design phase, and of the simultaneous remarkable decay of timber beams.

Fig. 5 - Values of the parameter  $\gamma_{sl}$  before and after the fire event.
