Artikel: Strength and ductility of beam-to-column connections in hybrid bridge

Strength and Ductility of Beam-to-Column Connections in Hybrid Bridge

Summary

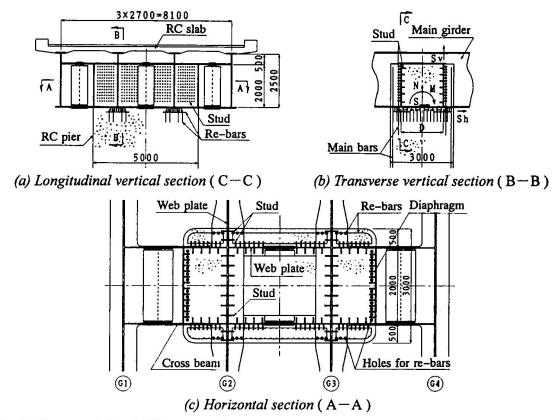
The structural detail of RC-type rigid connection adopted herein is illustrated in Fig. 1. In this type of connection, among the stress resultant transferred from steel girder into RC pier, the major bending moment and normal force will be transferred, in the tension side of the column, mainly through the shear resistance of studs installed on the outside of web plate of the cross

Fig. 1 Structural detail of beam-to-column connection

beam, and in the compression side, through both the shear resistance of the studs and the bearing resistance of concrete under the lower flange plate of main girders. Then the horizontal shear force will be transferred through the studs installed under the lower flange plate. Therefore, for the design of studs, it is assumed that the stress resultants from steel girders are transferred by the bearing resistance of the concrete under the lower flange and shear resistance of studs on the outside of cross beams and under the lower flange of main girder. Namely,

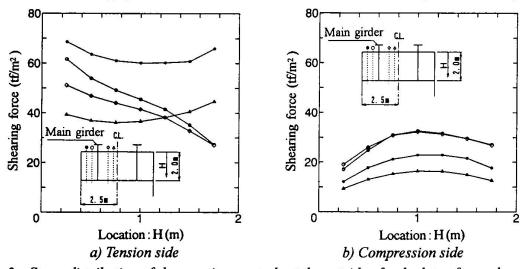
Fig. 3 shows the distribution of shear force acting on the shear spring elements at the both outsides of web plates of the cross beams. From the figures, it can be seen that the shearing forces acting on the studs are developing larger value in the tension side than the compression side of the column. It can be considered because, in compression side, the forces from main girders are mainly resisted by the bearing of the concrete under the lower flange plate of steel girder. The shearing force per unit area given by eq.(1) is about 130tf/m², which is over the double of the mean value 50tf/m² obtained by FEM analysis. It can be explained due to the pull out resistance of studs under the lower flange plate of main girder, the bearing resistance of concrete over the flange plate, and the shear resistance of studs on the web plates of main girders

Fig. 3 Stress distribution of shear acting on studs at the outside of web plate of cross beam

are contributing for the transmission of the resultant force in the tension side of the column. However, the eq.(1) was used for the design of studs considering that the shear strengths of studs are scattered depending on the state of the filling concrete and the shearing forces acting on studs are also scattered depending on the location. Fig. 4 shows the distribution of the horizontal shear and the bearing stress under the lower flange plate of main girder along the web line. From the figure, it can be seen that both the shear and bearing stress acting under the flange concentrate in the edge of compression side of the column. Therefore, additional reinforcements should be installed to softening the bearing stress.

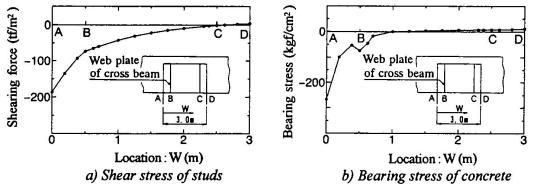
Fig. 4 Shear force distribution of studs and bearing stress distribution of concrete under the lower flange plate of main girder, respectively.
