**Zeitschrift:** IABSE reports = Rapports AIPC = IVBH Berichte  
**Band:** 77 (1998)

**Artikel:** Repairs of vertically deflected buildings  
**Autor:** Gromysz, Krzysztof  
**DOI:** <https://doi.org/10.5169/seals-58251>

## Repairs of Vertically Deflected Buildings

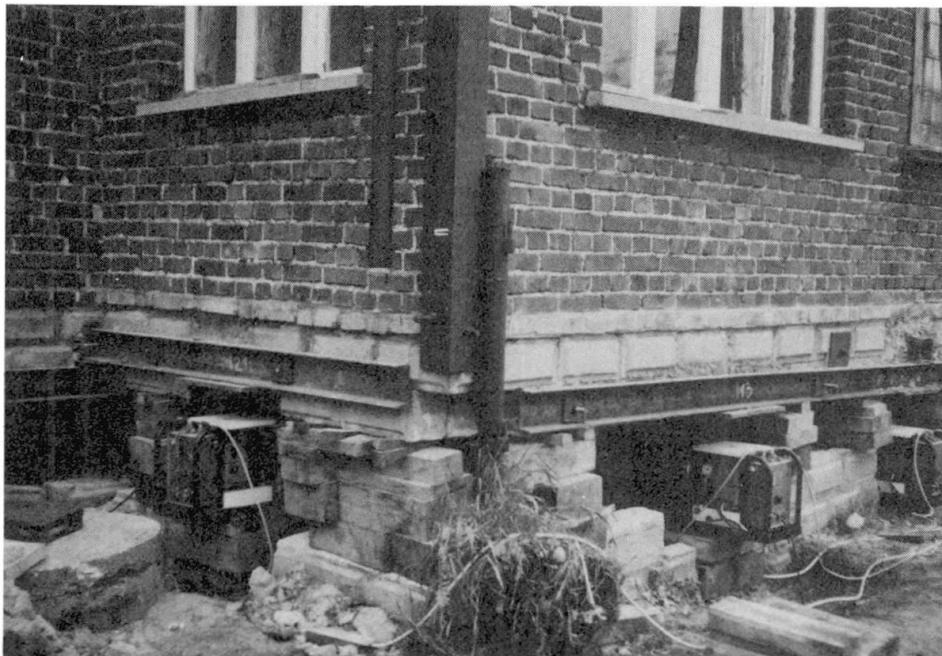
Fig.2 Built in jacks in cellar storey

Each object meant for rectification requires a number of preparatory works. The pre-rectification works last about a week and comprise hewing out the servo-motor recesses, cutting off the central heating, gas and water-sewage systems, propping the window- and door- heads and building in the jacks in the cellar storey.

is two channel bars running on both sides of the torn walls. Fig.2 shows built in jacks in cellar storey.
