Mold Fungus Formation in Large Panel Buildings with Subsequent Applied Thermal Insulation

Erich CZIESIELSKI
Univ.-Professor
Technische Universität Berlin
Germany

Summary

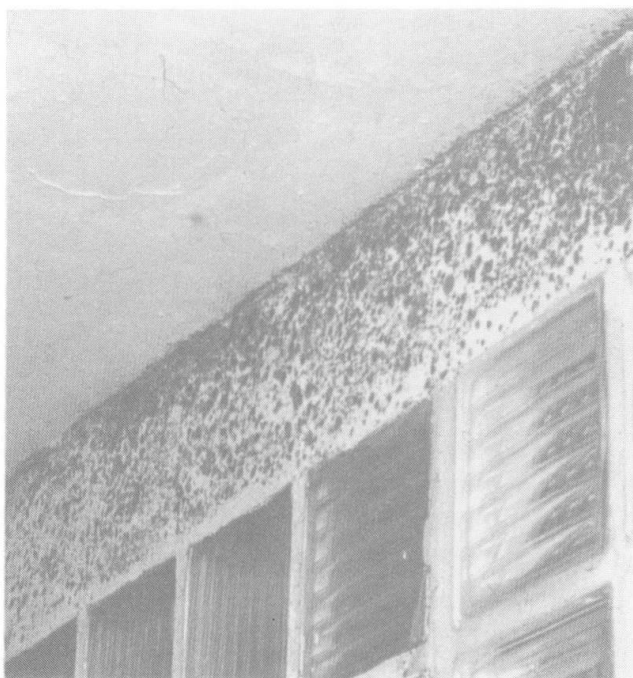
Fig. 1: Mold fungus

Mold fungus can grow and spread only in the presence of suitable living conditions (fig 1). Based on the spurs, fungus layers begin to grow on the walls. These layers may be green, black or red. In order to prevent the growth of mold fungus, no condensed water or moisture should form on the inner surfaces of rooms. For this, the minimum surface temperature in rooms should never be less than $+14^{\circ}\text{C}$.

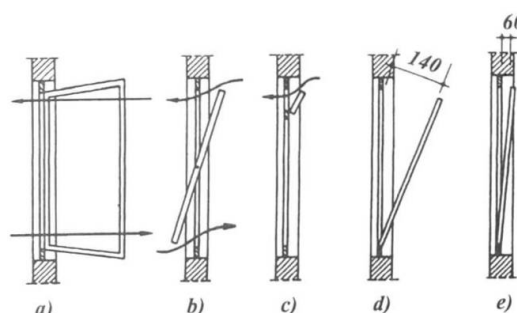
Fig. 2: Types of Window ventilation

The ventilation of dwelling due to air exchange through the new tight window joints is not enough in order to prevent the formation of condensed water. Window ventilation leads on the other hand to an extreme unnecessary air exchange between the interior and exterior and consequently to high energy losses. A cleave ventilation according to fig. 2e is enough to prevent a harmful humidity formation in dwellings.
