Zeitschrift: IABSE reports = Rapports AIPC = IVBH Berichte
Band: 77 (1998)

Artikel: Mold fungus formation in large panel buildings with subsequent applied thermal insulation
Autor: Cziesielski, Erich
DOI: <https://doi.org/10.5169/seals-58266>

Mold Fungus Formation in Large Panel Buildings with Subsequent Applied Thermal Insulation

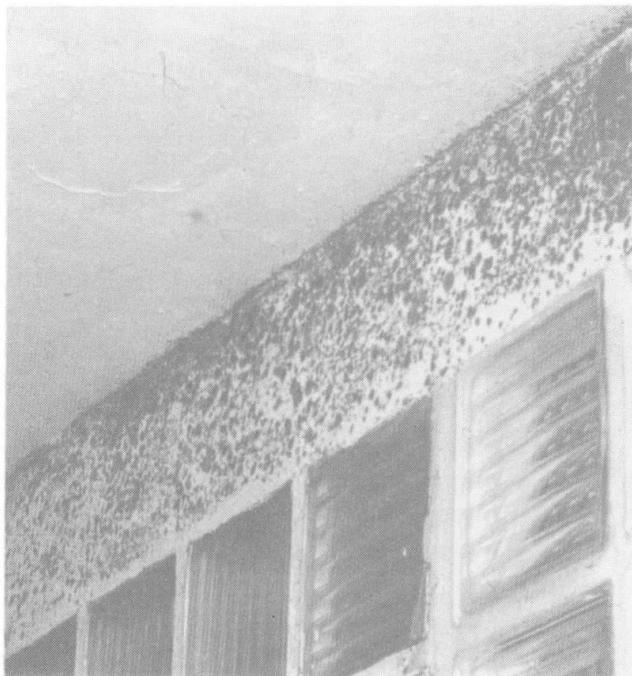
Fig. 1: Mold fungus

Mold fungus can grow and spread only in the presence of suitable living conditions (fig 1). Based on the spurs, fungus layers begin to grow on the walls. These layers may be green, black or red. In order to prevent the growth of mold fungus, no condensed water or moisture should format on the inner surfaces on rooms. For this, the minimum surface temperature in rooms should never be less than + 14 °C.

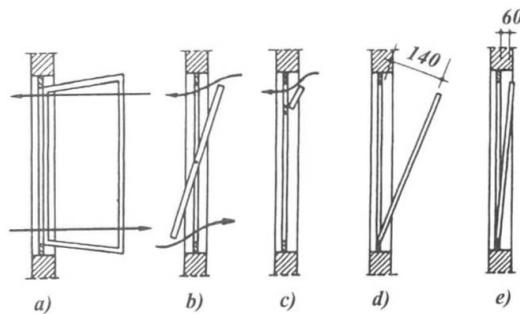
Fig. 2: Types of Window ventilation

The ventilation of dwelling due to air exchange through the new tight window joints is not enough in order to prevent the formation of condensed water. Window ventilation leads on the other hand to an extreme unnecessary air exchange between the interior and exterior and consequently to high energy losses. A cleave ventilation according to fig. 2e is enough to prevent a harmful humidity formation in dwellings.
