Artikel: Mold fungus formation in large panel buildings with subsequent applied thermal insulation
Autor: Cziesielski, Erich
DOI: <https://doi.org/10.5169/seals-58266>

Mold Fungus Formation in Large Panel Buildings with Subsequent Applied Thermal Insulation

Erich CZIESIELSKI
Univ.-Professor
Technische Universität Berlin
Germany

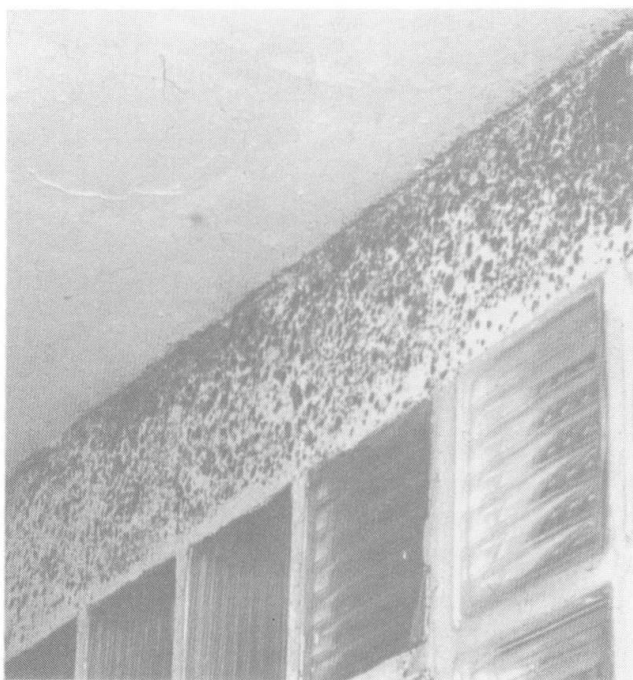
Fig. 1: Mold fungus

Mold fungus can grow and spread only in the presence of suitable living conditions (fig 1). Based on the spurs, fungus layers begin to grow on the walls. These layers may be green, black or red. In order to prevent the growth of mold fungus, no condensed water or moisture should form on the inner surfaces of rooms. For this, the minimum surface temperature in rooms should never be less than $+14^{\circ}\text{C}$.

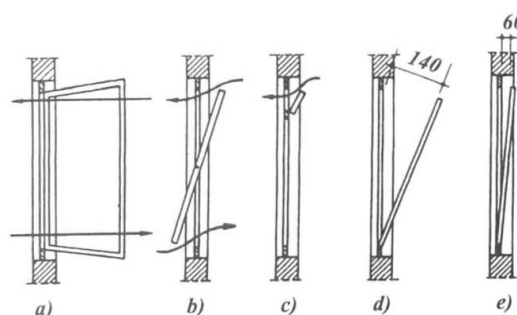
Fig. 2: Types of Window ventilation

The ventilation of dwelling due to air exchange through the new tight window joints is not enough in order to prevent the formation of condensed water. Window ventilation leads on the other hand to an extreme unnecessary air exchange between the interior and exterior and consequently to high energy losses. A cleave ventilation according to fig. 2e is enough to prevent a harmful humidity formation in dwellings.
