Zeitschrift: IABSE reports = Rapports AIPC = IVBH Berichte
Band: 77 (1998)

Mold Fungus Formation in Large Panel Buildings with Subsequent Applied Thermal Insulation

Erich CZIESIELSKI
Univ.-Professor
Technische Universität Berlin
Germany

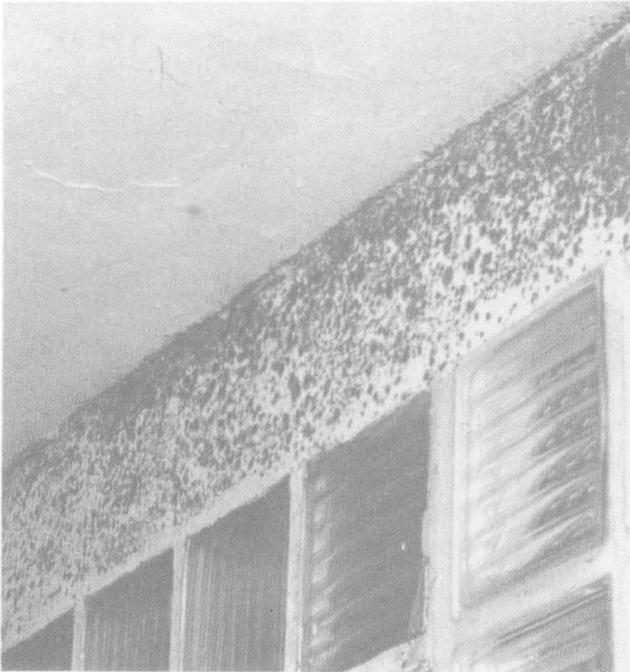
Fig. 1: Mold fungus

Mold fungus can grow and spread only in the presence of suitable living conditions (fig 1). Based on the spurs, fungus layers begin to grow on the walls. These layers may be green, black or red. In order to prevent the growth of mold fungus, no condensed water or moisture should form on the inner surfaces of rooms. For this, the minimum surface temperature in rooms should never be less than + 14 °C.

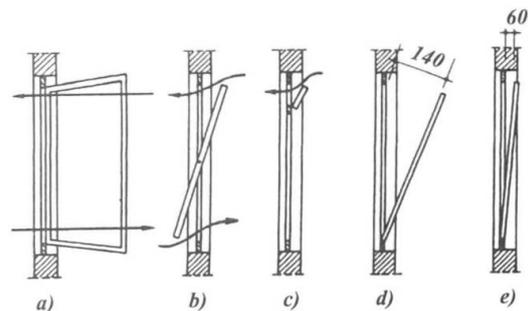
Fig. 2: Types of Window ventilation

The ventilation of dwelling due to air exchange through the new tight window joints is not enough in order to prevent the formation of condensed water. Window ventilation leads on the other hand to an extreme unnecessary air exchange between the interior and exterior and consequently to high energy losses. A cleave ventilation according to fig. 2e is enough to prevent a harmful humidity formation in dwellings.
