**Artikel:** Dynamic in situ tests on a damaged historical building

**Autor:** Zabel, Volkmar / Bucher, Christian

## Dynamic *in Situ* Tests on a Damaged Historical Building

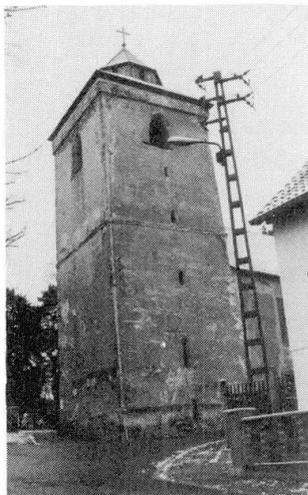
Fig. 1 : The bell tower, view from south-west

The appearance of the medieval Krölpa church tower is significantly characterized by its inclination which was caused by an uneven settlement of the ground. Today the tower is about 2.2 degrees out of the vertical and shows deep vertical cracks in the masonry of its four walls. These damages gave the reason for an investigation of the dynamic structural behaviour of the tower in its current state. It was intended to identify dynamic system properties as well as to model the structure with its specifics numerically.
