**Artikel:** Dynamic tests and verification of mechanical properties of a panel building  
**Autor:** Gattermayerova, H. / Bayer, J. / Kral, J.  
**DOI:** <https://doi.org/10.5169/seals-58184>

## Dynamic Tests and Verification of Mechanical Properties of a Panel Building

The calculated compressive stresses in the foundation base of an eight storey panel building due to standard wind load were compared with experimental results. The corresponding value of the compressive stress was obtained simultaneously with the displacement amplitudes of the roof from the ambient response of the building, which was also used to identify the predominant natural frequencies. This technique can help to assess the ambiguous mechanical behaviour in the event of redesign and rehabilitation of panel buildings.

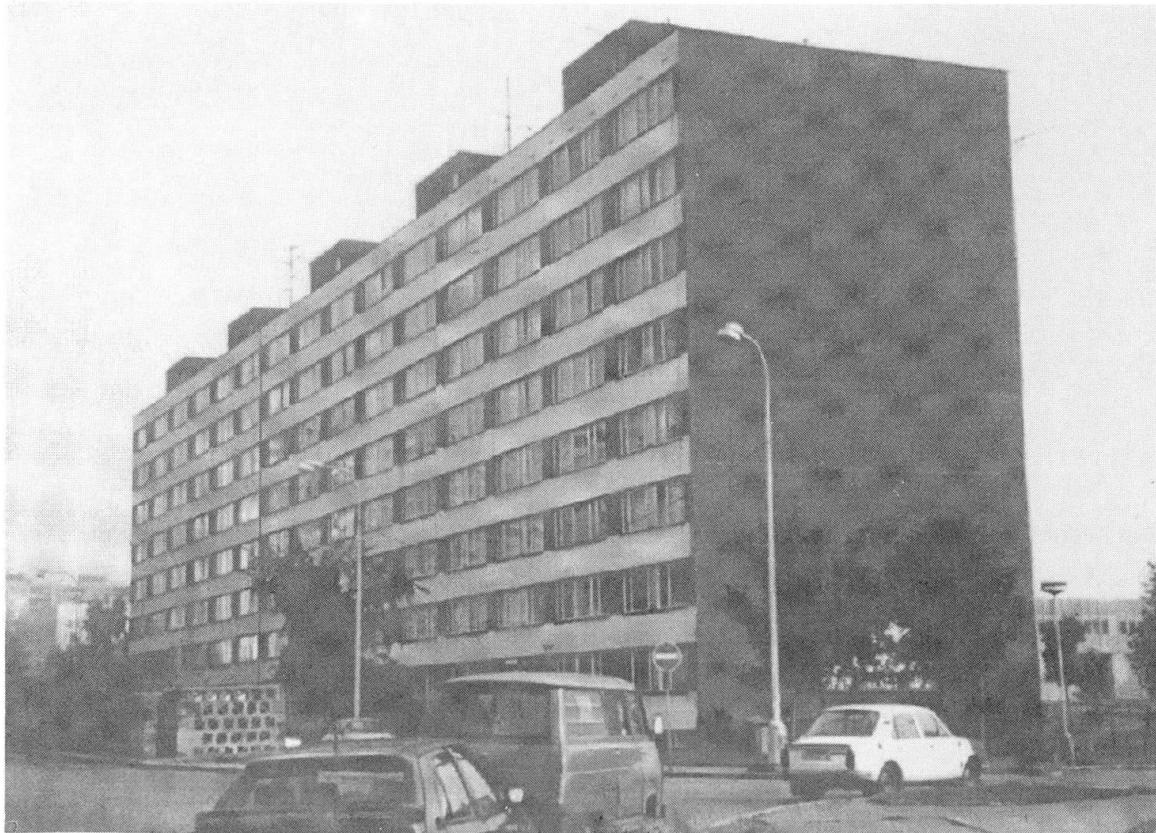
*Fig. 1: Photograph of the tested panel building*

The panel building that was chosen for the purposes of experimental verification (Resovska street, No. 22, 23, 24) was accomplished in the late seventies in Prague. It is an eight storey building consisting of three equal sections in a row, which are firmly attached to each other (see fig.1). The bearing system is formed by transversal walls 6,0 m apart and one 6m-long longitudinal wall in each section (see fig.2). The joints between the panels (0.19 m thick reinforced concrete slab-elements) consist of concrete and reinforcement. According to the visual survey some of the joints are weakened by hair-thin cracks. The front walls hang on the transversal walls and are not designed for load carrying purposes.
