Artikel: Seismic design for large-scale cut-and-cover tunnels
Autor: Kuwabara, Kiyoshi / Matsuda, Toru / Shimizu, Mitsuru
DOI: <https://doi.org/10.5169/seals-59052>

Seismic Design for Large-Scale Cut-and-Cover Tunnels

The cut-and-cover tunnel described in this paper pertains to a large-scale underground station with a length of 400 m, a cross section of 25 m height, and 25 m width in soft ground. One part of the top slab of the station will be required to serve as the foundation for an elevated viaduct structure, and the entire structure will be a very complicated to be built in a seismically high risk area, and in view of the fact that the structure will be an important train station, there will be many passengers, and seismic safety will be an important design task.

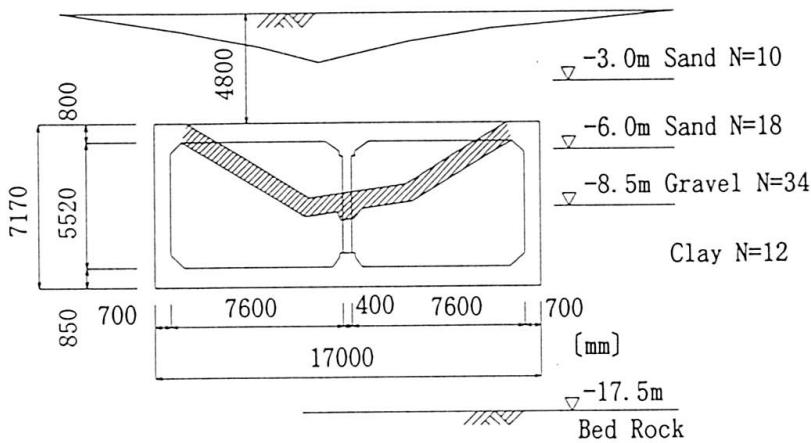
Fig. -1.1 Damages at Daikai Station

Of the civil structures that were damaged, this was the first time in the world that a subway system was subjected to large damage on a major scale. Especially, the Daikai Subway Station was almost completely demolished. Fig.-1.1 gives a cross section view of the station and describes the damages incurred¹⁾. The ground in the vicinity of the station had a shear wave velocity V_s of more than 200 m/s which is fairly good, the ground higher than the tunnel was $V_s = 140$ m/s. From the damage sustained by the station, it can be seen that the reinforced concrete central columns supporting the station upper slabs failed, and the upper slabs collapsed by breaking in two.

- 1) At the time of the earthquake, there was shear deformation within the layers of the ground, and there was shear deformation caused transverse to the tunnels. As a result, there was relative differential deformation caused between the upper and lower slabs.
- 2) There was average axial stress in excess of 80 MPa in the reinforced concrete center columns which was greater than in the side walls, and the center columns had less ductility where shear collapse set in ahead of bending collapse.
- 3) Due to the relative displacement between the top and bottom slabs, the central column support failed as it could not move in consonance with the side wall.

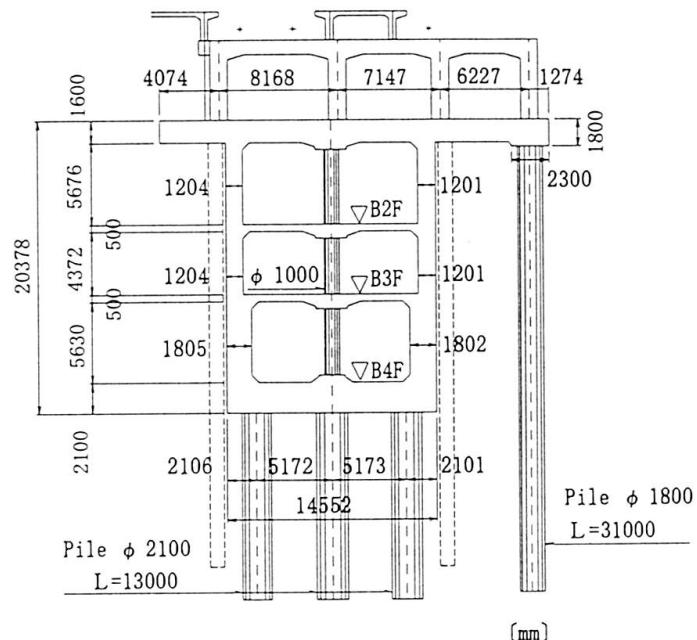
Fig. -2.1 Cross Section View of Yokohama MM21 Line Underground Station

The objective of this report is the large-scale subway station in the excavated tunnel as shown in Fig.-2.1. The main features that will require earthquake design are as follows:

- 1) The structure is located in an area with high seismic risk.
- 2) The station has heavy passenger traffic, and be a large-scale underground structure of high importance.
- 3) The station is located some -35 m underground in a soft clayey ground.
- 4) One part of the upper slab of the station will serve as the foundation for an elevated viaduct structure and the subway station will have a pile foundation.

The center column is a steel pipe column filled with concrete and all other member are made of reinforced concrete. The reasons for using concrete filled steel pipe is to ensure sufficient ductility of the center column, and not to set in ahead of shear collapse.

Fig.-2.1 gives a description of the foundation soils for the seismic analysis. The depth of ground layer is approximately 30 m from the bed rock for the seismic design, and the soils are soft clay with a $V_s = 120 \sim 150$ m/s.

Depth (m)	Soil Type	γ_t (tf/m ³)	V _s (m/s)	N-Value		
				10	30	50
5	A s1	1.70	140			
10	A c2-1	1.60	120			
15	A c2-2	1.60	120			
20	A c2-3	1.60	120			
25	A c2-4	1.60	120			
30	A c3	1.60	150			
35	K hc	2.00	420			
40

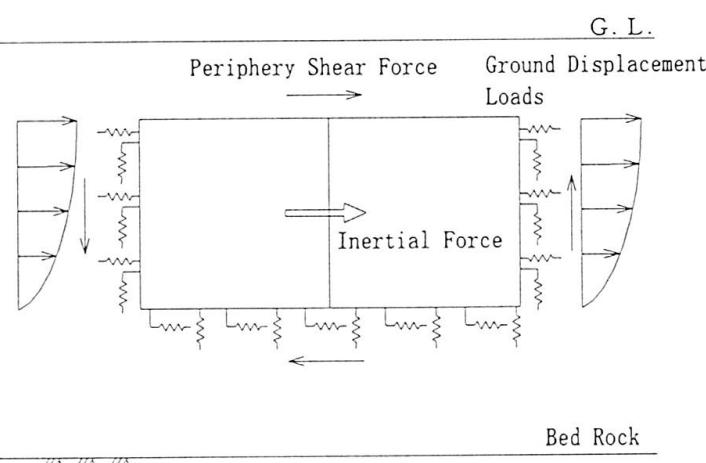
Fig. -3.1 The Concept of Seismic Deformation Method

Fig.-3.1 is the concept of the Seismic Deformation Method, and Fig.-3.2 gives the flow diagram of the Seismic Deformation Method. The analysis model is a framework model supported by the ground spring, and the bending stiffness are assumed at 1/5th of their total cross sectional state considering the loss of stiffness caused by earthquakes.

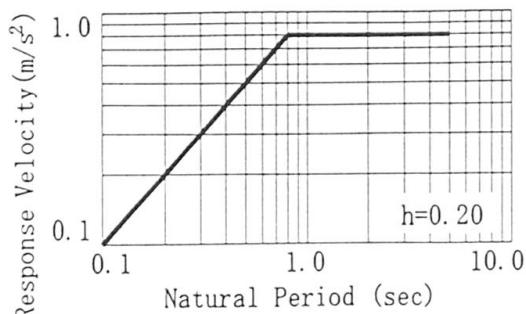
Fig. -4.1 Response Velocity Spectrum

For the earthquake motion inputs, Fig.-4.1 gives the velocity response spectrum, and Fig.-4.2 gives the acceleration corresponding to the spectrum. The velocity response spectrum in Fig.-4.1 is based on the ground motion observed of the South Hyogo Prefecture Earthquake .

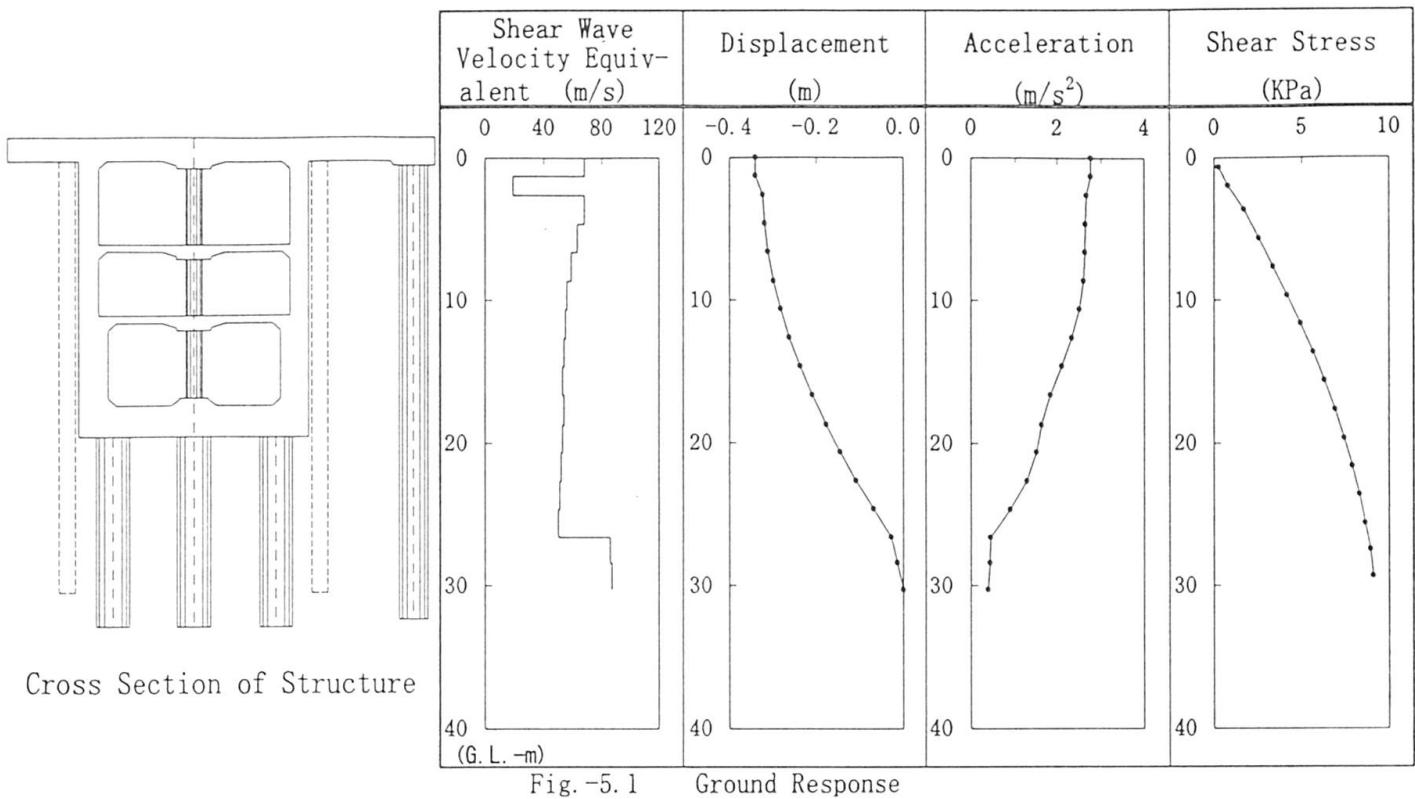
Fig. -5.1 Ground Response

Fig.-5.1 gives the ground response to be used for the seismic deformation method. This is calculated according to the One Dimensional Dynamic Analysis “SHAKE”.

The various loads of the seismic deformation method is based on the ground earthquake response from Fig.-5.1, and the ground displacement loads are obtained from the ground displacement and the ground spring, and the peripheral shear force is obtained from the ground shear force, and the inertia force was obtained from the ground acceleration

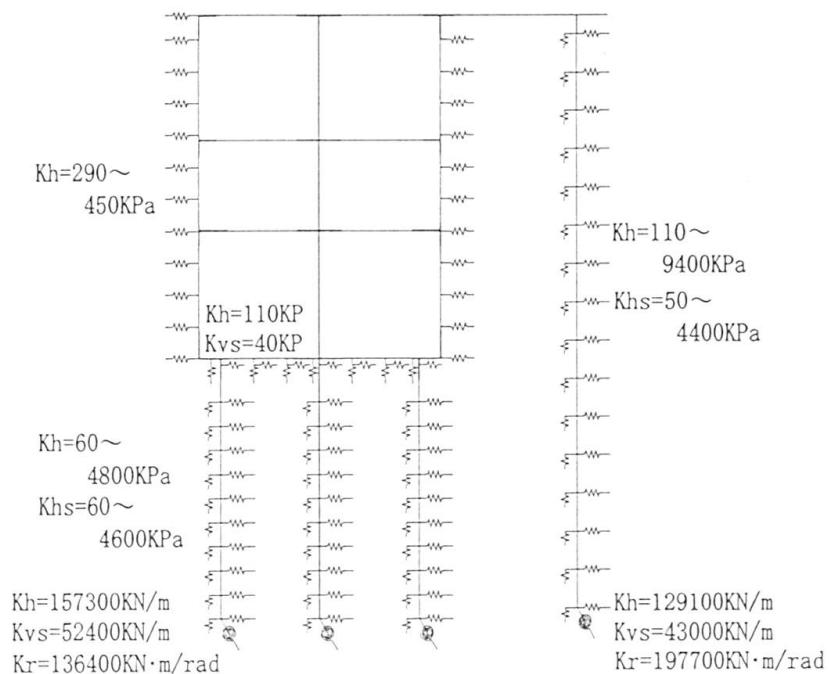
Fig. -5.2 Model of Seismic Deformation Method

Fig.-5.2 gives the analysis model of the seismic deformation method . The analysis model is a two dimensional framework supported by the ground spring, and the bending stiffness are assumed at 1/5th of their total cross sectional state considering the loss of stiffness caused by earthquakes.

The analysis model in Fig.-5.2 of the Seismic Deformation Method by the Uniform Loss of Stiffness Model basically agree with the Non-Linear Seismic Deformation Method. The different points are that the stiffness of the structure is not reduced uniformly, but the components have been given non-linear characteristics.

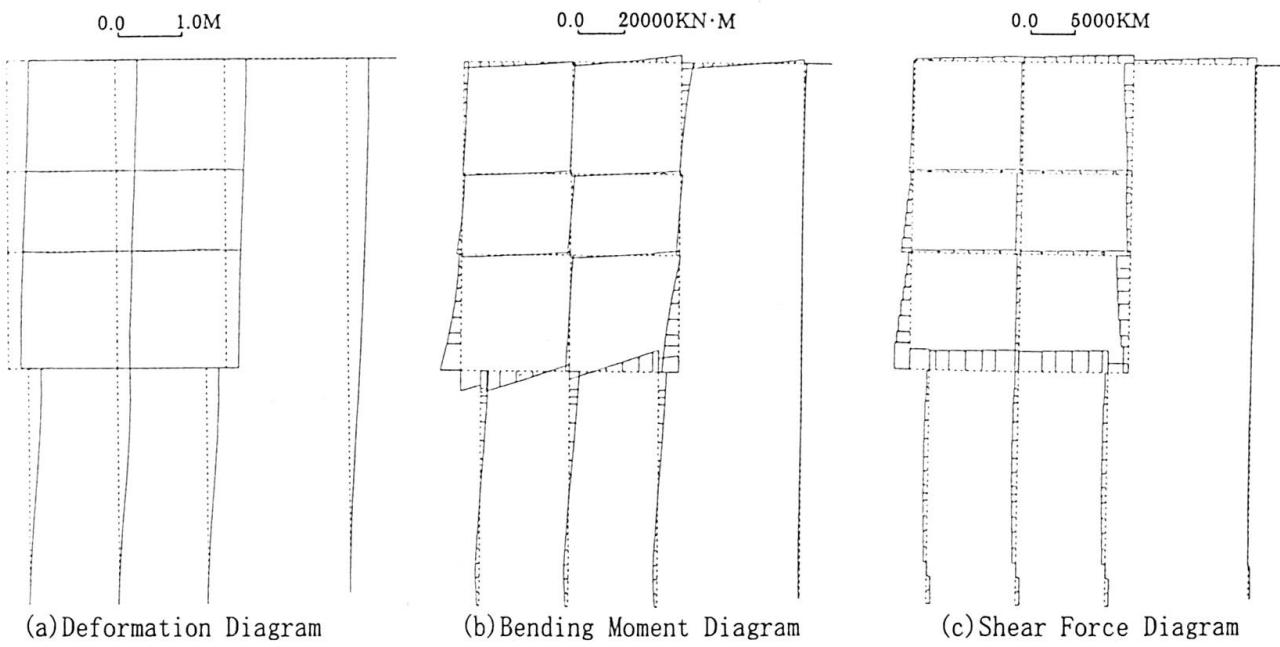
Fig. -5.3 Result of Seismic Deformation Method

Fig.-5.3 gives a display of the displacement, bending moment, and the shear forces obtained from seismic deformation method by the uniform loss of stiffness .

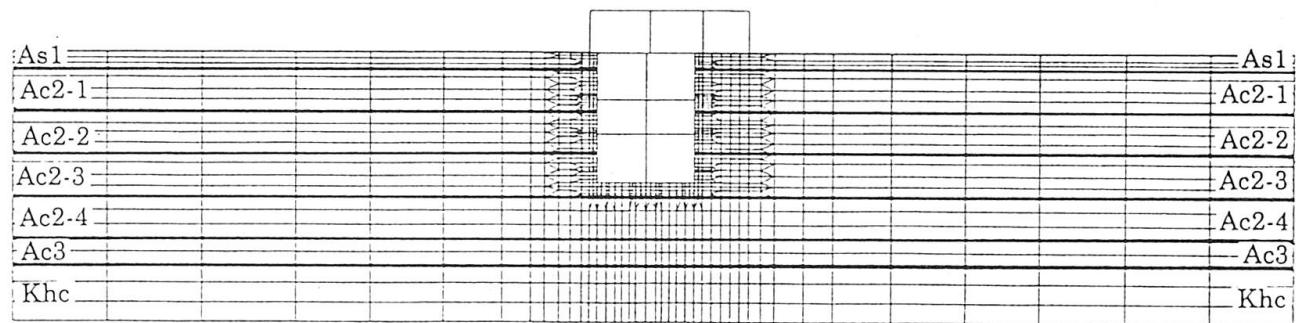
Fig. -6.1 Dynamic Analysis Model

The analysis model is a 2-dimensional FEM “FLUSH” of the ground~structure interaction system. The structure (excavated tunnel, viaduct, pile foundation) is a space frame model, and the ground foundation is displayed as a 2-dimensional solid model. In addition, the bending stiffness of the components are similar to the seismic deformation method. For the ground ,the loss of stiffness at earthquake time is considered.

Fig.-6.1 gives the Dynamic Analysis Model by the Uniform Loss of Stiffness Model. The input acceleration from Fig.-4.2 has been applied to the bed rock.

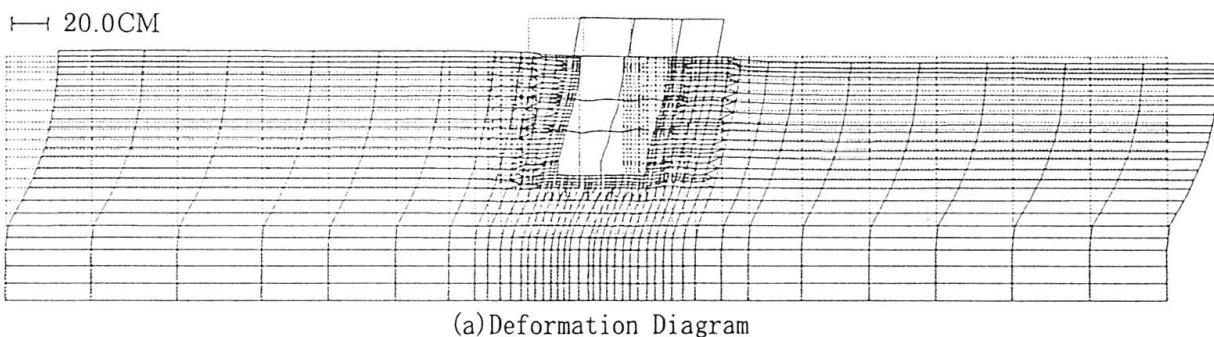
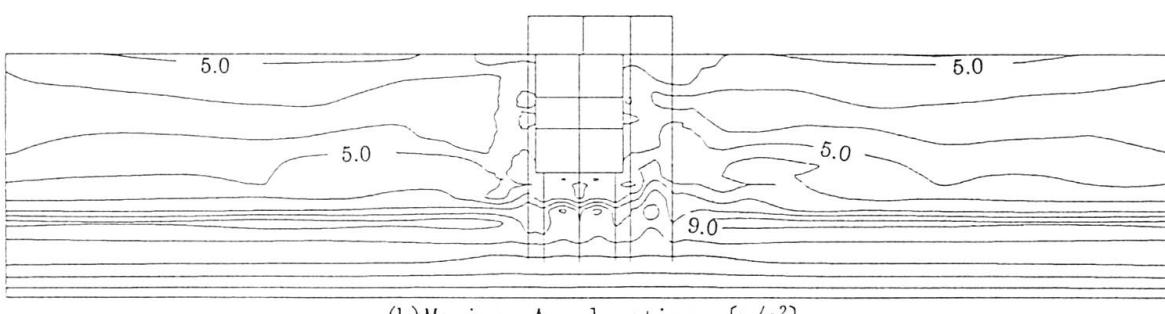
Fig. -6.2 Result of Dynamic Analysis

Fig.-6.2 gives a display of the deformation and maximum acceleration obtained from dynamic analysis.

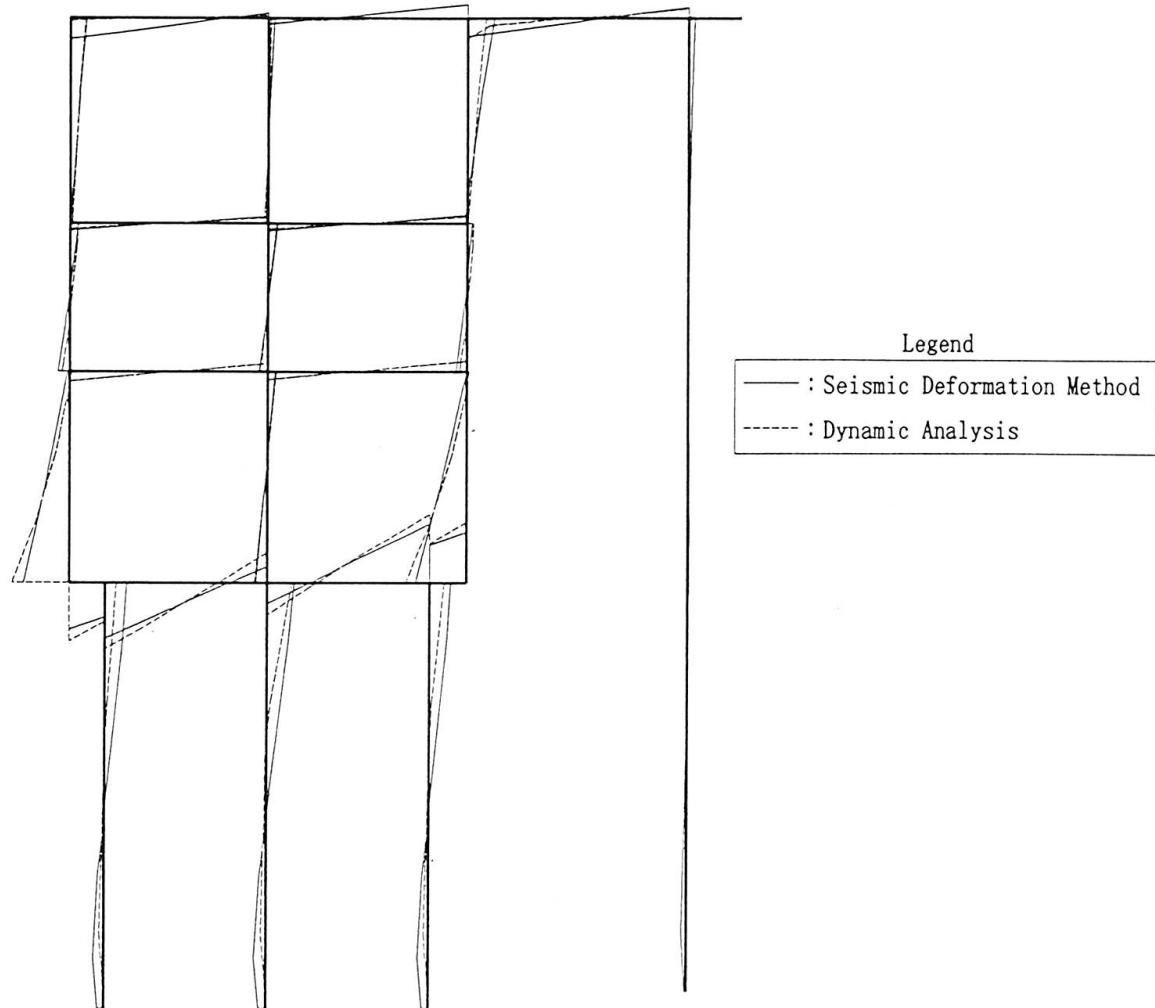
Fig. -6.3 Comparison of Bending Moment

Fig.-6.3 gives a comparison of the bending moment of analysis by the Seismic Deformation Method and the Dynamic Analysis. This shows that they are generally compatible, and the static analysis of the Seismic Deformation Method indicates that the interaction response (ground~structure, viaduct~subway tunnel~pile foundation) are generally displayed.

- 1) A comparison of the results of the Seismic Deformation Method and the Dynamic Analysis show that both methods are relatively compatible, and that the Seismic Deformation Method can almost fully display dynamic interaction (ground~structures, elevated bridge structure~excavated tunnel~pile foundation).
- 2) According to the non-linear seismic deformation method, the seismic design for large-scale earthquake loads are to secure the seismic safety as a whole structure.

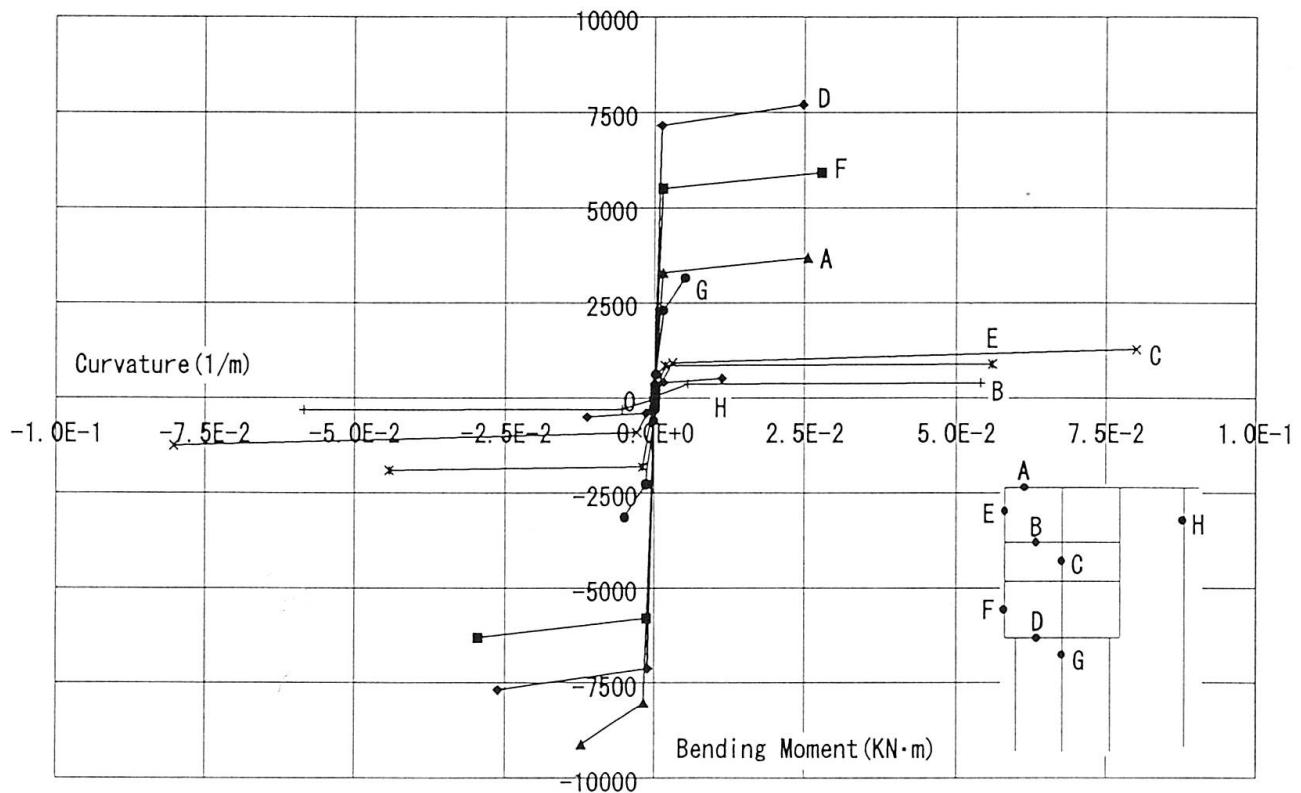
Fig. -7.1 The Characteristics for Bending Moment~Curvature

Fig.-7.1 gives the non-linear characteristics which have been obtained from References 8) and 9). The characteristics are $M \sim \Phi$ Type (bending moment ~ curvature).

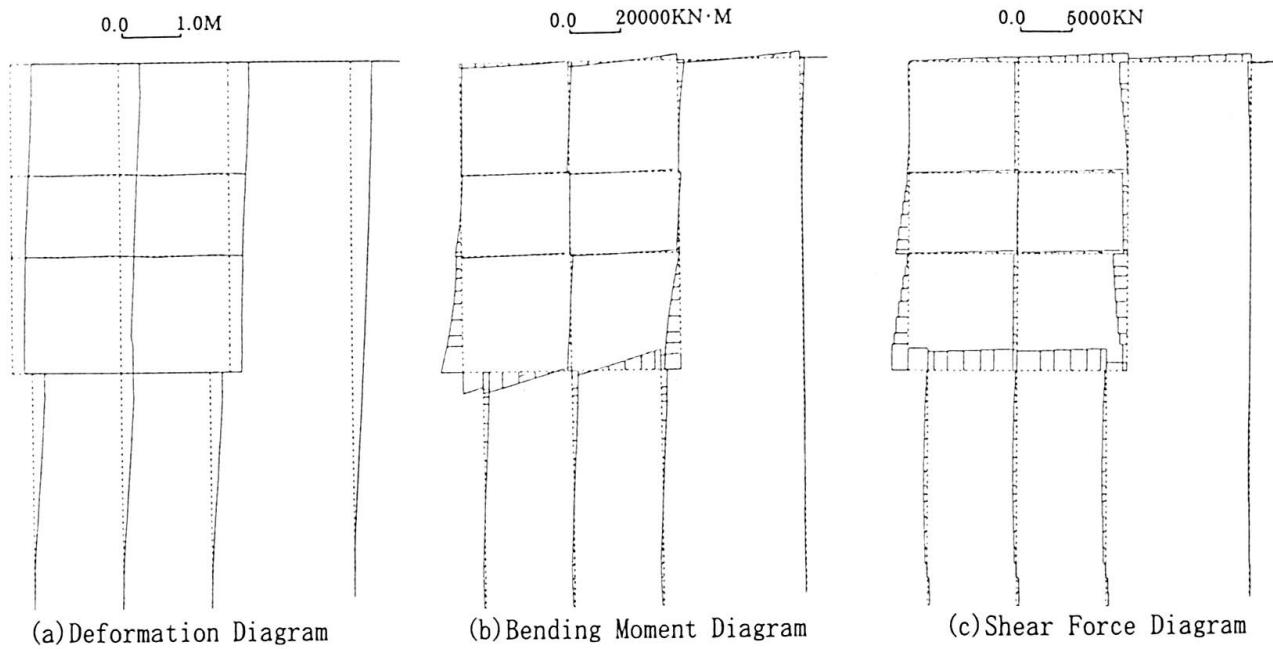
Fig. 7.2 Result of Non-linear Seismic Deformation Method

Fig.-7.2 gives a display of the displacement, bending moment, and the shear forces obtained by the non-linear seismic deformation method

The shear reinforcing steel in each member have been placed so that bending collapse will not set in ahead of shear collapse. After which, the deformation capability of side walls and center columns at each floor are evaluated by comparing the relative displacement of side walls and center columns at each floor and allowable displacement generated. In this case, the allowable displacement was determined based on reference 10). The result is given in Table.-7.1. show that the side wall and center column at each floor ensure sufficient ductility.
