**Artikel:** Seismic design for large-scale cut-and-cover tunnels  
**Autor:** Kuwabara, Kiyoshi / Matsuda, Toru / Shimizu, Mitsuru  
**DOI:** <https://doi.org/10.5169/seals-59052>

## Seismic Design for Large-Scale Cut-and-Cover Tunnels

The cut-and-cover tunnel described in this paper pertains to a large-scale underground station with a length of 400 m, a cross section of 25 m height, and 25 m width in soft ground. One part of the top slab of the station will be required to serve as the foundation for an elevated viaduct structure, and the entire structure will be a very complicated to be built in a seismically high risk area, and in view of the fact that the structure will be an important train station, there will be many passengers, and seismic safety will be an important design task.

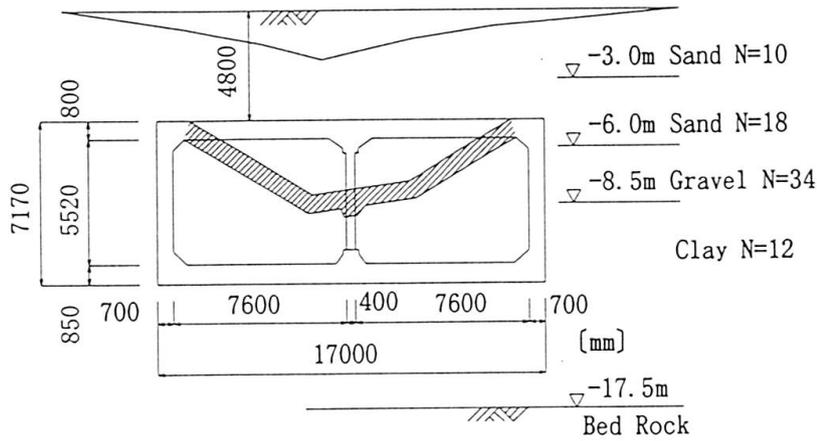
Fig.-1.1 Damages at Daikai Station

Of the civil structures that were damaged, this was the first time in the world that a subway system was subjected to large damage on a major scale. Especially, the Daikai Subway Station was almost completely demolished. Fig.-1.1 gives a cross section view of the station and describes the damages incurred<sup>1)</sup>. The ground in the vicinity of the station had a shear wave velocity  $V_s$  of more than 200 m/s which is fairly good, the ground higher than the tunnel was  $V_s = 140$  m/s. From the damage sustained by the station, it can be seen that the reinforced concrete central columns supporting the station upper slabs failed, and the upper slabs collapsed by breaking in two.

Although they did not collapse in a similar manner to the Daikai Station, there were ruptures due to shear failures in the reinforced concrete columns at Kamisawa and Sanno-Miya Stations, and the top and intermediate slabs gave way.

- 1) At the time of the earthquake, there was shear deformation within the layers of the ground, and there was shear deformation caused transverse to the tunnels. As a result, there was relative differential deformation caused between the upper and lower slabs.
- 2) There was average axial stress in excess of 80 MPa in the reinforced concrete center columns which was greater than in the side walls, and the center columns had less ductility where shear collapse set in ahead of bending collapse.
- 3) Due to the relative displacement between the top and bottom slabs, the central column support failed as it could not move in consonance with the side wall.

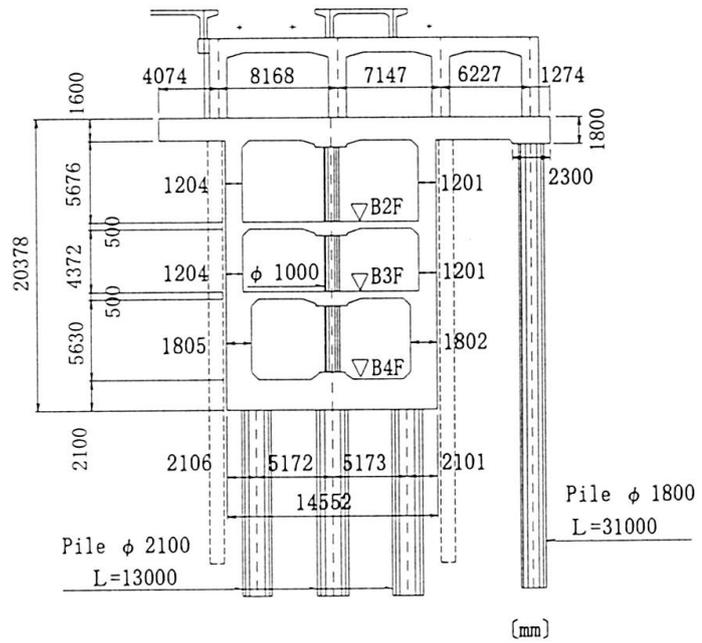
Fig.-2.1 Cross Section View of Yokohama MM21 Line Underground Station

The objective of this report is the large-scale subway station in the excavated tunnel as shown in Fig.-2.1. The main features that will require earthquake design are as follows:

- 1) The structure is located in an area with high seismic risk.
- 2) The station has heavy passenger traffic, and be a large-scale underground structure of high importance.
- 3) The station is located some -35 m underground in a soft clayey ground.
- 4) One part of the upper slab of the station will serve as the foundation for an elevated viaduct structure and the subway station will have a pile foundation.

The center column is a steel pipe column filled with concrete and all other member are made of reinforced concrete. The reasons for using concrete filled steel pipe is to ensure sufficient ductility of the center column, and not to set in ahead of shear collapse.

Fig.-2.1 gives a description of the foundation soils for the seismic analysis. The depth of ground layer is approximately 30 m from the bed rock for the seismic design, and the soils are soft clay with a  $V_s = 120 \sim 150$  m/s.

Depth (m)	Soil Type	$\gamma t$ (tf/m <sup>3</sup> )	V <sub>s</sub> (m/s)	N-Value		
				10	30	50
5	A s1	1.70	140			
	A c2-1	1.60	120			
10	A c2-2	1.60	120			
15	A c2-3	1.60	120			
20	A c2-4	1.60	120			
25	A c3	1.60	150			
35	K hc	2.00	420			
40

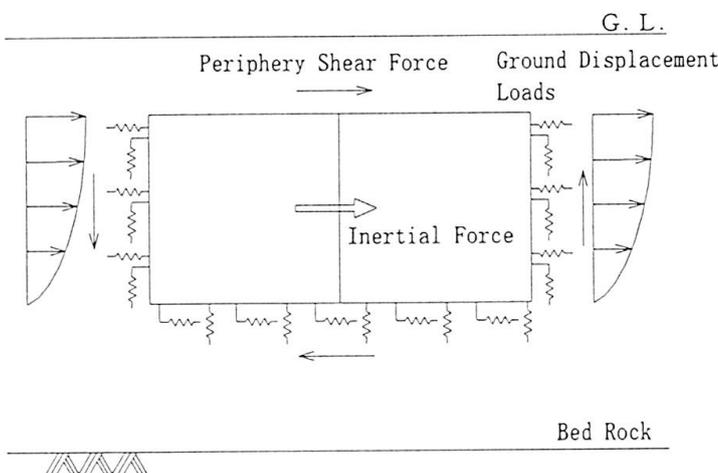
Fig.-3.1 The Concept of Seismic Deformation Method

Fig.-3.1 is the concept of the Seismic Deformation Method, and Fig.-3.2 gives the flow diagram of the Seismic Deformation Method. The analysis model is a framework model supported by the ground spring, and the bending stiffness are assumed at  $1/5^{\text{th}}$  of their total cross sectional state considering the loss of stiffness caused by earthquakes.

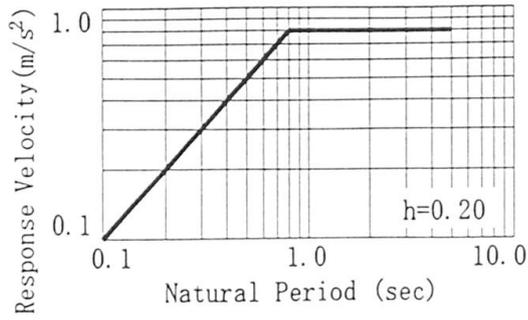
Fig.-4.1 Response Velocity Spectrum

For the earthquake motion inputs, Fig.-4.1 gives the velocity response spectrum, and Fig.-4.2 gives the acceleration corresponding to the spectrum. The velocity response spectrum in Fig.-4.1 is based on the ground motion observed of the South Hyogo Prefecture Earthquake .

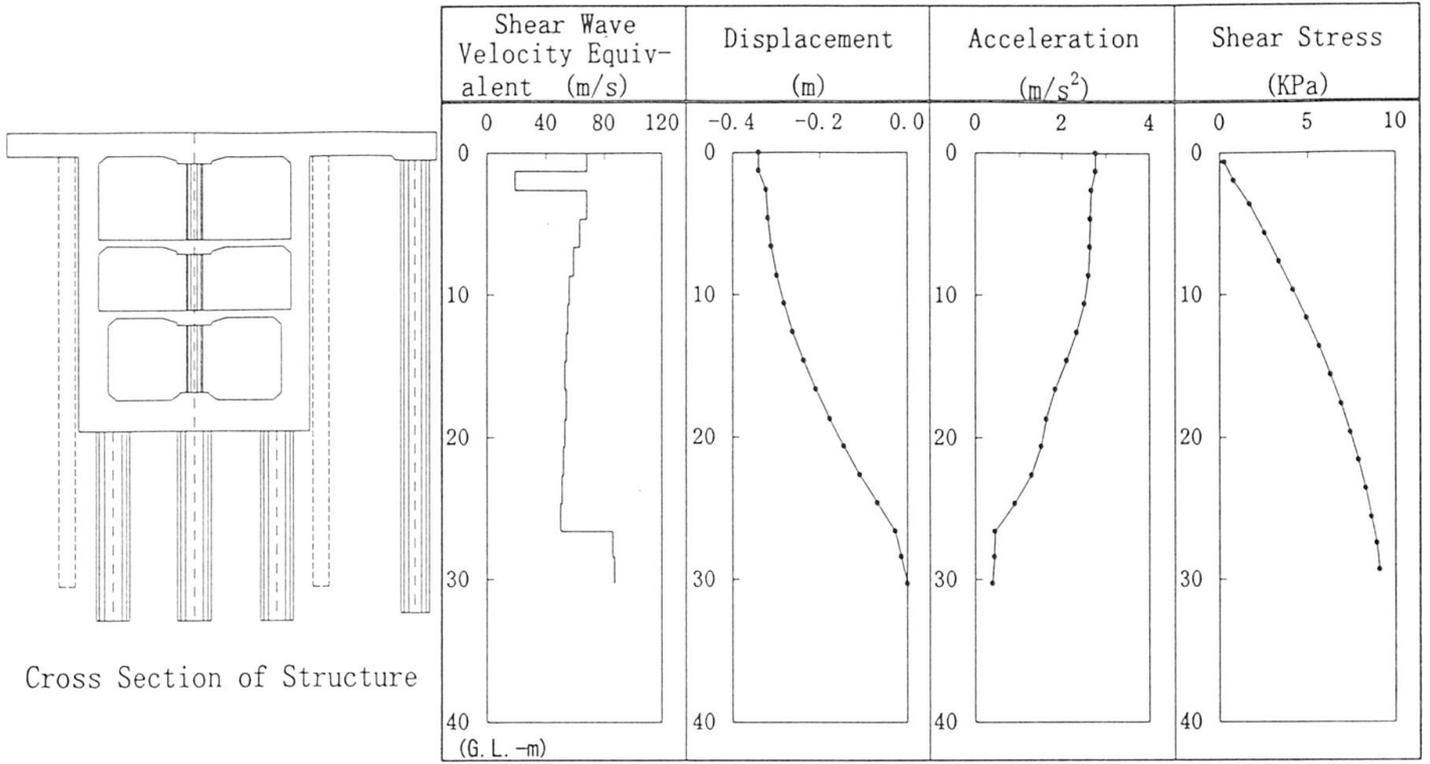
Fig. -5.1 Ground Response

Fig.-5.1 gives the ground response to be used for the seismic deformation method. This is calculated according to the One Dimensional Dynamic Analysis "SHAKE".

The various loads of the seismic deformation method is based on the ground earthquake response from Fig.-5.1, and the ground displacement loads are obtained from the ground displacement and the ground spring, and the peripheral shear force is obtained from the ground shear force, and the inertia force was obtained from the ground acceleration

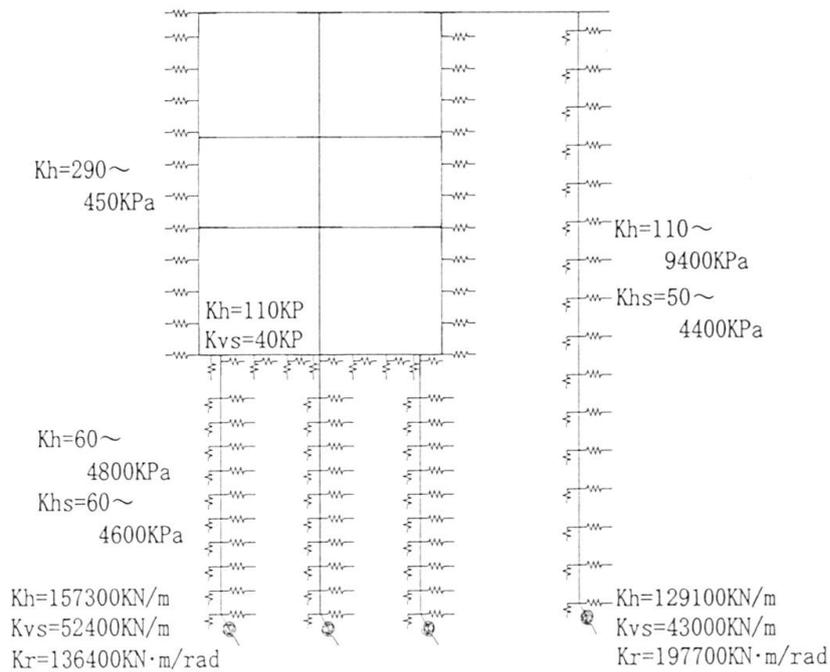
Fig.-5.2 Model of Seismic Deformation Method

Fig.-5.2 gives the analysis model of the seismic deformation method . The analysis model is a two dimensional framework supported by the ground spring, and the bending stiffness are assumed at 1/5<sup>th</sup> of their total cross sectional state considering the loss of stiffness caused by earthquakes.

The analysis model in Fig.-5.2 of the Seismic Deformation Method by the Uniform Loss of Stiffness Model basically agree with the Non-Linear Seismic Deformation Method. The different points are that the stiffness of the structure is not reduced uniformly, but the components have been given non-linear characteristics.

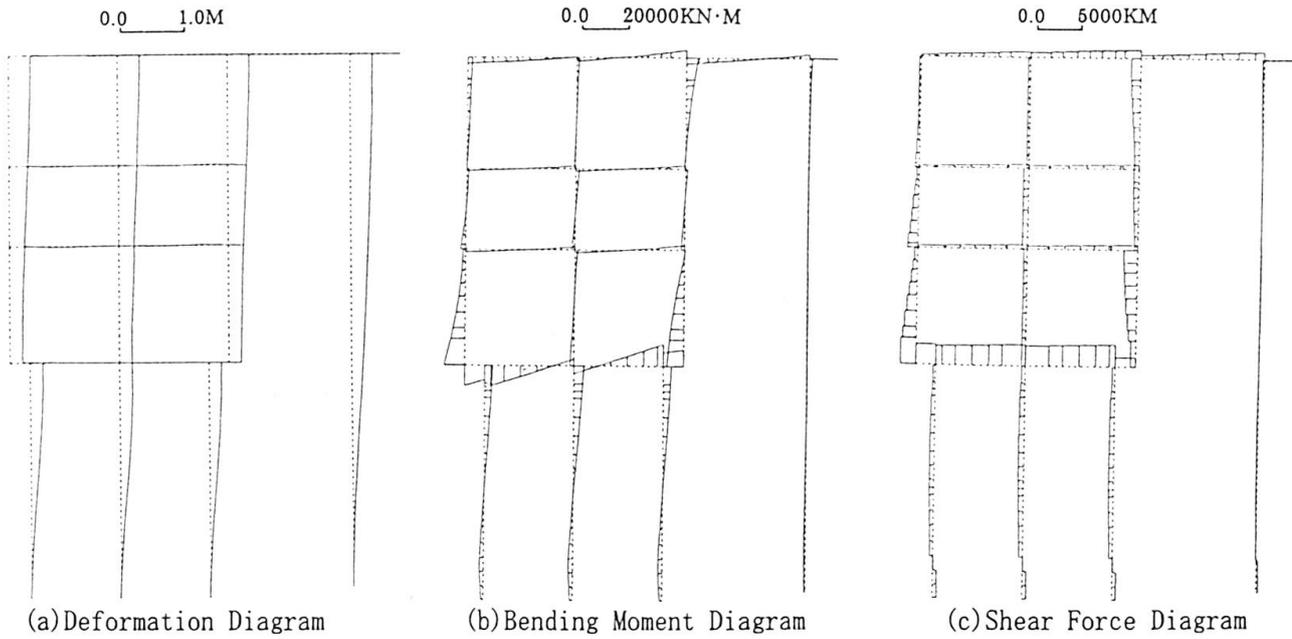
Fig.-5.3 Result of Seismic Deformation Method

Fig.-5.3 gives a display of the displacement, bending moment, and the shear forces obtained from seismic deformation method by the uniform loss of stiffness .

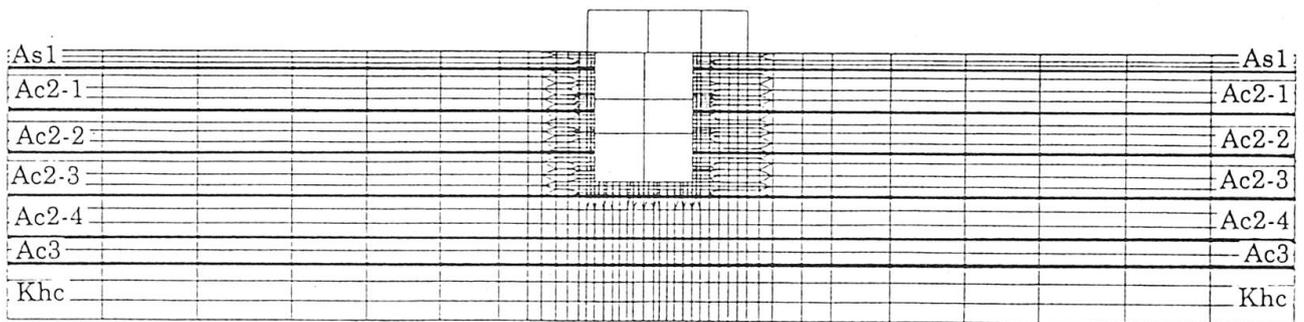
Fig.-6.1 Dynamic Analysis Model

The analysis model is a 2-dimensional FEM “FLUSH” of the ground~structure interaction system. The structure (excavated tunnel, viaduct, pile foundation) is a space frame model, and the ground foundation is displayed as a 2-dimensional solid model. In addition, the bending stiffness of the components are similar to the seismic deformation method. For the ground ,the loss of stiffness at earthquake time is considered.

Fig.-6.1 gives the Dynamic Analysis Model by the Uniform Loss of Stiffness Model. The input acceleration from Fig.-4.2 has been applied to the bed rock.

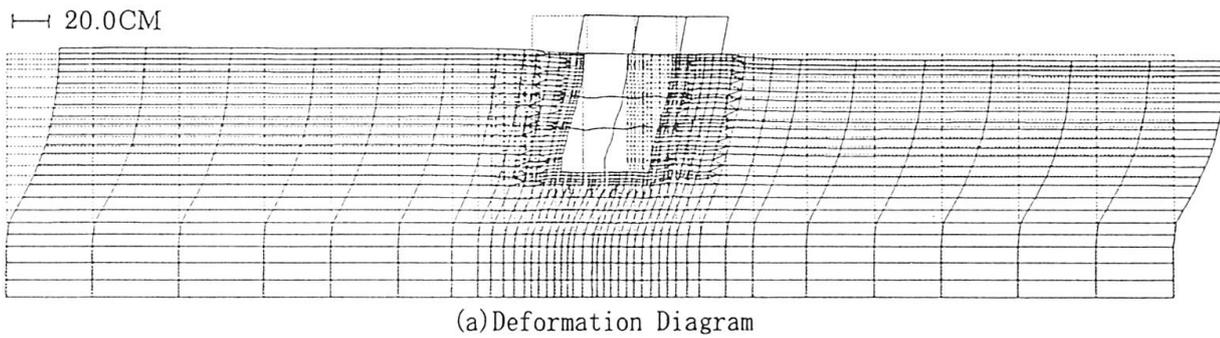
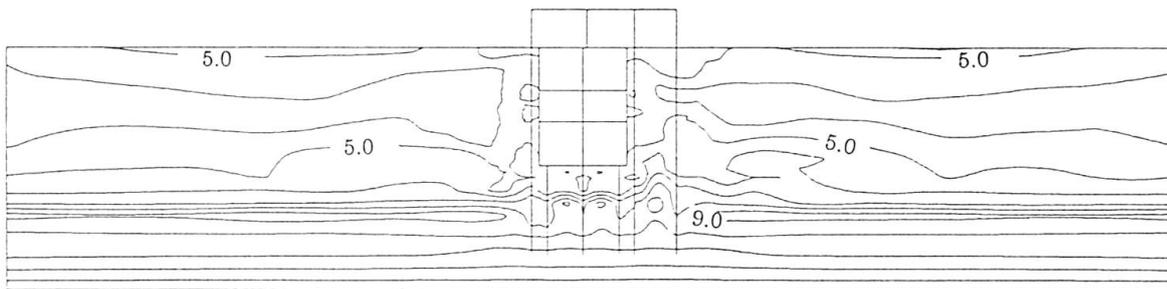
Fig.-6.2 Result of Dynamic Analysis

Fig.-6.2 gives a display of the deformation and maximum acceleration obtained from dynamic analysis.

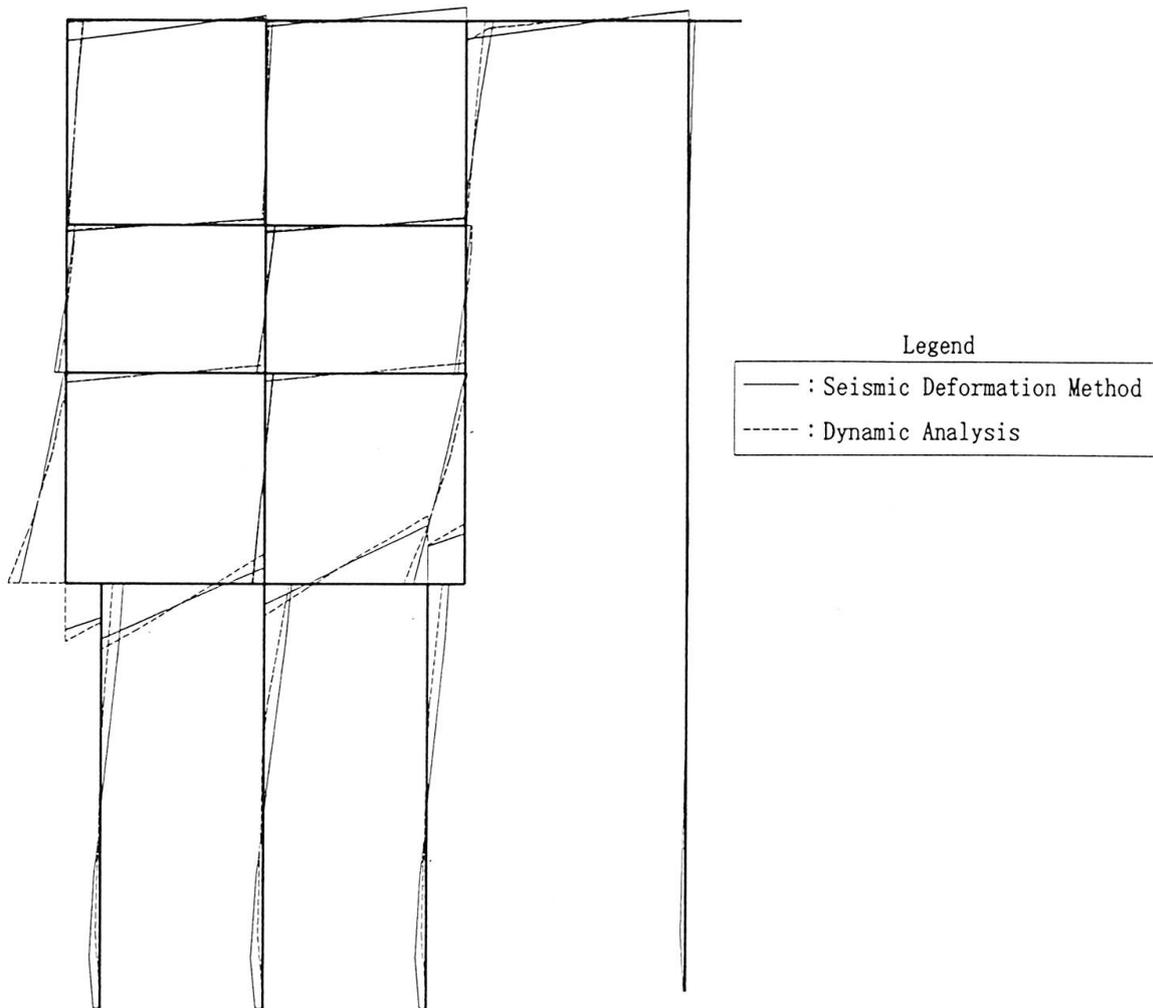
Fig.-6.3 Comparison of Bending Moment

Fig.-6.3 gives a comparison of the bending moment of analysis by the Seismic Deformation Method and the Dynamic Analysis. This shows that they are generally compatible, and the static analysis of the Seismic Deformation Method indicates that the interaction response (ground~structure, viaduct~subway tunnel~pile foundation) are generally displayed.

- 1) A comparison of the results of the Seismic Deformation Method and the Dynamic Analysis show that both methods are relatively compatible, and that the Seismic Deformation Method can almost fully display dynamic interaction (ground~structures, elevated bridge structure~excavated tunnel~pile foundation).
- 2) According to the non-linear seismic deformation method, the seismic design for large-scale earthquake loads are to secure the seismic safety as a whole structure.

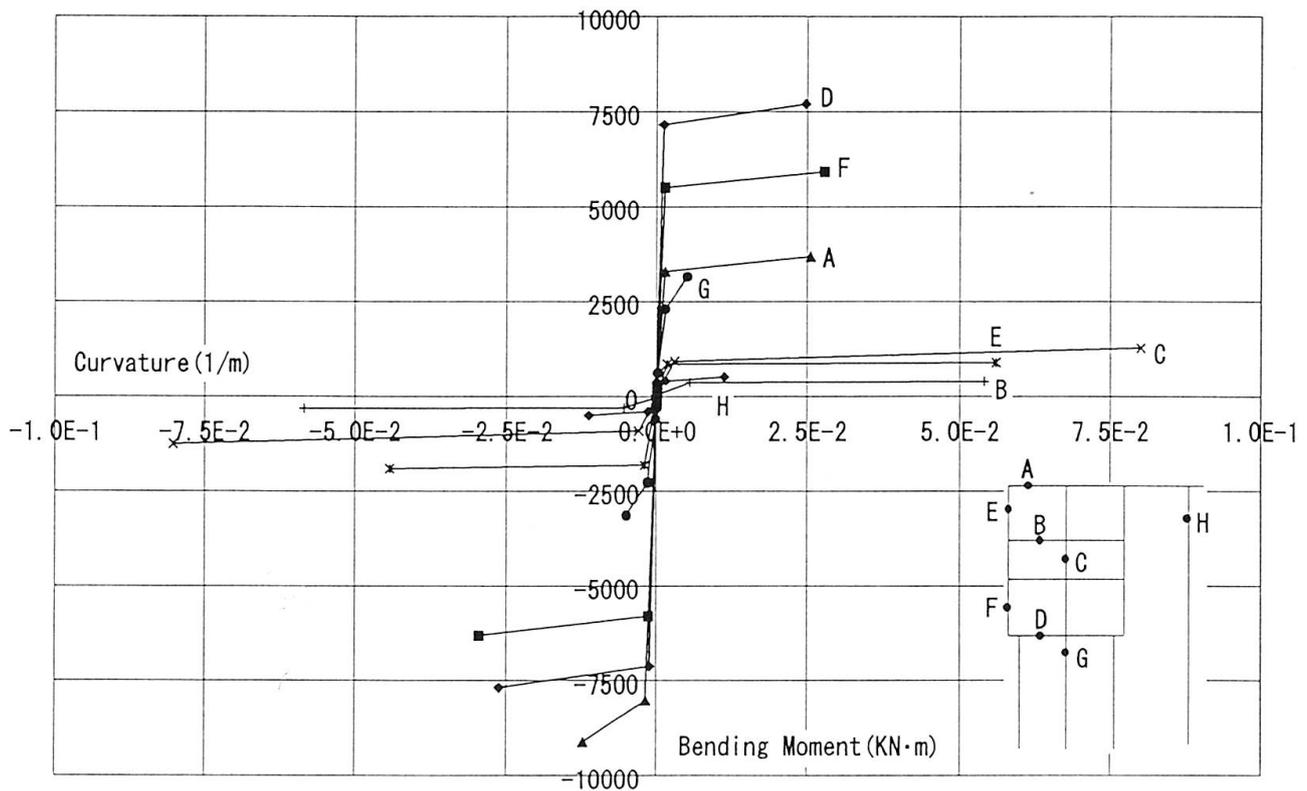
Fig.-7.1 The Characteristics for Bending Moment~Curvature

Fig.-7.1 gives the non-linear characteristics which have been obtained from References 8) and 9). The characteristics are  $M \sim \Phi$  Type (bending moment  $\sim$  curvature).

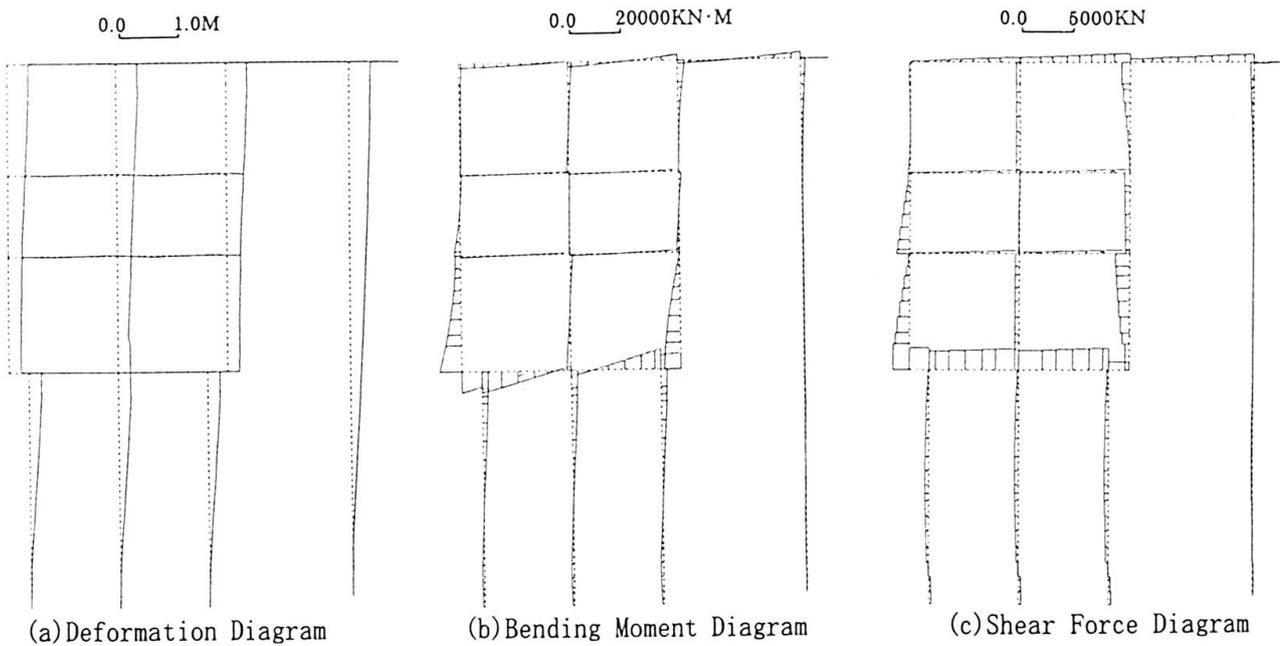
Fig.-7.2 Result of Non-linear Seismic Deformation Method

Fig.-7.2 gives a display of the displacement, bending moment, and the shear forces obtained by the non-linear seismic deformation method

The shear reinforcing steel in each member have been placed so that bending collapse will not set in ahead of shear collapse. After which, the deformation capability of side walls and center columns at each floor are evaluated by comparing the relative displacement of side walls and center columns at each floor and allowable displacement generated. In this case, the allowable displacement was determined based on reference 10). The result is given in Table.-7.1. show that the side wall and center column at each floor ensure sufficient ductility.
