Zeitschrift: IABSE reports = Rapports AIPC = IVBH Berichte
Band: 78 (1998)

Artikel: An effective and eternal maintenance method for concrete tunnel structures
Autor: Furuya, Tokiharu / Iwasa, Takayoshi / Sasajima, Yoshihiro
DOI: <https://doi.org/10.5169/seals-59068>

An effective and eternal maintenance method for concrete tunnel structures

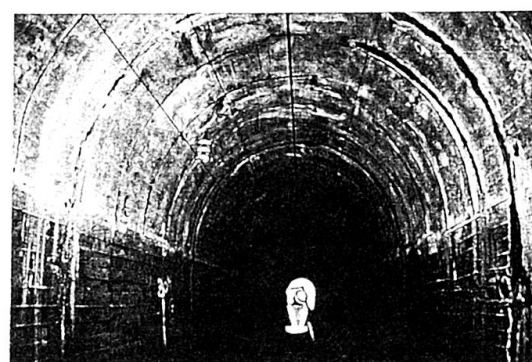
Figure 4. The surface after repair

The final process of coating on the whole surface of the lining was double coating method which applied XM on XC coating.

4 years have passed since this repair was conducted, now no water leakage and deterioration by freezing damage are observed, and the result of repair are going on quite satisfactory.
