Dynamic Tests and Monitoring of a Highway Bridge over the Danube

Jan BENCAT
Prof.
Univ. of Zilina
Zilina, Slovak Republic

Summary

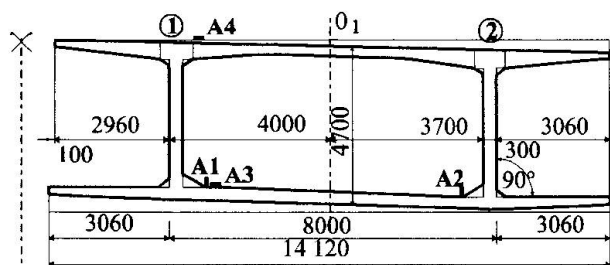
Fig. 1 Bridge cross section

The main bridge structure is composed of seven span continuous beams with one frame pier (P3). Other supports are formed by seven massive piers. The total length of the bridge is 761.0 m with spans 83.0 m + 174.0 m + 172.0 m + 4 x 83.0 m. The highway bridge consists of two independent bridges (left and right bridge -LB,RB) with three traffic lanes, on each bridge for one direction only and sidewalks on both sides. The bridge box cross-section is shown in Fig. 1 and the longitudinal section, in Fig. 2. The bridge including multispan junctions is fully described in [1].

Testing procedure and experimental analysis. The vibration amplitudes were investigated and recorded in selected points of the second and the third span, see Fig. 1, 2. The time history of vertical vibration has been registered by accelerometers (Brüel-Kjaer, BK-8306) at points 039 and 090 (A1, A2, A5, A6) on each independent bridge.

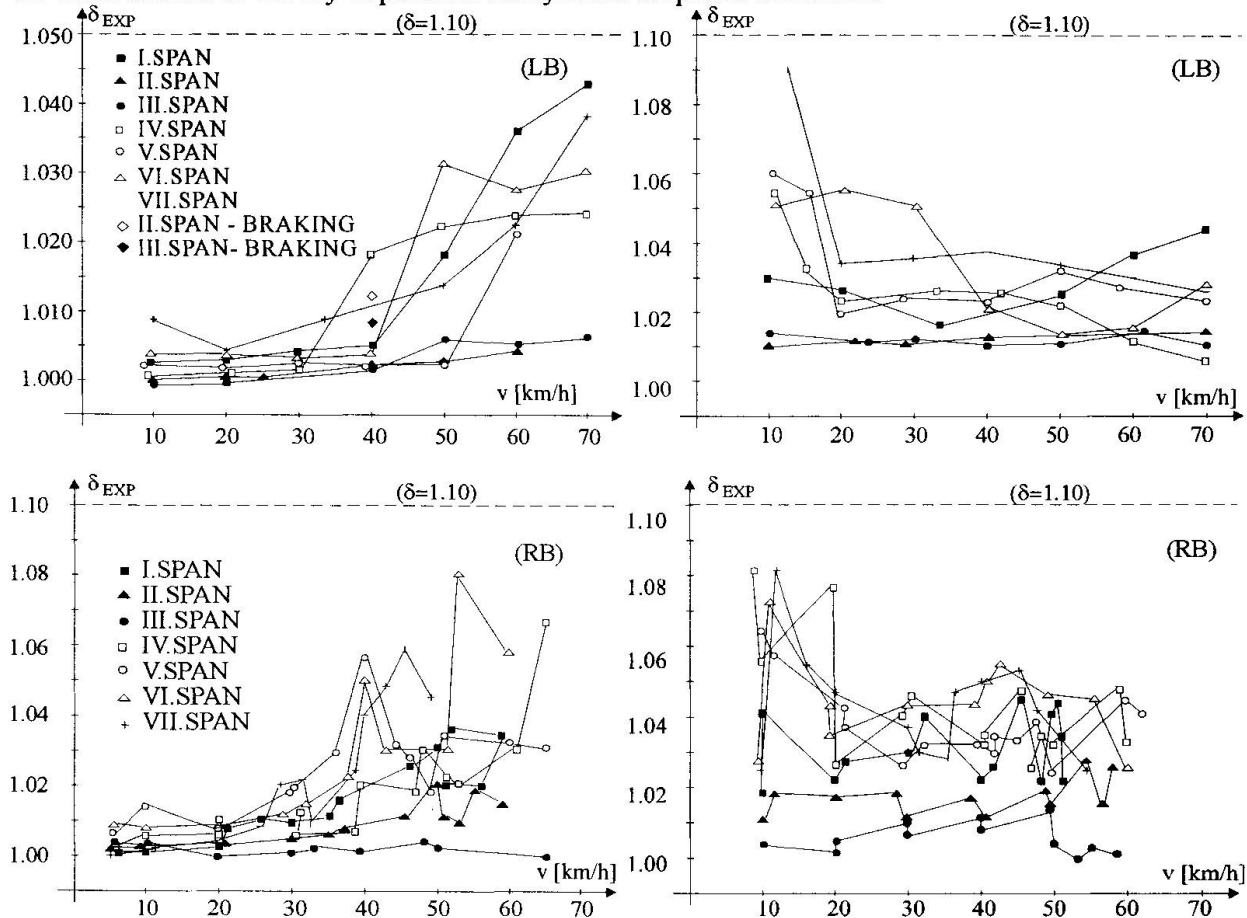
Fig. 4 DLF δ_{EXP} against vehicle velocity
- vehicle smooth passing

Fig. 5 DLF δ_{EXP} against vehicle velocity
- vehicle obstacle passing

where (see also Fig. 3), $\delta_{OBS} = w_{MAX} / w_s$ and $\eta_{DYN} = w_{DYN} / w$. The vertical static displacements at characteristic joint (012-178) due to standard live load (w) and due to testing load (w_{DYN}) have been computed by the bridge designer [1]. The calculated dynamic effectiveness η_{DYN} with theoretical and experimental values of the vertical displacements varied in the range $\eta_{DYN} = 0,09 \div 0,154$, for different span of the bridge. The dynamic load factor δ (DLF) used by the designer for the bridge under investigation according to [4] is $\delta = 1.10$, see also [1]. DLF of the experimental tests [3] are obtained from formula $\delta_{EXP} = 1 + (\delta_{OBS} - 1)\eta_{DYN}$, see also Fig. 3. The DLF against vehicle velocity are plotted in Fig. 4, 5. Natural frequencies have been obtained by using the spectral analysis from recorded responses due to various types of dynamic loading, see also Table 1. Since the accelerometers recorded only the dynamic component of vibrating structures, so we can consider those signals as an ergodic and stationary. The results of the analysis are fully described in [3]. Only two PSD are shown in Fig. 6, 7 of this paper. The comparison of theoretical (FEM) and experimental results of the natural frequencies $f(j)$ of the vibration bridge according to [3] are presented in Table 1.

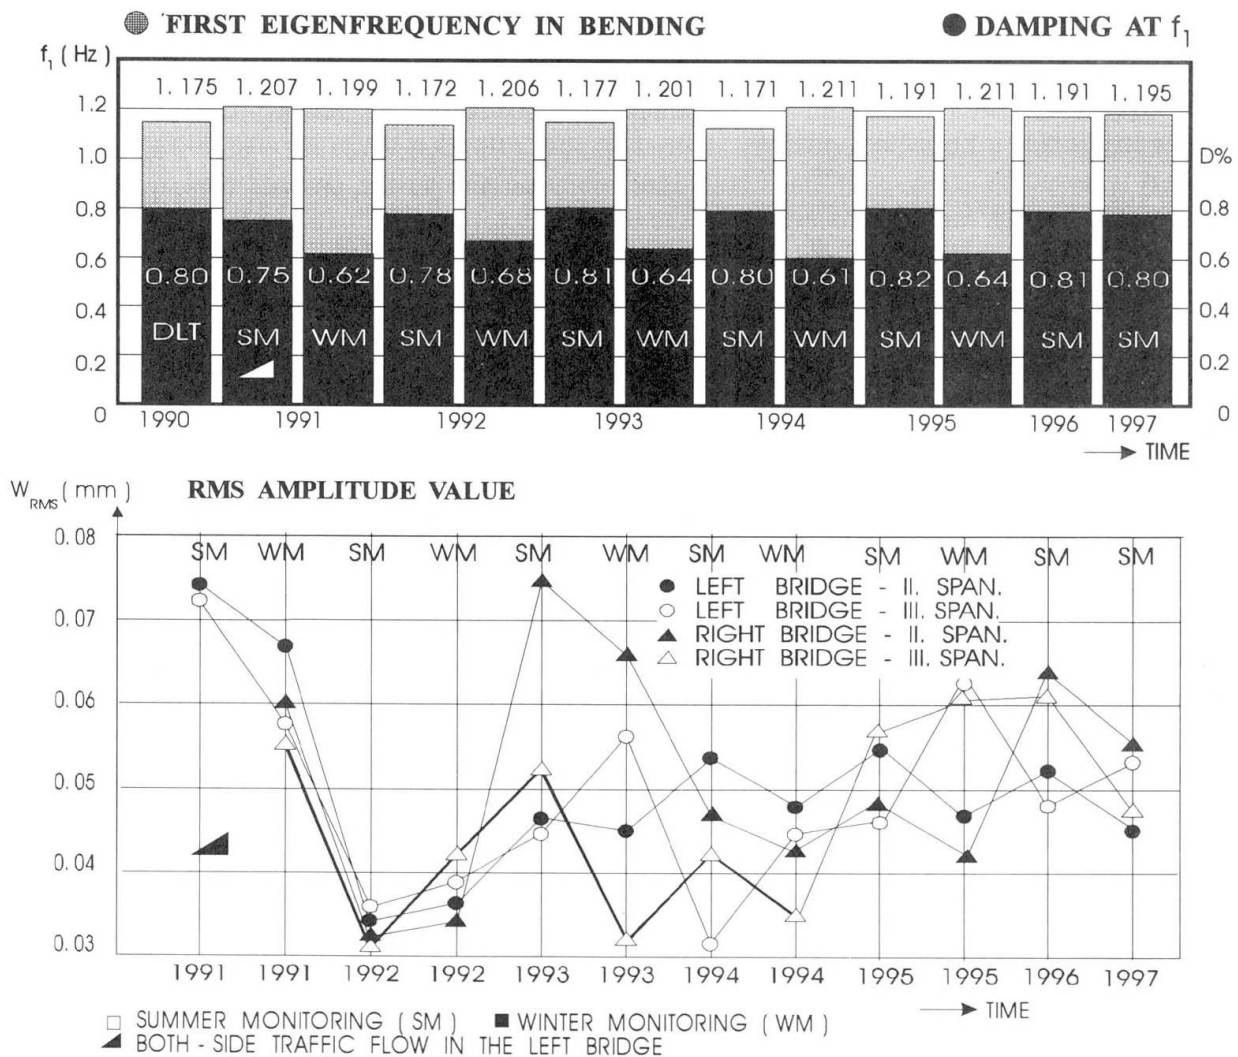
Experimental results. Results giving frequency and damping for lowest natural frequency in bending and RMS amplitude value from the monitoring tests of the bridges during whole measuring period are shown in Fig. 9. A 2.7% change in frequency is observed during a year (summer-winter) but it is systematic from one year to the next and is partly due to changes in ambient temperature. By measuring the frequency at the same time of year the changes from year to year are small and non systematic and correspond to a coefficient of variation of about 0.01. This may be considered negligible compared with the changes in natural frequency of about 30% corresponding to advanced deterioration observed in [5].

Fig.9 Changes in relative frequency, damping and displacement RMS amplitude values, 1990 - 1997

There is not the same systematic change of damping and scattering of results is big. What causes these changes is not clarified. There are changes in the temperature during the day. This may give changes in length of bridge which can influence support conditions and damping. Windspeed, water level, ambient relative humidity and temperature gradients through the deck, transport in the bridge deck, in particular at the surface, and may there by also change damping [6],[7].

There is a difference of the displacement amplitude RMS value measured in may 1991 in comparison with other measurements results. It was maybe caused by both-side motor traffic flows on the left bridge. All the following measurements were performed in conditions of the one side traffic flow on each of the two bridges La Franconi. The changes of the amplitude RMS value is caused mainly by changes of the intensity of the regular motor traffic.
