Artikel: Reconstruction of the Benten Viaduct after the 1995 earthquake

Reconstruction of the Benten Viaduct after the 1995 Earthquake

"Benten Viaduct" is a reconstructed bridge of Hanshin Expressway Kobe Route, which was suffered from the Hanshin/Awaji Earthquake seriously. This section had been consisted of 8 bridges before the earthquake and revived as an innovative structure, 19-span continuous rigid frame bridge with seismic isolators installed underneath the steel piers. This paper reports the outline of the seismic isolation design and techniques on the field for this innovative bridge structure, comparing the result of analysis with that of vibration experiment applied onto the actual bridge structure.

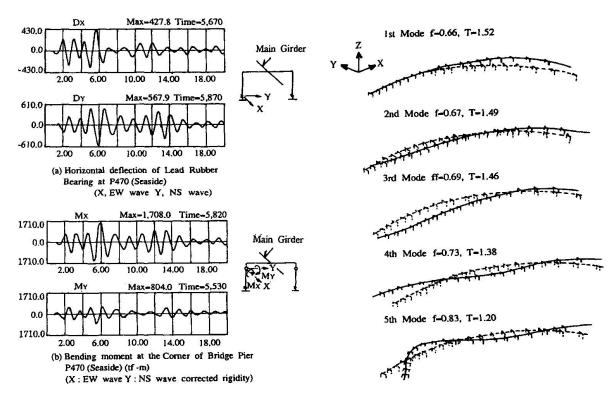
Fig. 4 An Example of Response Analysis
On Time History

The time histories were exemplified in the Figure 4 for the response in the horizontal deflection of the seismic isolator and the bending moment at the beam joint at P470. Maximum deflections were 428mm in the longitudinal direction of bridge and 568mm in the transverse direction, which were observed after 6 seconds from the beginning of earthquake.

The results of natural vibration analysis on the entire model is shown on Figure 5 and all up to 5th modes shows inherent mode of horizontal direction. From the result of natural vibration analysis applied on a plane model, the mode for horizontal move at the bearing position is so remarkable that the similar tendency may be seen in a three dimensional model.

Fig. 5 Results of Natural Vibration Analysis

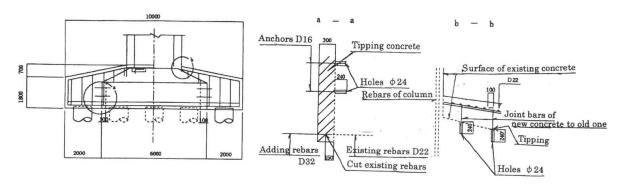
Fig 6 Reinforcement of Pile and Footing

Before the reconstruction project, bearing capacity (qd) of existing pile foundation was researched by means of corn penetrating test. Bearing capacity of 300 to 600 tf/m² was confirmed in most part, however, there still found some foundations which had only 150 tf/m² of qd. Therefore, these foundations had to be reinforced with adding piles, and the number of them were fourteen, which was 30% of the foundations among Benten section.

Also, the reinforced bars were jointed to the existing ones by means of enclosed arc welding. Details of reinforcement of footing are shown in figure 6.

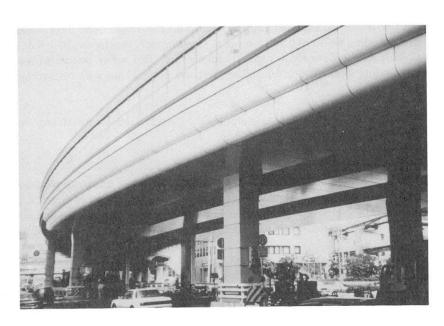
Photo. 4 Complete Structure of Benten Viaduct

Benten Viaduct also has aesthetic cover plates beneath the girder because Kobe municipal government had a plan to develop Benten section into a recreational area.

And more, advanced noise absorbers were adopted like other restored part of Kobe Route. It was installed on top of noise barriers to get the same effect as making noise barriers 1.5 to 2.0 higher.
