Zeitschrift: IABSE reports = Rapports AIPC = IVBH Berichte
Band: 79 (1998)

Artikel: Reconstruction of the Benten Viaduct after the 1995 earthquake
Autor: Hayashida, Mitsuhiro / Hayashi, Hidenao / Kawakita, Shiro
DOI: <https://doi.org/10.5169/seals-59867>

Reconstruction of the Benten Viaduct after the 1995 Earthquake

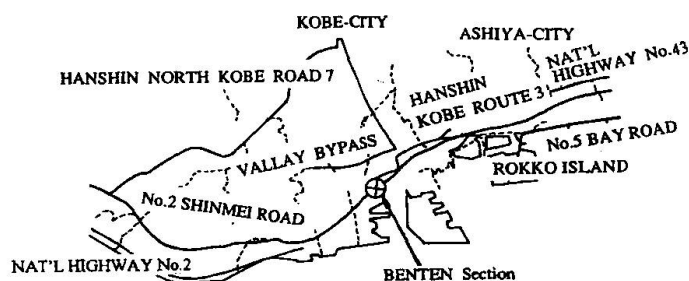
Fig. 1 Location

The Hanshin/Awaji Earthquake occurred on January 17, 1995, caused tremendous damage on the Hanshin Expressway Kobe Route, especially at Benten section (referred in Figure 1). The reconstructed bridge, “Benten Viaduct”, was determined to be the 19-span continuous rigid frame with steel deck along with the installation of seismic isolator. The general view of structure is shown in Figure 2.

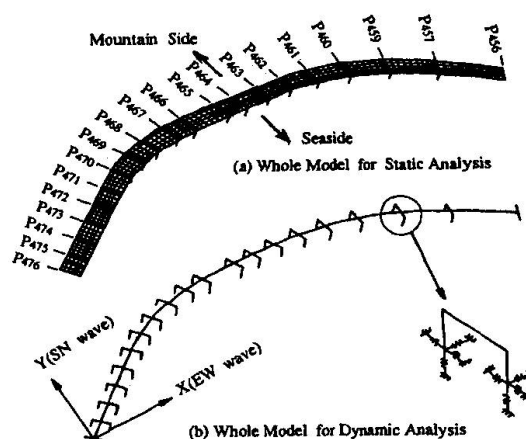
Fig. 3 Entire Models for Analysis

According to the strategy above, it was decided to adopt a continuous rigid frame. It was supposed that the additional piling reinforcement was needed for rigid connection or for hinge connection and finally it was concluded to adopt the structure of installing seismic isolation bearing on the foundation (referred in Table 1). Since the Benten Viaduct is warped to the seaside and the overhang length of cross beams differs slightly, analysis was made on the entire structural model of the two types shown on Figure 3.

In static analysis model (a) in the Figure 3 was used. The superstructure consisted of main girders, beams, and piers which was supported by the two way horizontal spring as well as perpendicular and rotational ones. The characteristic of isolator is expressed in natural period (T) and the ratio of yield point load (Q_d/W_u)[2]. In order to give an appreciate initial coefficient of bearing reaction for the static analysis model, the period and the ratio of yield point load were decided by applying a representative bridge pier that would satisfy the following three design objects.

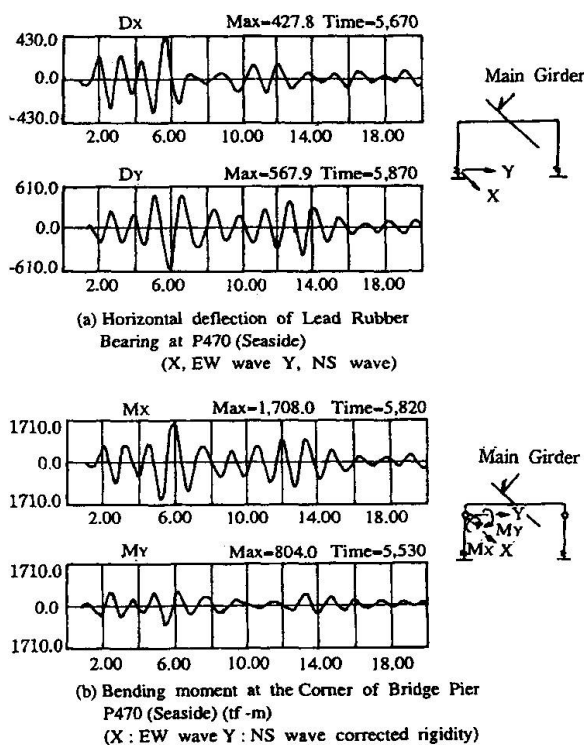
Fig. 4 An Example of Response Analysis
On Time History

The time histories were exemplified in the Figure 4 for the response in the horizontal deflection of the seismic isolator and the bending moment at the beam joint at P470. Maximum deflections were 428mm in the longitudinal direction of bridge and 568mm in the transverse direction, which were observed after 6 seconds from the beginning of earthquake.

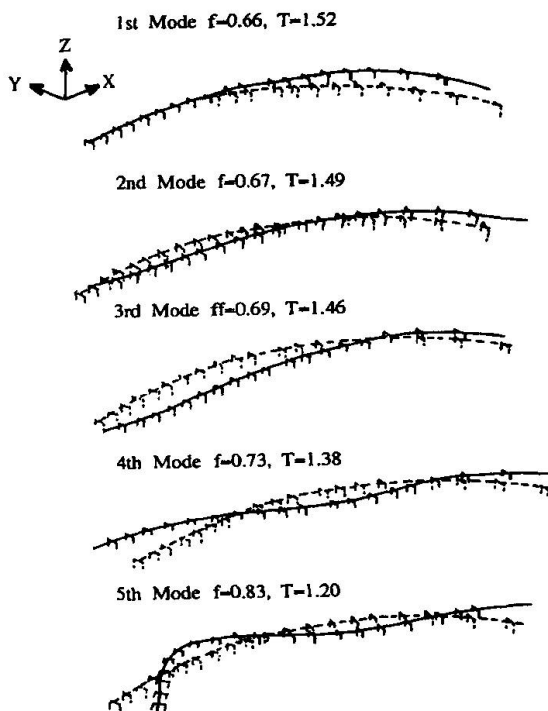
Fig. 5 Results of
Natural Vibration Analysis

The results of natural vibration analysis on the entire model is shown on Figure 5 and all up to 5th modes shows inherent mode of horizontal direction. From the result of natural vibration analysis applied on a plane model, the mode for horizontal move at the bearing position is so remarkable that the similar tendency may be seen in a three dimensional model.

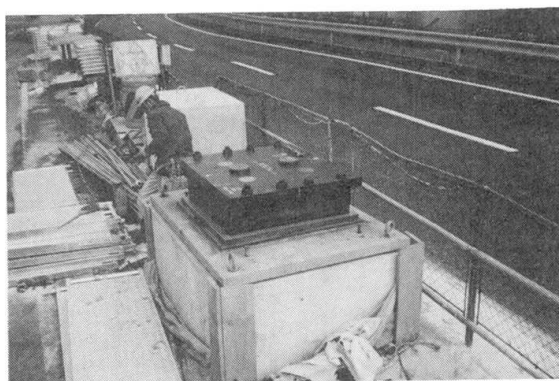
Photo. 1 Seismic Isolation Bearing

Benten Viaduct has so much dimension of statically indeterminate that LRB was supposed to be more effective than HDR, because it is softer on various temperature range and harder under strong earthquake force. Each LRB bearings was designed in the same height nevertheless the difference of their design load in order to make the deformation characteristics regular. The appearance of seismic isolation bearing is shown in Photograph 1.

Seismic isolation bearing was designed referring to the “Manual of Isolation Design for Highway Bridge.” There are two types of seismic isolator, LRB (Lead Rubber Bearing) and HDR (High Dumping Rubber). LRB is a laminated-rubber bearing concluding lead plugs inside to give bi-linear deformation characteristic, while HDR is made of laminated super elastic gum.

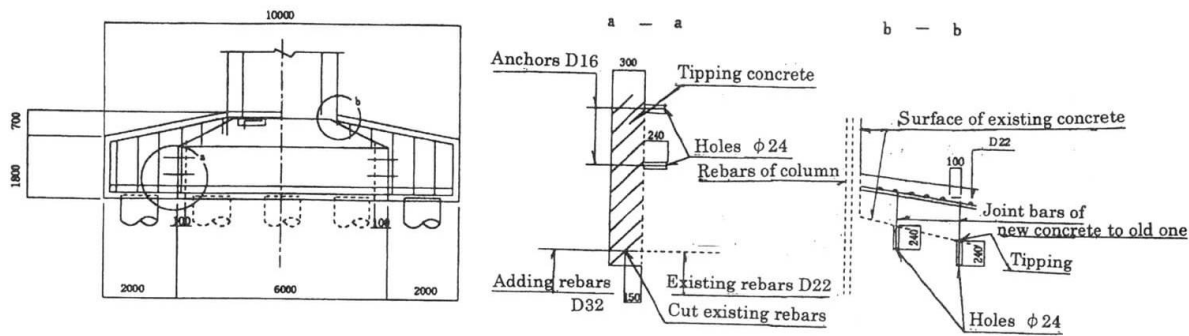
Fig 6 Reinforcement of Pile and Footing

Also, the reinforced bars were jointed to the existing ones by means of enclosed arc welding. Details of reinforcement of footing are shown in figure 6.

Before the reconstruction project, bearing capacity (q_d) of existing pile foundation was researched by means of cone penetrating test. Bearing capacity of 300 to 600 tf/m^2 was confirmed in most part, however, there still found some foundations which had only 150 tf/m^2 of q_d . Therefore, these foundations had to be reinforced with adding piles, and the number of them were fourteen, which was 30% of the foundations among Benten section.

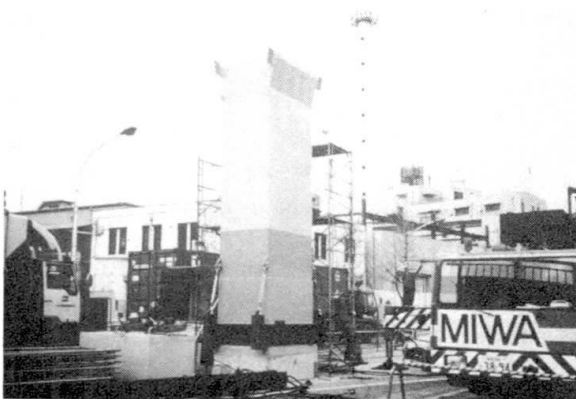
Photo. 2 Stabilizer System

The steel piers were unstable on the soft seismic isolation bearings until they formed a three-dimension rigid frame. In the field work, a stabilizer system were invented as shown in photograph 2. This system was introduced to stabilize the columns before the erection of girder and deck, and it could save the accuracy of piers and bearings also. The stabilizer was designed to have a temporary horizontal bearing capacity against 0.15G.

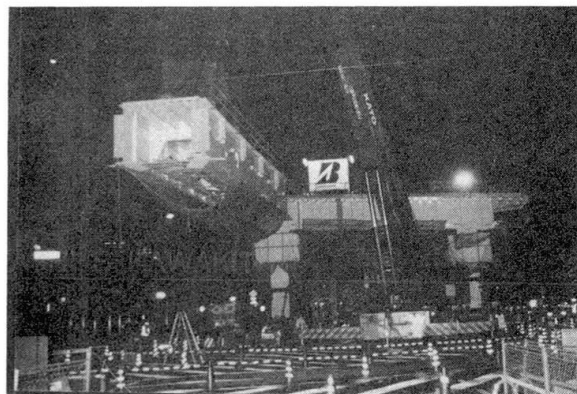
Photo. 3 Erection of Girder and Deck

The length of Benten Viaduct is as much as 686m, which causes $\pm 28\text{mm}$'s expansions at both ends from the difference of temperature of ± 10 degrees centigrade. To keep an adequate accuracy of erection, columns and cross beams were built up first. After that, plate girders with steel deck were erected measuring and correcting the errors at each pier points. The accuracy of erection was finally found to be less than 5 mm at the isolators point.

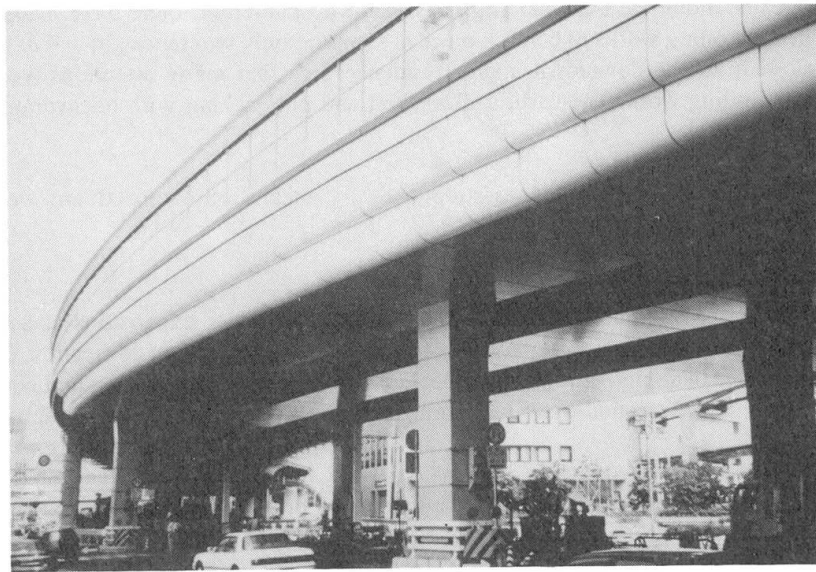
Photo. 4 Complete Structure of Benten Viaduct

Benten Viaduct also has aesthetic cover plates beneath the girder because Kobe municipal government had a plan to develop Benten section into a recreational area.

And more, advanced noise absorbers were adopted like other restored part of Kobe Route. It was installed on top of noise barriers to get the same effect as making noise barriers 1.5 to 2.0 higher.

Benten Viaduct is a long continuous rigid frame bridge which is expected never to fail again. The bridge also has a dumping function against the vibration of earthquake. Besides multiple earthquake restrainers were recommended by the specification [4] by the Ministry of Construction in 1995.
