Establishment of Foundation Design Parameters for Limestone

Tove Feld and S. Juel Petersen

1 THE ØRESUND LINK PROJECT

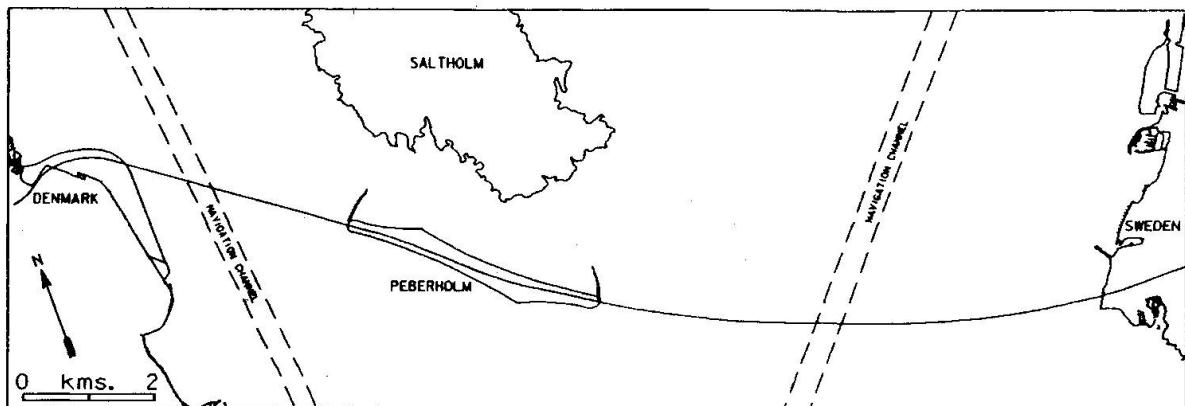
Fig.1 Alignment for the Øresund Link between Denmark and Sweden

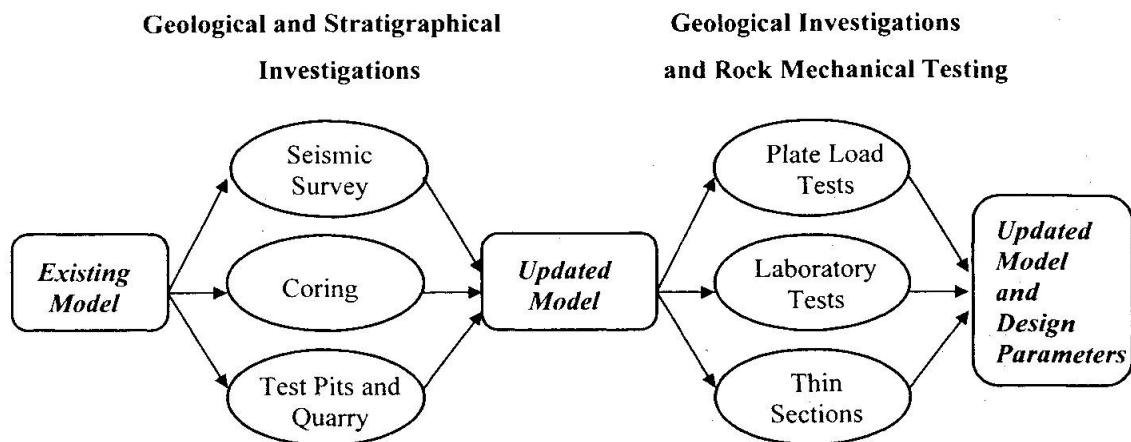
Fig. 2 Methodology for Establishment of Geology and Parameters

Based upon existing knowledge about the geology and the stratigraphy of the Link Area, an Existing Model, ref. Fig.2, for the geology was established. Via this Existing Model additional geological and stratigraphical investigations were planned and executed. These investigations constituted reflection seismic and refraction seismic surveys and borehole logging for assessment of the stratigraphy, performance of core drillings for collection of samples for geological and rock mechanical description and performance of coccolith analysis, and performance of test pits inland on the Danish side, in the Sound and inland on the Swedish side, and investigations of a limestone quarry on the Swedish side. The test pits were performed to extrapolate the detailed investigations in the Sound. These investigations resulted in an Updated Model, ref. Fig.2, for the geology and the stratigraphy. To further assess the rock mechanical parameters and the foundation design parameters for the Copenhagen Limestone large size plate load tests, 0.5 m size laboratory tests and thin sections analysis of the limestone were performed. This finally led to the Updated Model and the Design Parameters for the Copenhagen Limestone. The process and the various activities within the process is presented schematically in Fig. 2., and described in further details below.

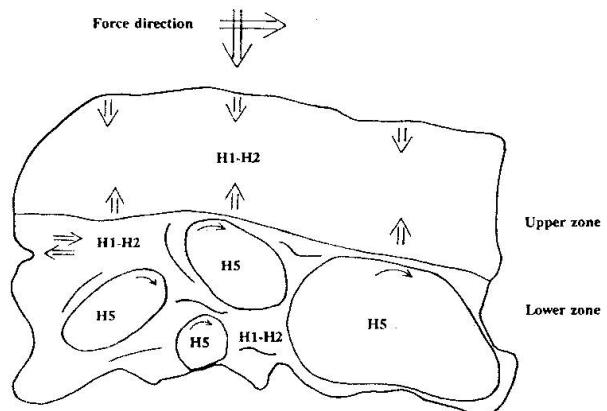
Fig. 4 Principal Sketch of Limestone Sample.

shells and more indurated limestone parts, ductile flow and the directions of deformations of the material within the samples, as depicted in Fig. 4. In the analysis comparisons were made, both between the reference samples and the sheared samples, and within each individual sheared sample. This study provided the information that for slightly indurated limestone without any content of hard nodules, the limestone will experience a reduction of the porosity leading to a stronger material which eventually will endure a higher failure load than limestone with some content of hard nodules. The explanation is that the nodules will prevent the compaction of the limestone during shearing, leading to unchanged strength parameters for the slightly indurated material, and to movement of the nodules which will further cause fissures to open and to destabilize the material. This leads to a comparatively lesser bearing capacity of the material with the content of nodules.

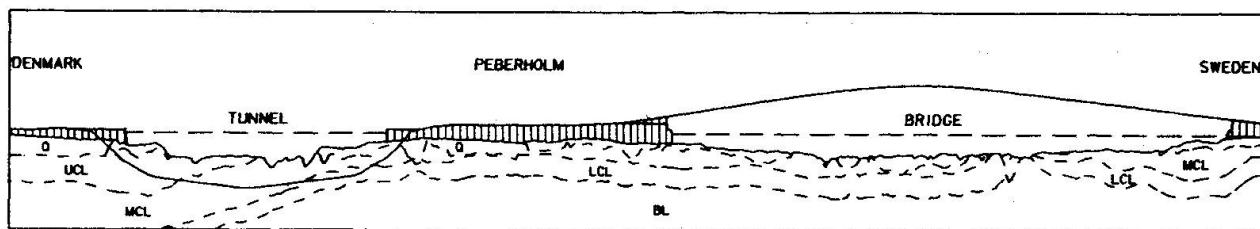
Q = Quaternary/UCL = Upper Copenhagen Limestone/MCL = Middle Copenhagen Limestone/LCL = Lower Copenhagen Limestone/BL = Bryozoan

Fig. 5 Longitudinal Profile of the Geological Section of the Øresund Link Alignment.

The Copenhagen Limestone can be subdivided into three stratigraphical subunits, named Upper, Middle and Lower Copenhagen Limestone, the variation and location of the subunits are shown in Fig. 5.

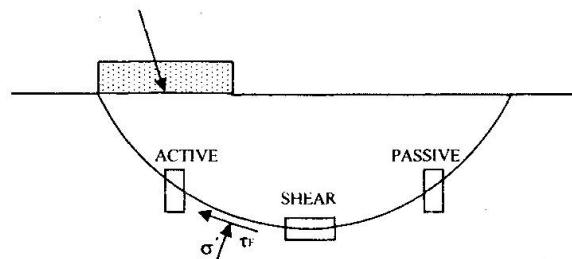
Fig. 6 Principal Failure Conditions

In Fig. 6 the principal failure conditions in the mechanism are depicted. This failure surface has previously been introduced [1].

The shear strength at any part of the failure surface can be given by: $\tau_F = c' + \sigma' \cdot \tan \phi'$.
