Establishment of Foundation Design Parameters for Limestone

For the establishment of the design parameters for the foundation design for the stay bridge and the immersed concrete tunnel for the 15 km long Øresund Link Project between Sweden and Denmark, a geological model was first established. The geological model included the method of deposition of the Copenhagen Limestone, and was developed assisted by seismic profiling, boreholes, geophysical borehole logging and visits to quarries.

1 THE ØRESUND LINK PROJECT

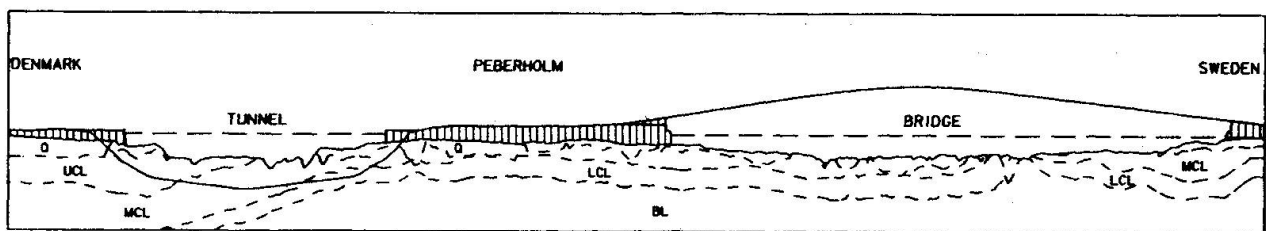
Fig. 5 Longitudinal Profile of the Geological Section of the Øresund Link Alignment.

The Copenhagen Limestone can be subdivided into three stratigraphical subunits, named Upper, Middle and Lower Copenhagen Limestone, the variation and location of the subunits are shown in Fig. 5.

Q = Quaternary/UCL = Upper Copenhagen Limestone/MCL= Middle Copenhagen Limestone/LCL=Lower Copenhagen Limestone/BL=Bryozoan

The degrees of induration varies from unlithified to very strongly indurated, due to varying degree of calcite cementation and silicification. The strongly indurated limestone typically occurs as 0.2-0.4 m thick layers intersected by less indurated rock, however benches up to 1.5 m have been found, as have flint layers typically of a 0.5 m thickness. At some locations, the upper part of the limestone series, has been disturbed by glacial processes.

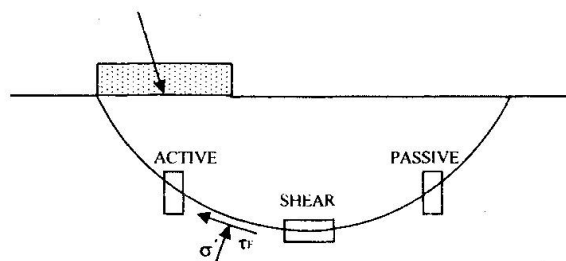
Fig. 6 Principal Failure Conditions

In Fig. 6 the principal failure conditions in the mechanism are depicted. This failure surface has previously been introduced [1].

The shear strength at any part of the failure surface can be given by : $\tau_F = c' + \sigma' \cdot \tan \phi'$.

From the insitu plate load tests performed at Lernacken [4] it became evident that the failure mechanism of the limestone could be divided into active, shear and passive failure conditions, as illustrated in Fig. 3.
