## Establishment of Foundation Design Parameters for Limestone

## **SUMMARY**

## 1 THE ØRESUND LINK PROJECT

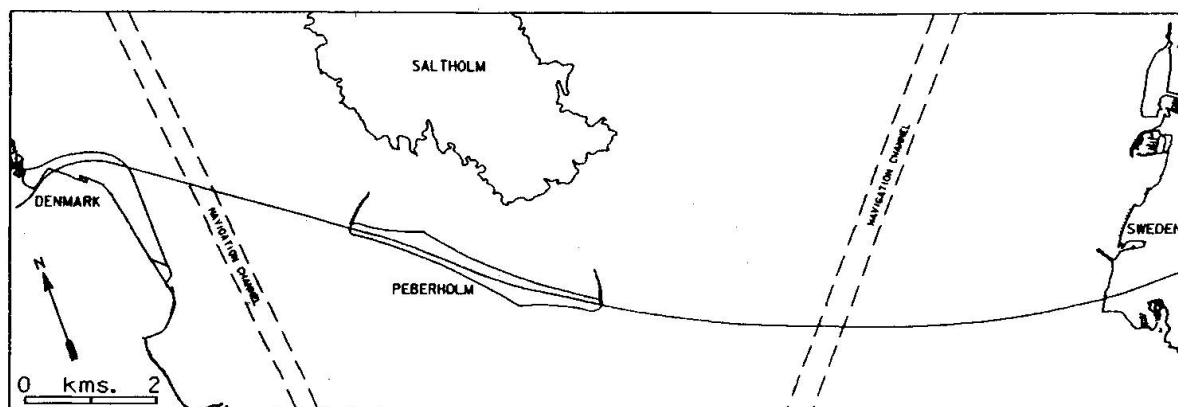
Fig.1 Alignment for the Øresund Link between Denmark and Sweden

The fixed link comprises a 3510 m long immersed tunnel, a 4055 m long artificial island and a high bridge and approach bridges of a total length of 7845 m. The combined road and rail link is scheduled to open for traffic in the year 2000.

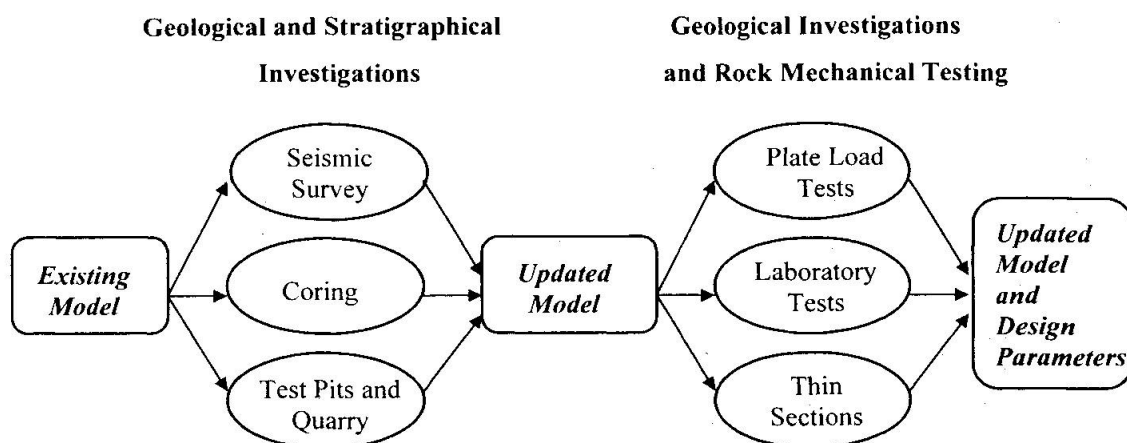
Based upon existing knowledge about the geology and the stratigraphy of the Link Area, an Existing Model, ref. Fig.2, for the geology was established. Via this Existing Model additional geological and stratigraphical investigations were planned and executed. These investigations constituted reflection seismic and refraction seismic surveys and borehole logging for assessment of the stratigraphy, performance of core drillings for collection of samples for geological and rock mechanical description and performance of coccolith analysis, and performance of test pits inland on the Danish side, in the Sound and inland on the Swedish side, and investigations of a limestone quarry on the Swedish side. The test pits were performed to extrapolate the detailed investigations in the Sound. These investigations resulted in an Updated Model, ref. Fig.2, for the geology and the stratigraphy. To further assess the rock mechanical parameters and the foundation design parameters for the Copenhagen Limestone large size plate load tests, 0.5 m size laboratory tests and thin sections analysis of the limestone were performed. This finally led to the Updated Model and the Design Parameters for the Copenhagen Limestone. The process and the various activities within the process is presented schematically in Fig. 2., and described in further details below.

Fig. 2 Methodology for Establishment of Geology and Parameters

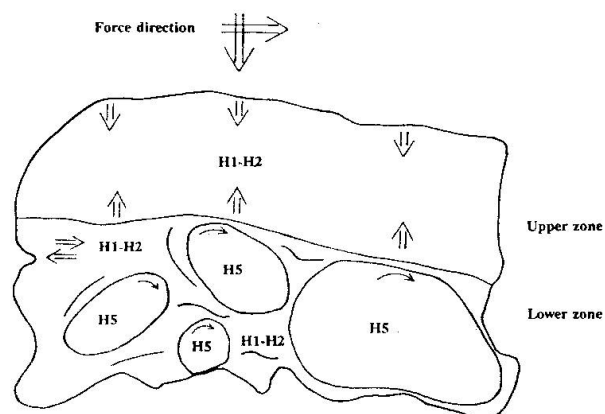
Fig. 4 Principal Sketch of Limestone Sample.

shells and more indurated limestone parts, ductile flow and the directions of deformations of the material within the samples, as depicted in Fig. 4. In the analysis comparisons were made, both between the reference samples and the sheared samples, and within each individual sheared sample. This study provided the information that for slightly indurated limestone without any content of hard nodules, the limestone will experience a reduction of the porosity leading to a stronger material which eventually will endure a higher failure load than limestone with some content of hard nodules. The explanation is that the nodules will prevent the compaction of the limestone during shearing, leading to unchanged strength parameters for the slightly indurated material, and to movement of the nodules which will further cause fissures to open and to destabilize the material. This leads to a comparatively lesser bearing capacity of the material with the content of nodules

To study the physics of the limestone at failure, both undisturbed reference samples and samples of material subjected to shearing at the plate bearing tests were extracted, ref [3] and [5]. Both the reference samples and the sheared samples were impregnated under vacuum by epoxy, to stabilize the samples and to enable a microscopic study of thin sections under UV-light. In the microscopic study the following subjects were analyzed: changes of the porosity, fissures and patterns of fissures, fissuring and movements of

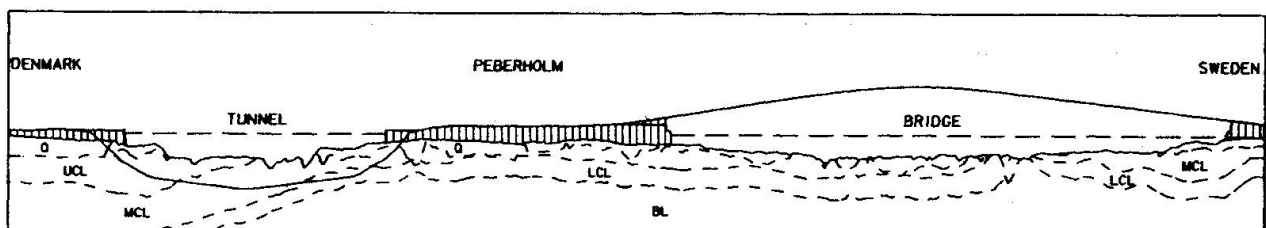
The Copenhagen Limestone can be subdivided into three stratigraphical subunits, named Upper, Middle and Lower Copenhagen Limestone, the variation and location of the subunits are shown in Fig. 5.

Q = Quaternary/UCL = Upper Copenhagen Limestone/MCL= Middle Copenhagen Limestone/LCL=Lower Copenhagen Limestone/BL=Bryozoan

Fig. 5 Longitudinal Profile of the Geological Section of the Øresund Link Alignment.

The subunits were identified and mapped through stratigraphical studies based on the geological description of core samples and samples from test pits, supplemented by geophysical logs and reflection seismic [2].

The degrees of induration varies from unlithified to very strongly indurated, due to varying degree of calcite cementation and silicification. The strongly indurated limestone typically occurs as 0.2-0.4 m thick layers intersected by less indurated rock, however benches up to 1.5 m have been found, as have flint layers typically of a 0.5 m thickness. At some locations, the upper part of the limestone series, has been disturbed by glacial processes.

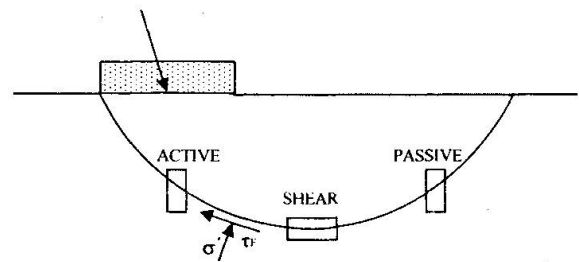
In Fig. 6 the principal failure conditions in the mechanism are depicted. This failure surface has previously been introduced [1].

The shear strength at any part of the failure surface can be given by :  $\tau_f = c' + \sigma' \tan \phi'$ .

Fig. 6 Principal Failure Conditions

From the insitu plate load tests performed at Lernacken [4] it became evident that the failure mechanism of the limestone could be divided into active, shear and passive failure conditions, as illustrated in Fig. 3.
