Zeitschrift:	Cahiers d'archéologie romande
Herausgeber:	Bibliothèque Historique Vaudoise
Band:	160 (2016)
Artikel:	The charterhouse of Roermond and its urban setting and development
Autor:	Dukers, Birgit
DOI:	https://doi.org/10.5169/seals-835656

The Charterhouse of Roermond and its Urban Setting and Development

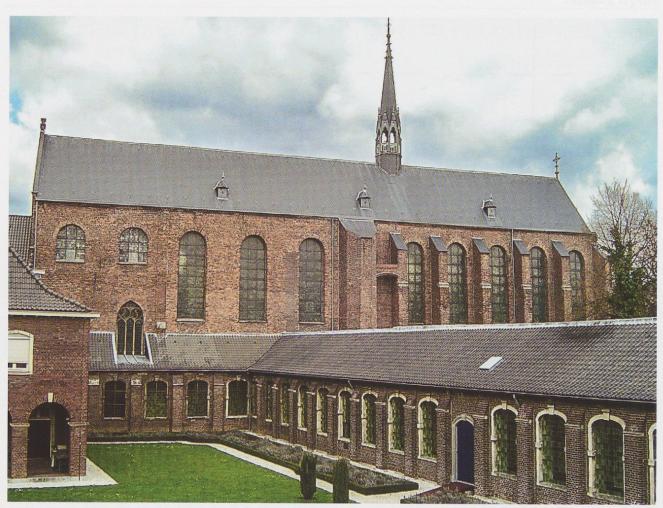
Fig. 1 - The church and cloisters of the charterhouse of Roermond. B. Dukers.

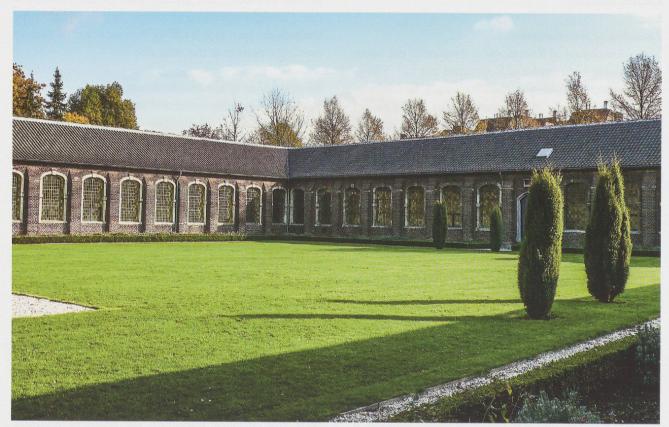
Fig. 2 - The cloisters (renovated 1750). B. Dukers.

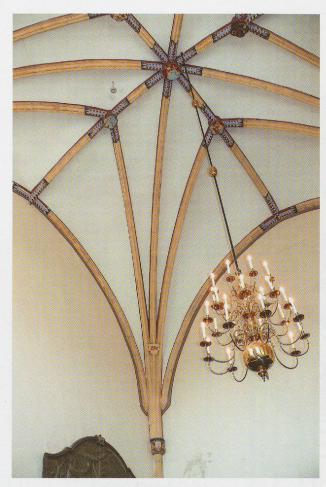
Fig. 3 - Stone vault of the chapter house (1556). B. Dukers.

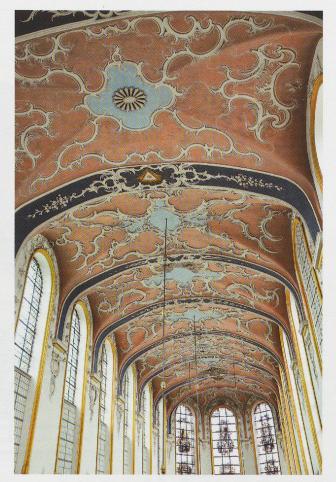
Fig. 4 - Stucco vaults of the church (ca. 1750). B. Dukers.

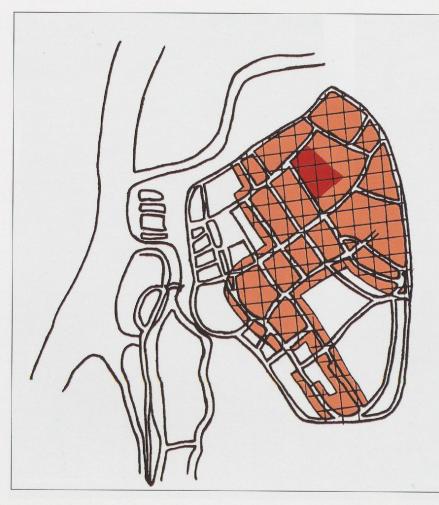
Fig. 5 - City plan of Roermond and extent of the city fire of 1554 (the charterhouse in red). J.G.C. Venner/B.Dukers.

The charterhouse was damaged by city fires in 1554 and 1665 (Fig. 5 and 6). Also some neighbouring houses at the Voogdijstraat are damaged or burned down. Archival documents show that in the course of time the Carthusians bought most plots along the Voogdijstraat, destroyed the buildings and added the plots their garden, so that by the end of the seventeenth century their cloister garden completely enclosed the *claustrum maior* and the monks' cells. The garden had a

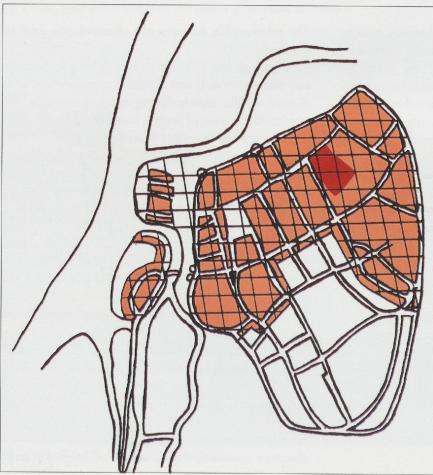
Fig. 6 - City plan of Roermond and extent of the city fire of 1665 (the charterhouse in red). J.G.C. Venner/B.Dukers.

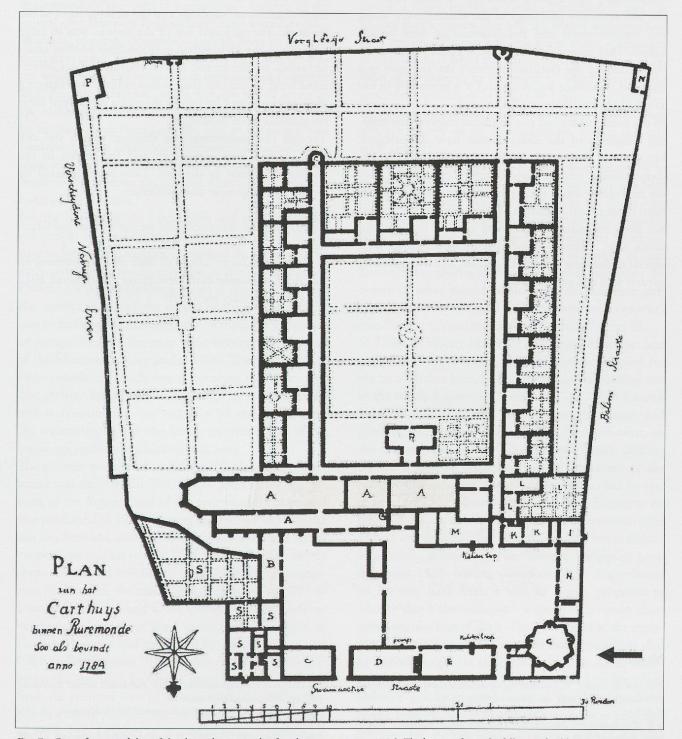
Fig. 7 - Copy of a groundplan of the charterhouse, made after the suppression in 1784. The letters refer to the following buildings: A church, chapterhouse and refectory - B coach house - C stables - D brewery and kitchen - E guesthouse - F sacristy - G Bethlehem chapel - H laybrothers' quarters - I parlour - K cell of the procurator - L cell of the prior - M monks' kitchen - N orangerie - P barn Gemeentearchief Roermond.

A drawing of the ground plan of the complex, made after its dissolution in 1784, gives a good overview of the charterhouse in its 'final' form, that must have been quite similar to the original layout. It shows that the complex consisted of three zones. First there was the more public area, close to the Swalmerstraat. Here were the entrance buildings, lay brothers' quarters, guest quarters (possibly combined with the hospital),

of the buildings, their ground plan, inhabitants and furniture. The ground plan (Fig. 7) shows that the territory of the charterhouse had been enlarged as to two third of the building block. Soon after the dissolution all the monks' cells and the Bethlehem chapel were demolished. In 1786 the Norbertine nuns of St. Gerlach moved into the remaining buildings. When the French arrived in Roermond in 1798, they were forced to leave the monastery, but the nuns bought their property back and remained until 1841. The complex was then transformed into a priest seminary. In 1923 many of the old economy buildings of the charterhouse along the Swalmerstraat and Bethlehemstraat were demolished. They were rebuild to house priest students. In the middle of the twentieth century the complex was changed into office buildings and it is nowadays in use as office of the diocese of Roermond.
