**Artikel:** Days of Wine and Saurers

# Days of WINE AND SAURERS

ARTICLE BY  
PAUL TOL

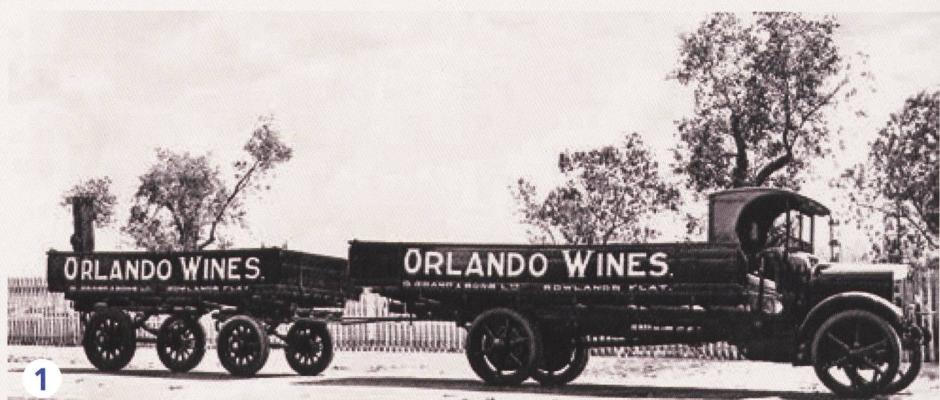
▲ The new Saurer with its trailer is ready to go to work. This photograph was taken on North Terrace, Adelaide, prior to being driven to Rowland Flat - date unknown. © Gramp Family

life. From the photograph, it is clear that the windscreen, cab ('C' type), and rear body would have been locally made with the Saurer coming into Adelaide as a 'chassis/cowl'. The attached trailer would also have been made locally, and in all probability, by the same local motor body builder.

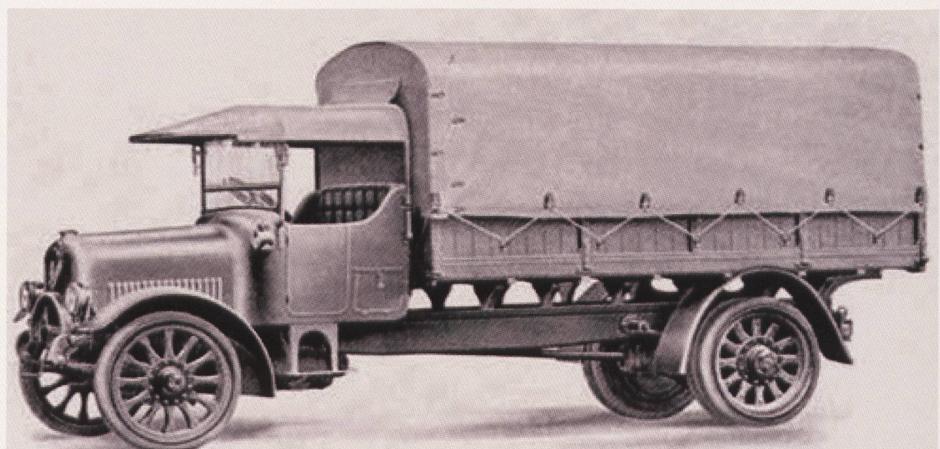
▲ The Saurer A Type, first released in 1917. The truck could be ordered with solid or pneumatic tyres. © Archive of Saurer Museum in Arbon.

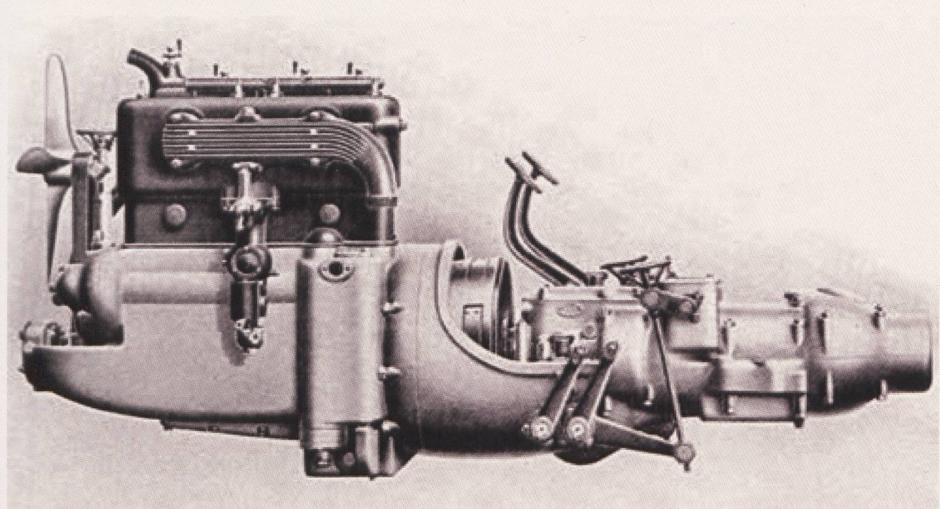
**The engine was Saurer's AD type, with the following brief specifications:**

**Bore:** 110mm

**Stroke:** 180mm

**Output:** 40bhp @1,000rpm, maximum engine speed 1,250rpm. Fitted with Saurer's patented engine brake

**Fuel:** Petrol, fuelled through Saurer's patented two nozzle carburettor

▲ The left-hand side view of the AD type petrol engine, bell housing and transmission assembly. The clutch is a cone type. © Archive of Saurer Museum in Arbon

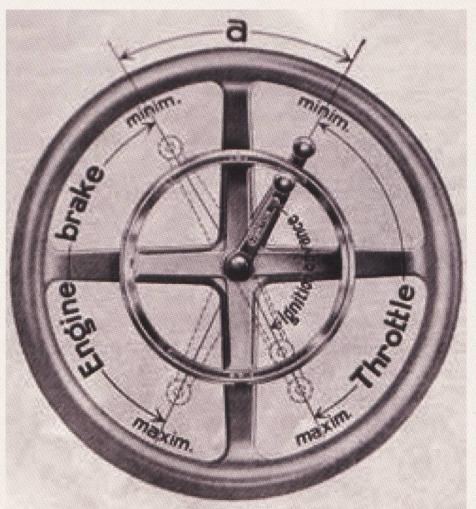
▲ The throttle and engine brake control lever is mounted on the Saurer's steering wheel. © Archive of Saurer Museum, Arbon.

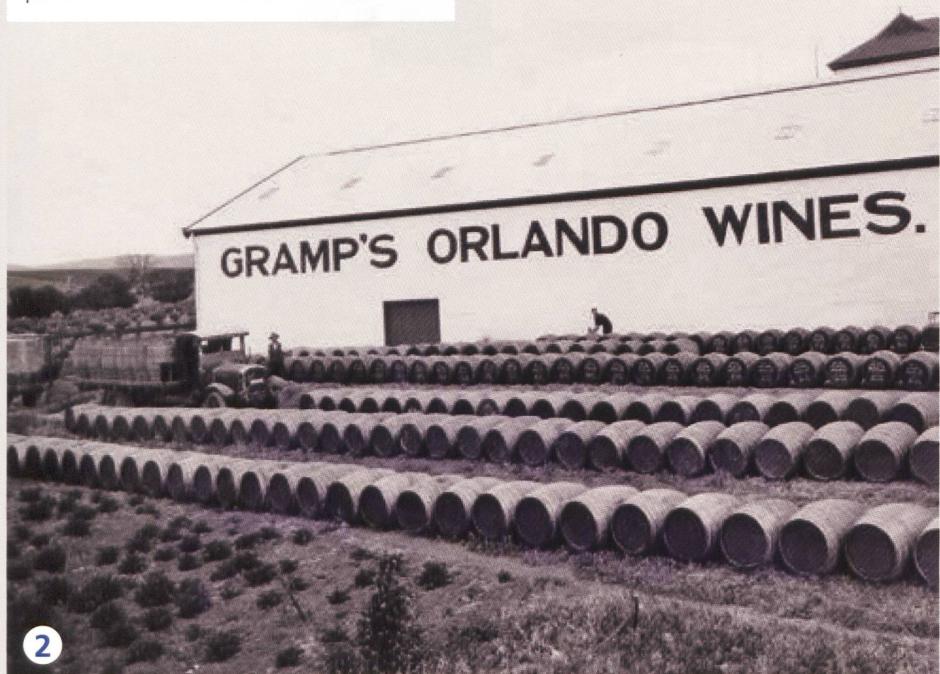
▲ c.1929 – the Saurer in the 'barrel' yard at the Rowland Flat Winery, loaded with export wine barrels. Note the truck is still on solid rubber tyres and lighting is still missing. © Gramp Family

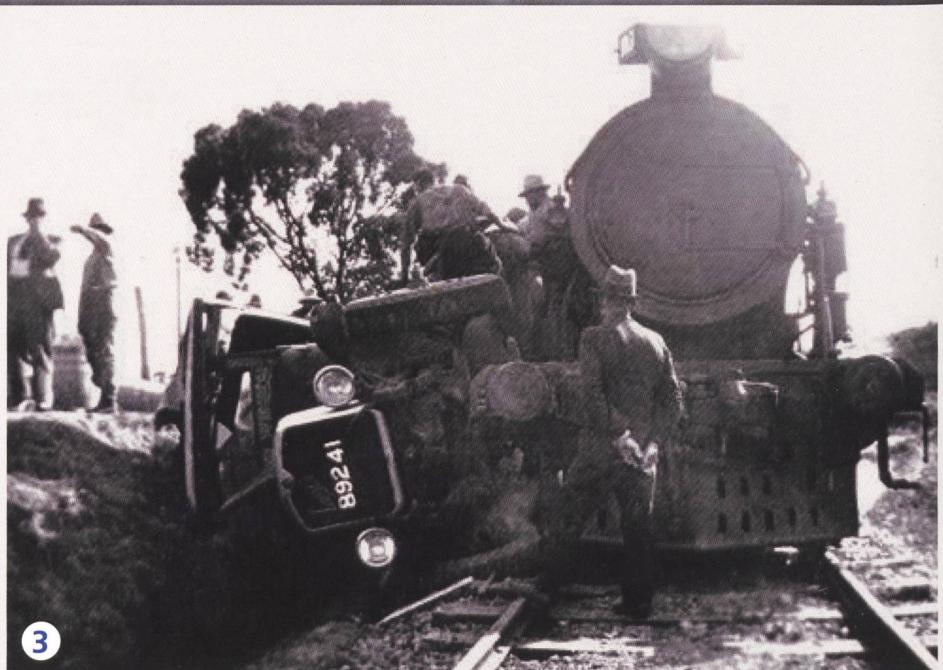
▲ Taken head on, the Saurer lies on its side after colliding with the Rx class locomotive on the Rowland Flat railway crossing. © Gramp Family

Continued... clear of the front of the locomotive, which caught the table of the lorry, which twisted the main chassis girders. Six hogsheads of wine were broken, the fluid being totally lost. The front of the locomotive was only slightly damaged, but it was unable to proceed and a special train was ordered to convey passengers to Adelaide and enroute.

ins Erdreich. Die Lokomotive trug nur einen Blechschaden davon. Auf dem Unglücksbild kann man sehen, dass der Saurer zweifellos umgebaut worden war, mit elektrischem Licht und Luftreifen ausgestattet. Der Saurer wurde wieder instand gestellt und diente insgesamt während 38 Jahren der Gramp Familie. Mitte der fünfziger Jahre wurde er dann remisiert wegen zu hohem Spritverbrauch und 1972 wurde er verschrottet.

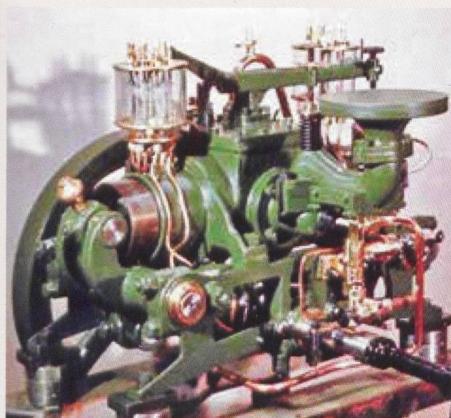
▲ The 1898 Saurer 5hp 'balancer' petrol engine. © Archive of Saurer Museum in Arbon

**1898** First passenger 'car' produced with a 5hp 'balancer' petrol engine introduced, which was a 1 cylinder opposed piston type, with a 28km/hr top speed.

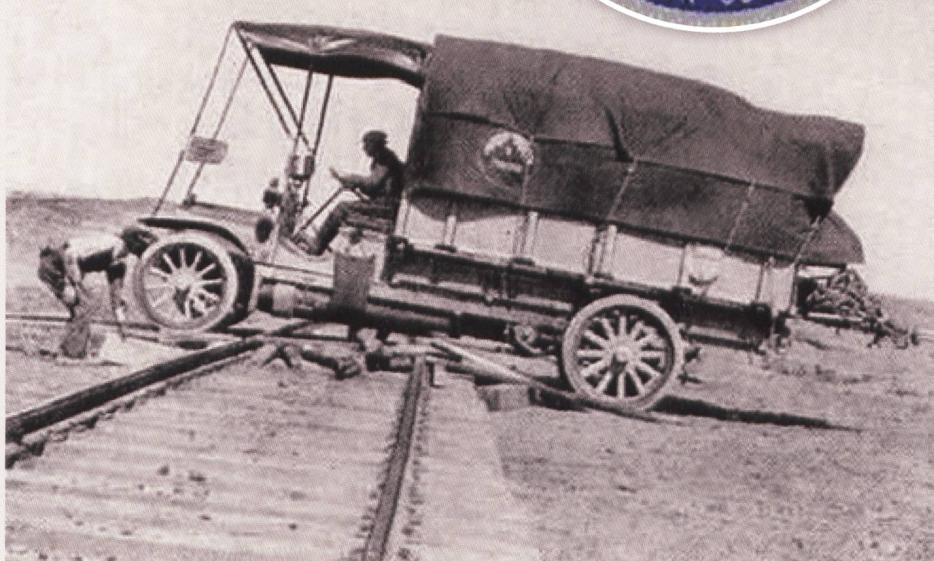
▲ In 1911, this Saurer truck with a 5 ton load crosses a railway line somewhere in the USA. It would complete the trip trouble free! © Archive of Saurer Museum in Arbon

**1911** Saurer is the first laden truck (5 ton) to drive across the USA from east to west.
