Zeitschrift: Gazette / Oldtimer Club Saurer
Herausgeber: Oldtimer Club Saurer
Band: - (2018)
Heft: 108

Artikel: Days of Wine and Saurers
Autor: Tol, Paul
DOI: <https://doi.org/10.5169/seals-1037368>

Days of WINE AND SAURERS

ARTICLE BY
PAUL TOL

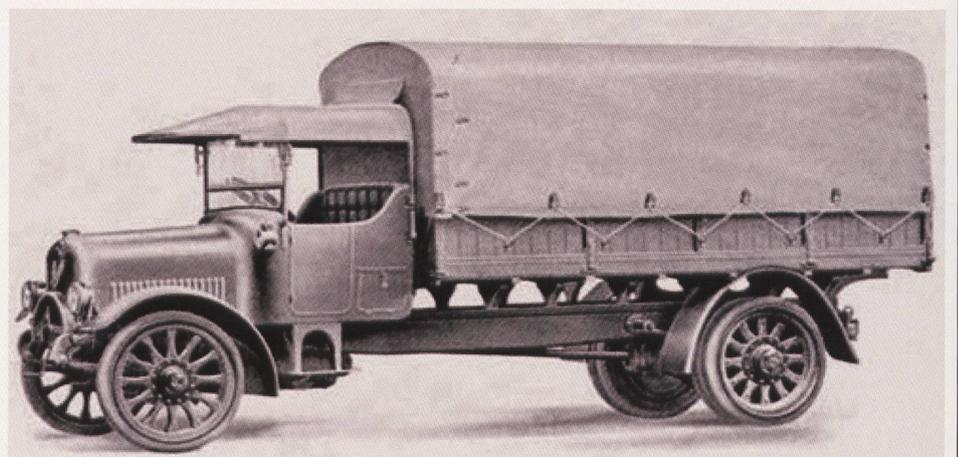
▲ The Saurer A Type, first released in 1917. The truck could be ordered with solid or pneumatic tyres. © Archive of Saurer Museum in Arbon.

1917 The 'A' Type truck was introduced, with this model being used by the Gramp and Hattey families. In all, about 2,700 'A' Types would be made, with this model ceasing in 1926.

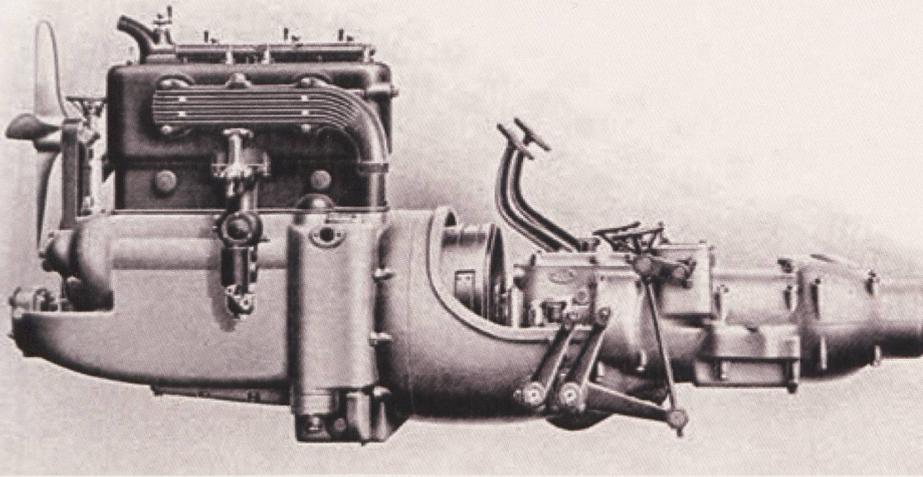
▲ The left-hand side view of the AD type petrol engine, bell housing and transmission assembly. The clutch is a cone type. © Archive of Saurer Museum in Arbon

The engine was Saurer's AD type, with the following brief specifications:

Bore: 110mm

Stroke: 180mm

Output: 40bhp @1,000rpm, maximum engine speed 1,250rpm. Fitted with Saurer's patented engine brake

Fuel: Petrol, fuelled through Saurer's patented two nozzle carburettor

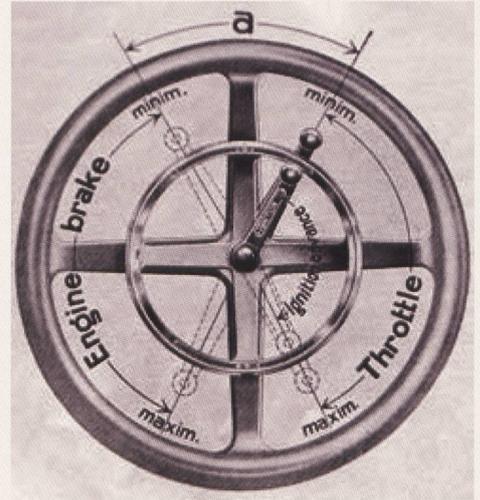
▲ The throttle and engine brake control lever is mounted on the Saurer's steering wheel. © Archive of Saurer Museum, Arbon.

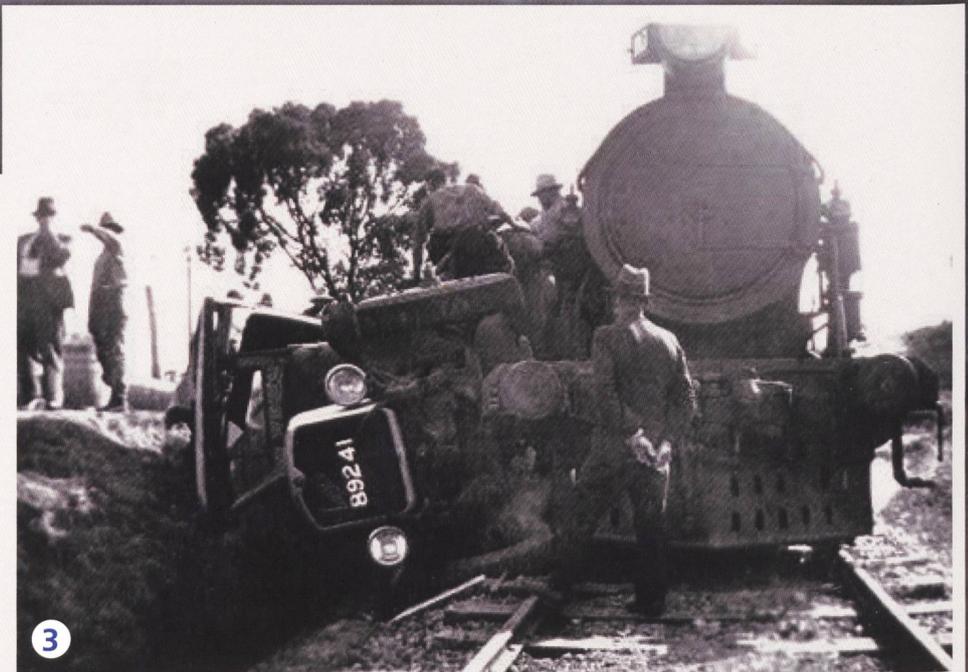
▲ Taken head on, the Saurer lies on its side after colliding with the Rx class locomotive on the Rowland Flat railway crossing. © Gramp Family

Continued... clear of the front of the locomotive, which caught the table of the lorry, which twisted the main chassis girders. Six hogsheads of wine were broken, the fluid being totally lost. The front of the locomotive was only slightly damaged, but it was unable to proceed and a special train was ordered to convey passengers to Adelaide and en-route.

ins Erdreich. Die Lokomotive trug nur einen Blechschaden davon. Auf dem Unglücksbild kann man sehen, dass der Saurer zweifellos umgebaut worden war, mit elektrischem Licht und Luftreifen ausgestattet. Der Saurer wurde wieder instand gestellt und diente insgesamt während 38 Jahren der Gramp Familie. Mitte der fünfziger Jahre wurde er dann remisiert wegen zu hohem Spritverbrauch und 1972 wurde er verschrottet.

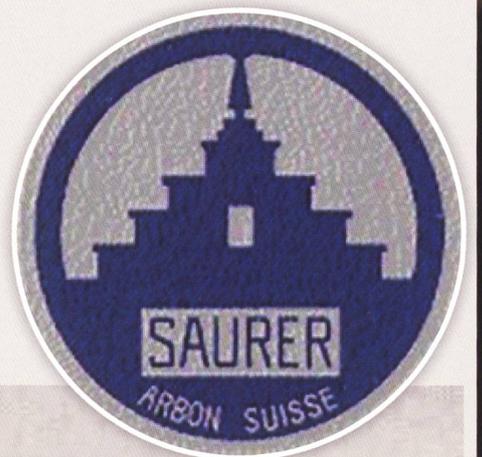
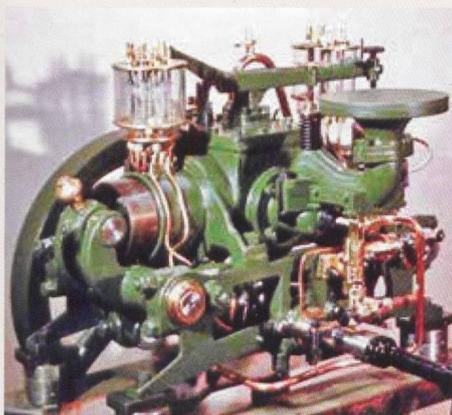
▲ The 1898 Saurer 5hp 'balancer' petrol engine. © Archive of Saurer Museum in Arbon

1898 First passenger 'car' produced with a 5hp 'balancer' petrol engine introduced, which was a 1 cylinder opposed piston type, with a 28km/hr top speed.
