Structural connections of prefabricated concrete units - some matters of current concern

Structural connections of prefabricated concrete units – some matters of current concern

By K. G. Bernander, Stockholm

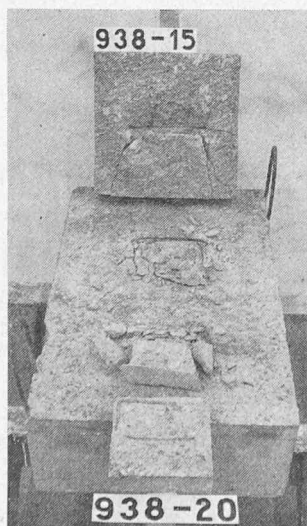
Fig. 10. Types of anchor rupture of stirrups cast into a thin concrete topping. Note the difference in type of rupture for smaller (15×15 cm²) and larger (30×30 cm²) surfaces. When size was (61.5×61.5 cm²) the rupture was a pure tension cone around the stirrup

Fig. 10 shows the mode of failure. In all cases here presented the anchor of the stirrup in the topping became critical, however, often at displacements beyond the maximum load.

Where small contact surface the anchor failure was due to splitting of the topping. Where large contact surface the failure in the topping formed a tensile rupture cone around the stirrup.
