**Artikel:** The accident at Aigle CFF station  
**Autor:** Edwards, Ian  
**DOI:** <https://doi.org/10.5169/seals-855295>

## THE ACCIDENT AT AIGLE CFF STATION

By Ian Edwards

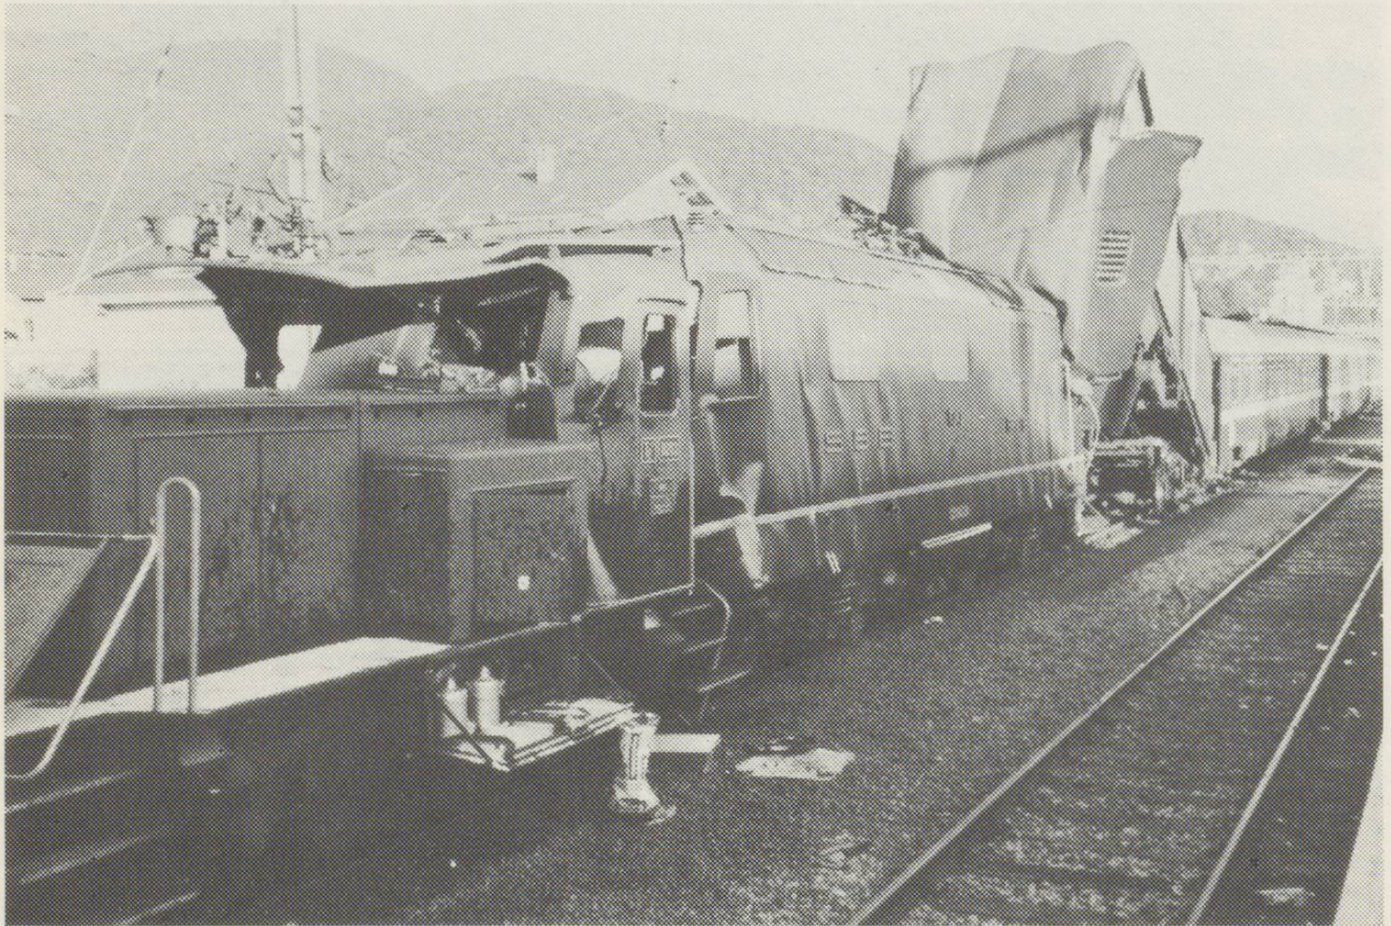
A local pickup freight train hauled by locomotive type Ae4/7 No. 11953 was stationary on the track at platform three, while a shunter type TeIV No. 8203 removed two of the parcel wagons and reversed down to the south end of the loop. In the meantime the main line route through the station was signalled for the passage of the 105 Km/h Milan to Geneva Eurocity express hauled by locomotive Re4/4 No. 11343. The initial impact at between 60 to 80 Km/h was between the express and the shunting locomotive, in which the TeIV and its two baggage wagons was pushed all the way back up the loop into the rear of the pickup freight. The second impact was between the express/shunter and the pickup freight.

*Collision of EC "Lemano" with freight train at Aigle.*

The impact with the pickup freight caused the destruction of a closed freight wagon, and forced one of the open wagons type Fs-u No. 987 up onto the overhead catenary gantry in doing so unloading vegetables onto both track and platform. The shunting engine was badly damaged both front and back and lost its pantograph in the accident. On the express train the damage consisted of; the locomotive was badly crushed in the front and the rear, the RIC Baggage coach Type D No. 51 85 92 70 107 located

Just one and a half hours after the accident, the wiring crews were hard at work clearing away the damaged catenary and wires and installing new parts. It was around 2100 hours that the first train - southbound towards Brig - passed through the area, headed by an Re4/4IV No. 10103 with its pantograph lowered and being propelled by locomotive type Em3/3 No. 18810 located at the rear of the train.

The next morning when I returned to the station at 1000 hours, I found that during the night the double slip points at the entrance to the loop had been replaced. The RIC baggage coach had been cut into two pieces and deposited along with the remains of the freight wagon - which had ended up on the catenary gantry - on the goods platform. The coaches of the "Lemano" had been towed away during the night to St. Triphon just 5 kilometres south of Aigle. The two locomotives remained locked together until about 1400 hours, as they were parted the full extent of the damage to the Re4/4II locomotive could be seen. The pantograph was missing, the rear cab was completely crushed by the baggage coach, the front cab was pushed back by the impact

With all the damaged rolling stock out of the way, the permanent way teams set about replacing all the damaged and buckled track in the loop area. It was the end of the week before the loop was back in full use and normal service was resumed through the station. All that could be seen to indicate something out the ordinary had occurred, were some button carrots lodged in the most unlikely places. At this time the actual cause of the accident is not known but it would point to being human error, this will be proved or disproved when the results of the C.F.F. inquiry are announced.

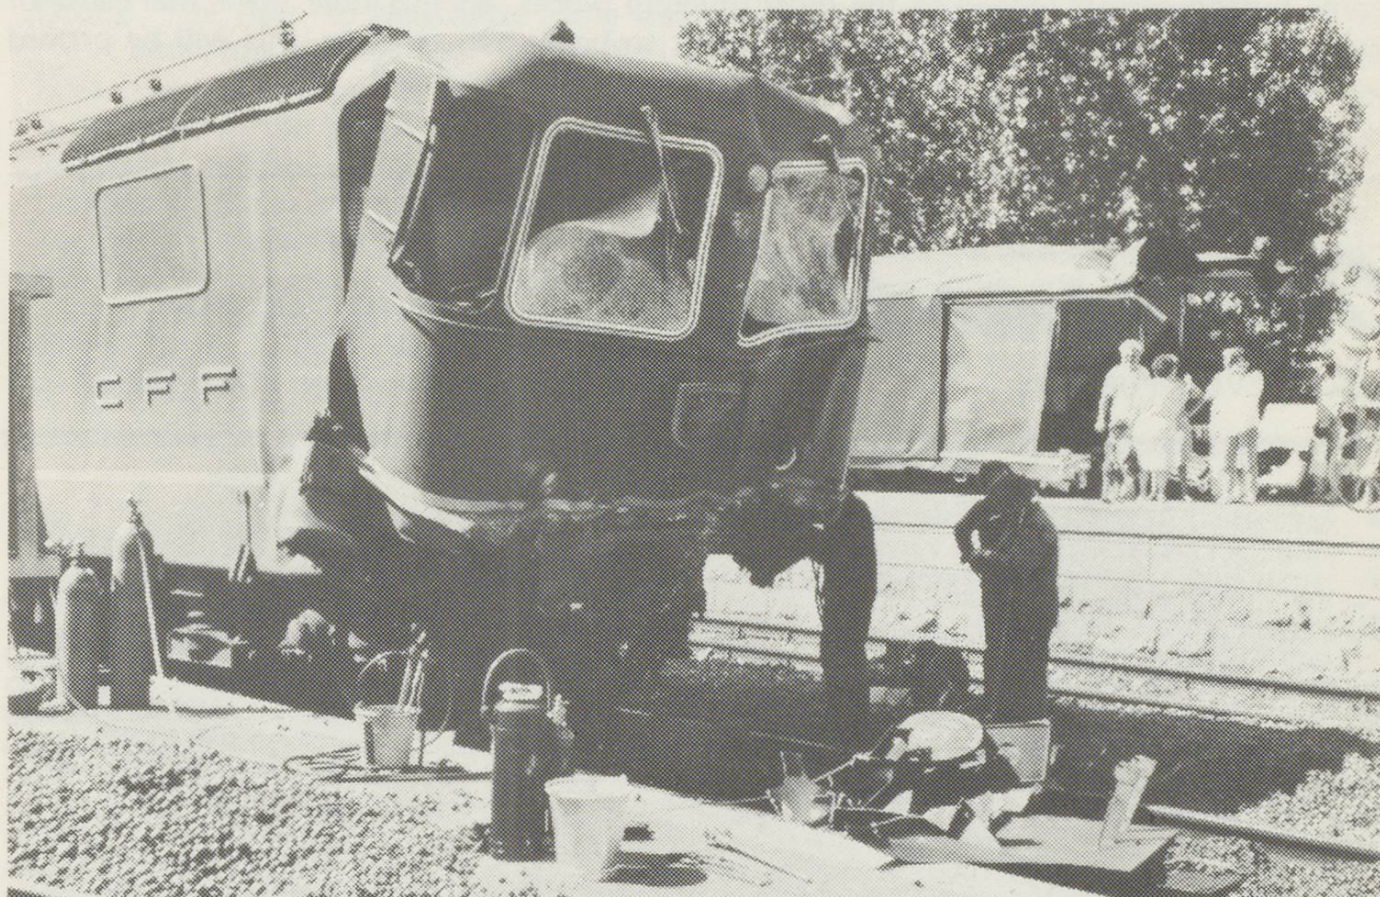
just behind the Re4/4 was bent double as it was pushed upwards through the front of the platform canopy before coming to rest above the locomotive, the first of the C.F.F. type Bpm coaches was damaged where the baggage coach had crumpled the front area, and the restaurant coach lost its pantograph as the overhead wires were dragged down. The rest of the coaches of the express appeared to be undamaged and remained on the track. Catenary wires through a large part of the station area were brought down. Amazingly, when the rescue teams arrived just minutes later they found that nobody was seriously hurt but about fifty people required treatment for minor injuries and shock. Fortunately the driver of the express escaped injury, as he could be seen walking around inside the locomotive looking for an exit as both doors had been crushed, eventually leaving via one of the side windows.

*Re4/4II locomotive No. 11343, showing damage to front area.*

with the shunting locomotive, and the front bogie had been pushed back about 400 mm. Before the Re4/4 locomotive could be moved the buffers had to be cut away along with all equipment below the cab floor including the front part of the bogie itself. When this had been done the locomotive was jacked up to enable the bogie to be replaced onto the track, it was then towed away. Just after 1400 hours the remains of the pickup freight had been checked and any repairs that were required prior to moving it had been done, it was then taken away closely followed by the TeIV shunting locomotive.
