Artikel: The nitpicker strikes again. Part 1, Early 2-axle vans

The Nitpicker strikes again Part 1

Early 2-axle vans

by John Jesson

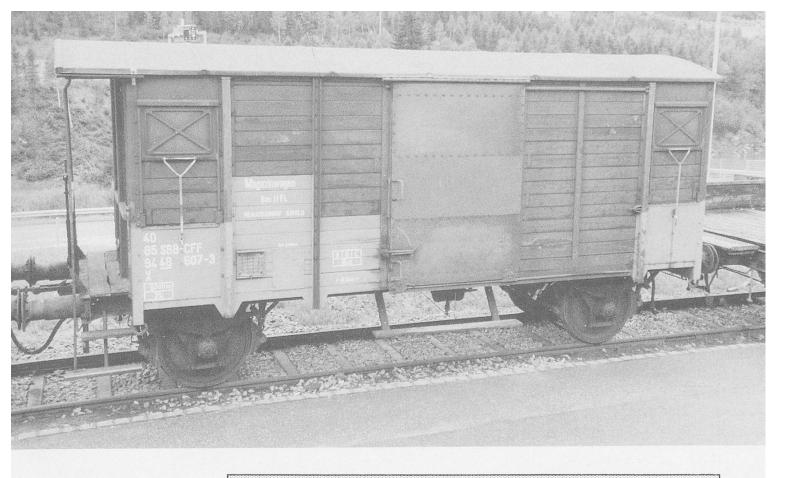
No K2 vans remain in revenue-earning service on the SBB, but many are in evidence as departmental vehicles. These two, now stores vans, were photographed at Airolo in September 1994. 48 607 is allocated to Airolo and carries inscriptions in German, the old inscriptions have been painted out, as has the door logo. 45 637, which has had the benfit of a new coat of paint, belongs to Rodi-Fiesco and its inscriptions are in Italian.
